# Deterioration of Iowa Highway Concrete Pavements: A Petrographic Study

Paul E. Stutzman

December, 1999

## **Executive Summary**

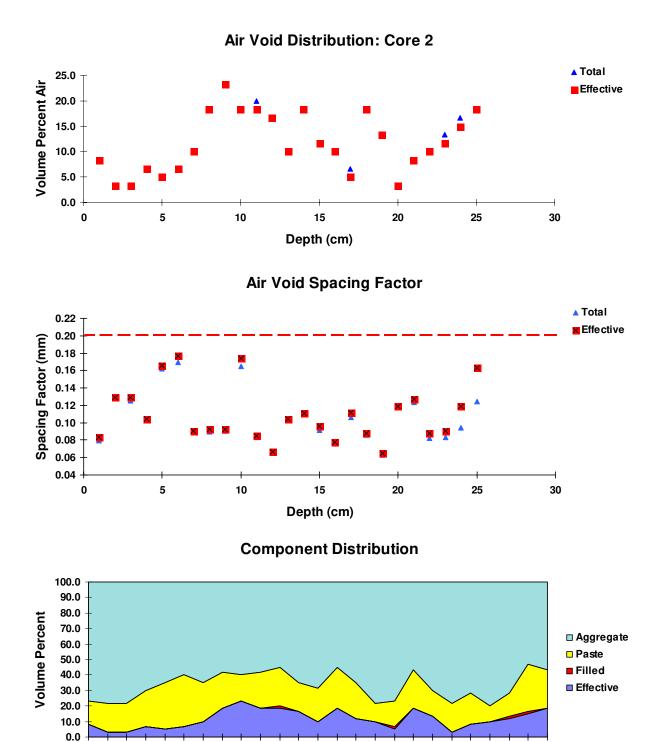
Figure 13. Iowa 175 Core 2 air void and materials distribution plots. A decrease in air near the surface may reflect the loss of entrapped air. The blue triangles represent an air void parameter estimate for the original concrete; the red box represents that value as affected by void filling, if present.

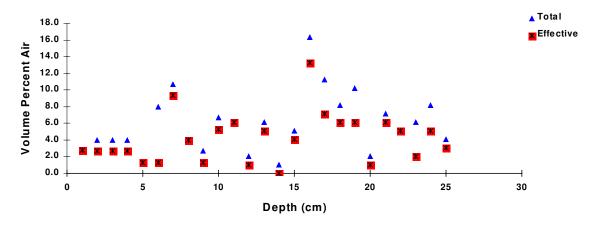
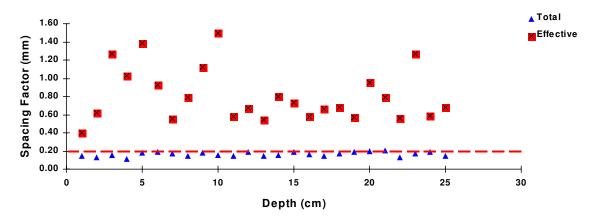
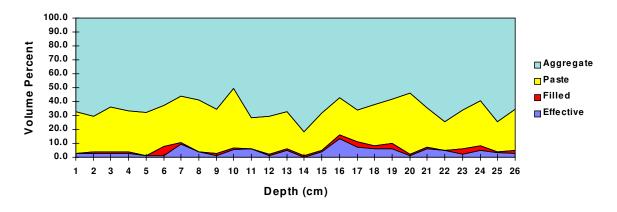
Figure 18: Air void distribution, spacing factors, and concrete component distribution versus depth for Core 7. The red boxes represent the current value, the blue triangle, the original value, and the red line in the spacing factor plot denotes the ASTM C 457 recommended limit for freeze-thaw protection.

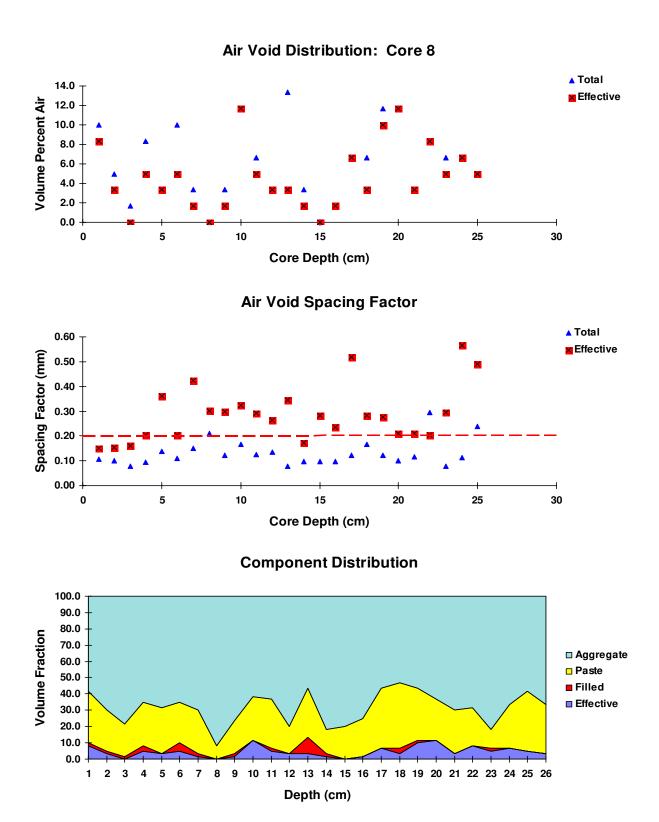
Figure 19: Air void distribution and spacing factors versus depth, and concrete component distribution for Core 8, mid-panel.

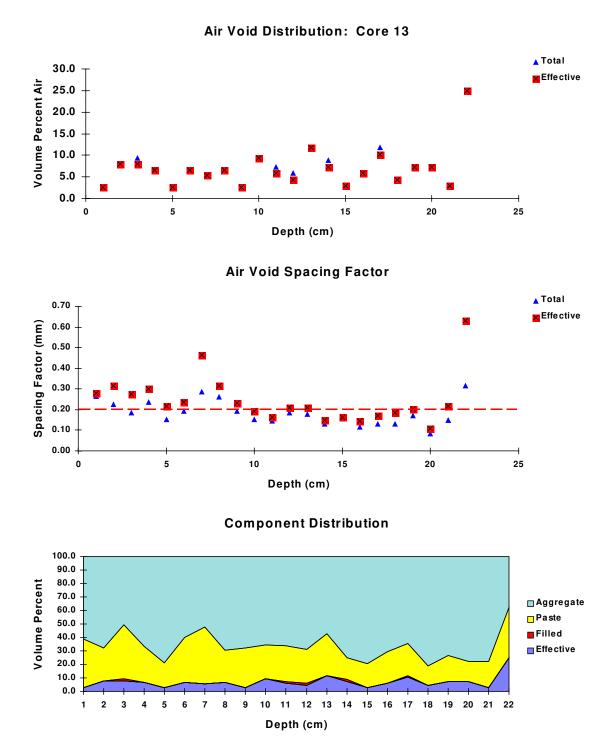
Figure 25. Air void distribution and spacing factors versus depth, and concrete component distribution for Core 13. The air volume appears uniform with depth while the spacing factor appears substandard in the upper 100 mm. Filling has resulted in a slight increase in the spacing factor.

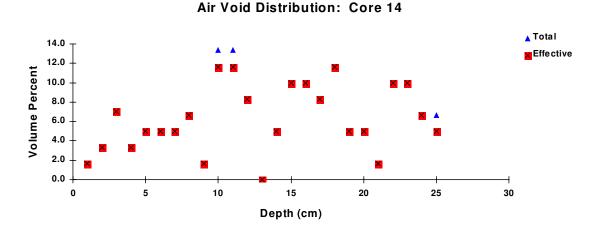
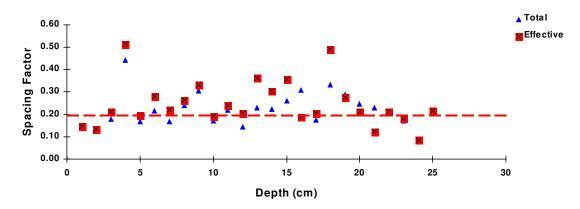
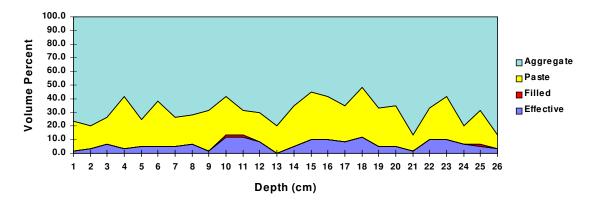
Figure 26. Air void distribution and spacing factors versus depth, and concrete component distribution for Core 14. The total air volume appears similar to that of Core 13 from the joint and appears uniform with depth (deviations from the median probably reflect entrapped air voids). The spacing factor appears marginal to sub-standard at depths below 6 cm, and filling of the smaller entrained air voids has resulted in an increase in void spacing factor.

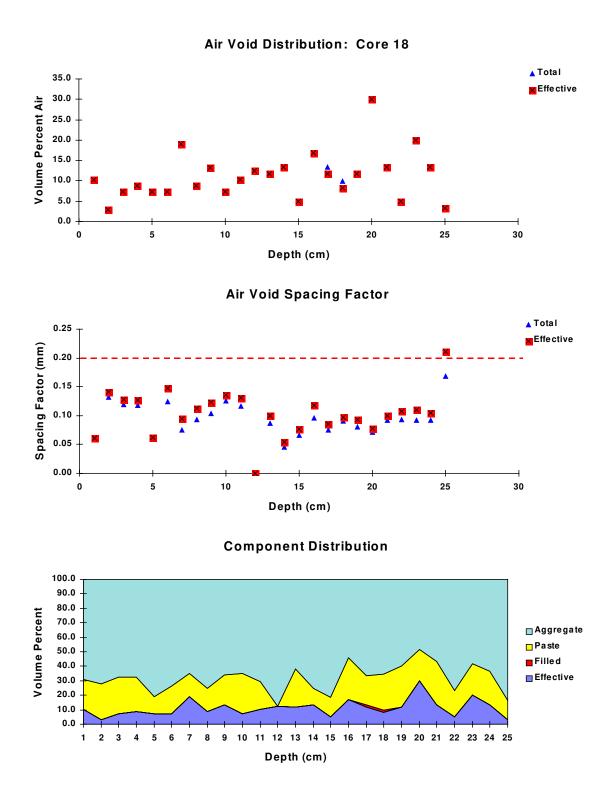
Figure 28. Air void and component distribution plots for core 18. Little loss of air void volume is evident with only a slight, uniform loss of air void spacing factor. Component distribution appears uniform from top to bottom.

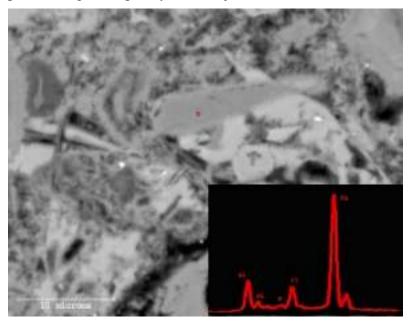
Figure 30. Friedel's salt in hardened paste is identified here using X-ray microanalysis. It appears to be a primary hydration product in the paste throughout the cores, suggesting that it may be a result of the presence of chlorides in the original mix as opposed to the infiltration of road salts.

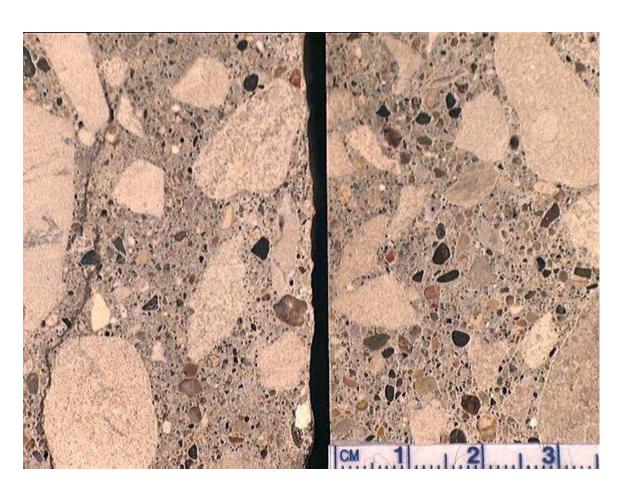
Visual examination of Cores 18 and 19 found a likely difference in aggregate grading (Figure 35) with Core 18 appearing to have a more uniform, and perhaps smaller, aggregate gradation. The apparent change in aggregate gradation may have affected the development of the higher-volume entrained air void system in Core 18. However, specific surface values indicate a coarse air void size distribution.

Figure 35. Core 19 (left) appears to have a finer-sized sand and possibly a larger maximum coarse aggregate size when compared to Core 18 (right).

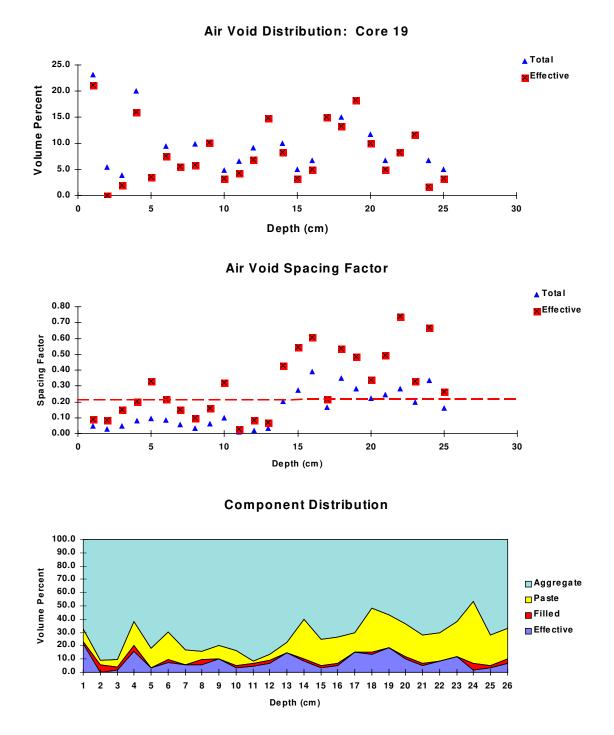
Graphical representation of the air void and component distributions indicates a decrease in spacing factor and an increase in cement paste content with depth (Figure 36). The spacing factors for both the total (original) and effective systems fall beyond that necessary for frost protection at depths greater than 150 mm.

Figure 36. Core 19 data show a decrease in spacing factor with depth and possibly a trend to an increased loss of spacing factor with depth. The component distribution plot shows a possible increase in aggregate and decrease in paste in the upper half of the core.

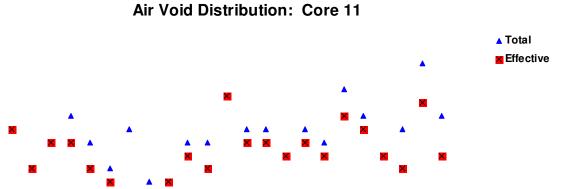
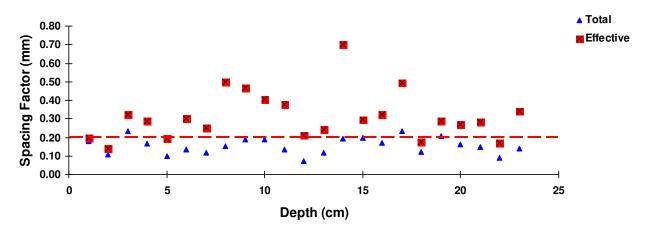
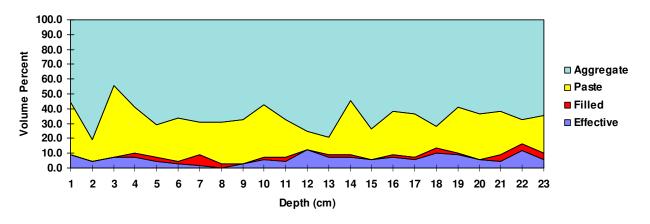
Figure 41: Core 11 air void parameters and component distribution show a loss of air void spacing yet relatively uniform air void volume and materials distribution.

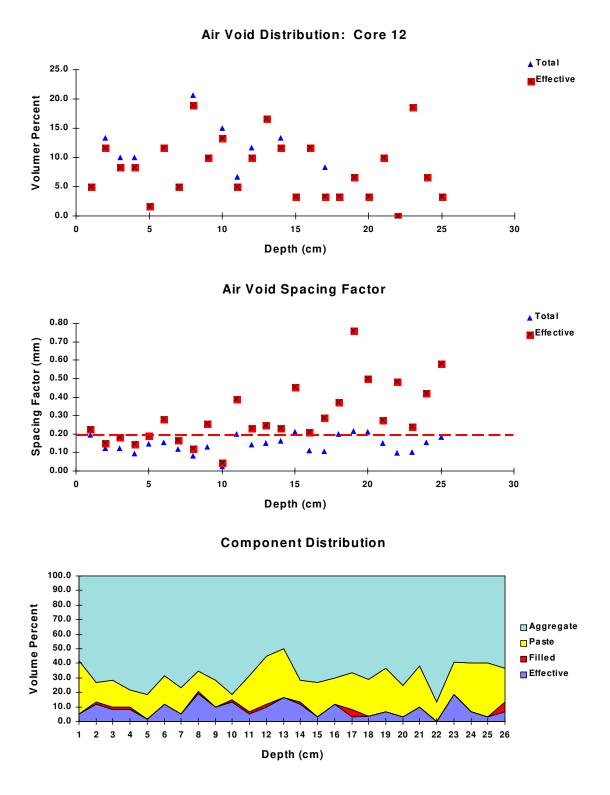
Figure 42. Core 12 air void volume and spacing parameters, and component distribution shows an increased degree of entrained air void filling with depth.

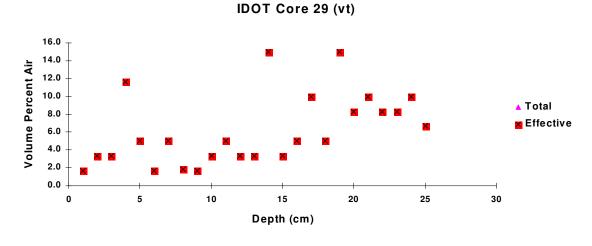
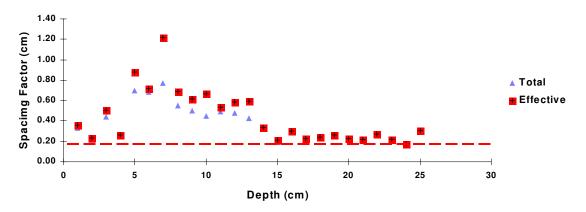
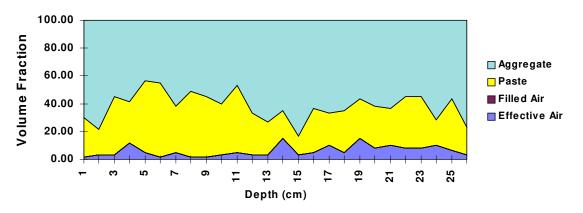
Figure 44. Core 29, centered on a well-defined vibration trail exhibits a significant increase in spacing factor in the upper half. This probably represents the zone of influence of the immersion vibrator probe. Note that the spacing factor is generally not satisfactory at any depth.
