Dynamic investigation on the Mirandola bell tower in post-earthquake scenarios

Abstract After the seismic events of the 20th and 29th of May 2012 in Emilia (Italy), most of the monumental and historic buildings of the area were severely damaged. In a few structures, partial collapse mechanisms were observed (e.g. façade tilting, out-of-plane overturning of panels...). This paper presents the case-study of the bell tower of the Santa Maria Maggiore cathedral, located in Mirandola (Italy). The dynamic response of the structure was evaluated through operational modal analysis using ambient vibrations, a consolidated non-destructive procedure that estimates the dynamic parameters of the bell-tower. The dynamic tests were carried out in pre-intervention and post-intervention conditions in order to understand the sensitivity of dynamic measurements to safety interventions. Furthermore, a comparative study is made with similar cases of undamaged masonry towers up to the 6th mode. Finally, an investigation on the state of connections and of the building itself is carried out via FE model updating.

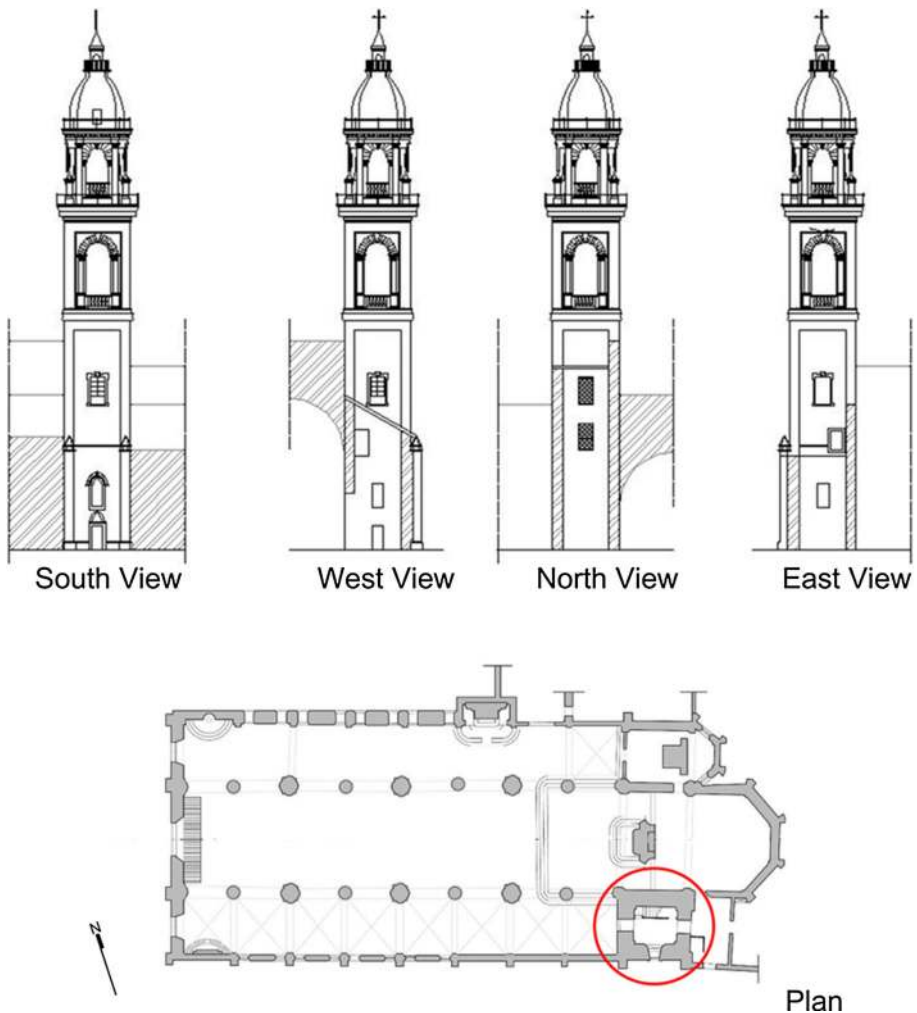
Fig. 1 Main fronts of the bell-tower and plan

The construction of the bell-tower of S. Maria Maggiore cathedral in Mirandola (Modena, Italy) (Fig. 1) started in the late fourteenth century. The bell-tower, made of brick masonry, is located on the south-east side of the cathedral. It is square in plan with dimension of 5.90 m and has a current height of 48 m. The building, like the whole cathedral, is the result of several alterations which occurred over the centuries. The most relevant modifications were made in the seventeenth century when the height of the original tower was tripled (Ceretti 1889) and the structure was reinforced and partially rebuilt to withstand the new loads. Another important alteration dates back to the eighteenth century, when the bell-tower was completed with an octagonal stone roofing.

The bell tower has two orders of large openings close to the top, unusually the larger ones are at the lower level (21 m) and the top ones at the belfry level (30.5 m). In the

bottom part of the tower there are other modestly sized openings and some of these have been successively walled up. The internal flooring of the tower bell are masonry vaults, as visually confirmed by a post-earthquake survey. Moreover, a series of small stone flights of stairs connects the various levels of the structure up to the belfry. There is no information available about the foundations of the tower to the authors. The geologic settings of the area of Mirandola were analysed by Milana et al. (2014). The area of Mirandola is characterized by a modest historical seismicity. Until the 2012 Emilia Earthquake in which the maximum intensities were recorded, the seismic events occurred did not cause significant damages to the tower.

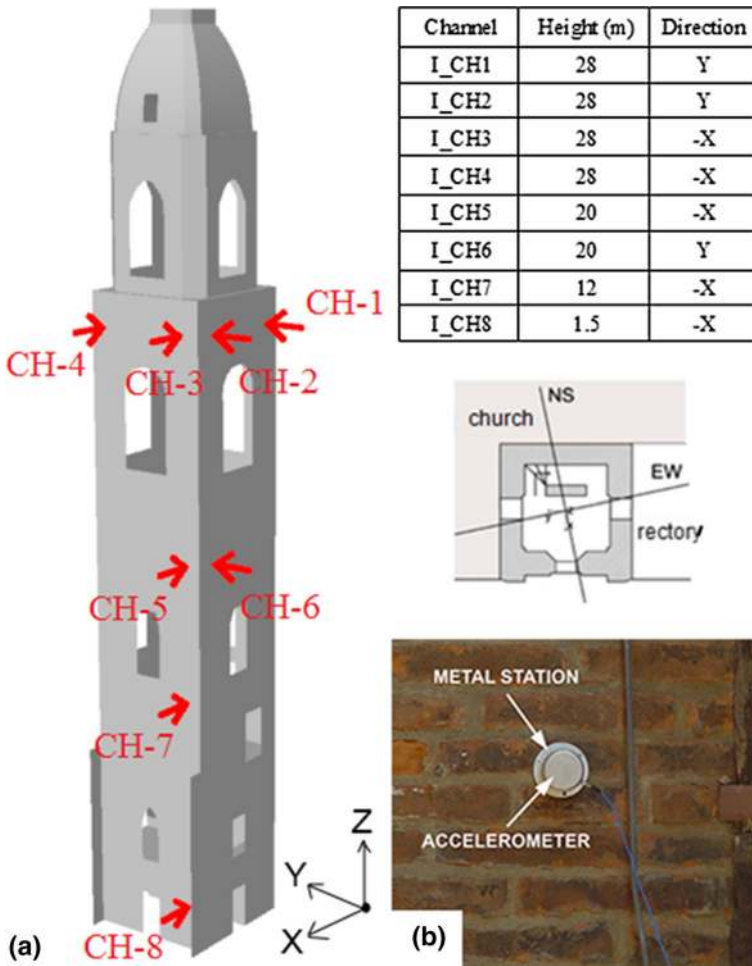
Fig. 6 a Instrumentation setup, location and orientation of accelerometers. b Detail of the installation of the accelerometer on the bell-tower

The accelerometers were installed by means of special metal bases fixed directly on the wall with expansion anchors (Fig. 6b). The metal bases were left in place to simplify the execution of more tests to assess further damage and the long-term effectiveness of the

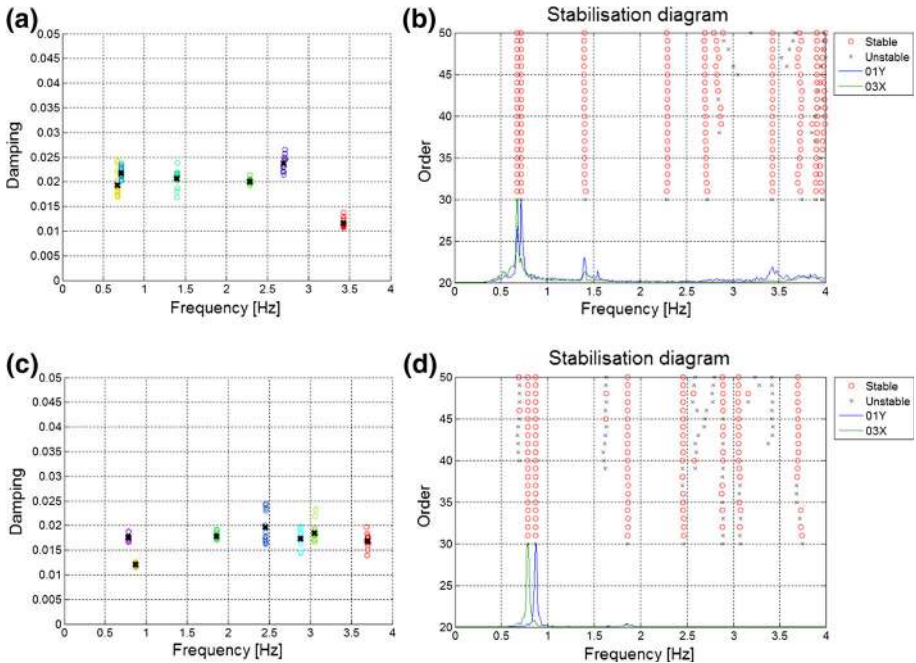
Fig. 7 Bell-tower modal identification results (frequency-damping clustering and stabilisation diagram): **a**, **b** PR-I, **c**, **d** PS-I. The stabilisation parameters chosen for the graph were: $\delta f = 0.005$, $\delta \zeta = 0.1$, $MAC = 0.95$

Figure 7 shows the stabilisation diagrams obtained for some of the signals made available by dynamic monitoring. The identification procedure entails a series of pre-processing operations on the signals (mean removal, de-trending, filtering) carried out by an expert operator in order to ease the identification process of the algorithm. For a detailed discussion on the identification process for masonry structures one can refer to Ceravolo et al. (2016).

From the modal frequencies and from Δf it can be clearly noticed how the installation of the safety interventions mitigated the effects of the extensive damage suffered by the bell-tower (De Stefano and Ceravolo 2007). In fact, the first two bending modes (Table 1) increased of the 16 and 21 %, from 0.68 and 0.72 to 0.79 and 0.87 Hz; whereas the first torsional mode had an increase of 32 %, from 1.41 to 1.86 Hz. For what concerns the damping ratios, the trend is not as clear. Anyhow, 6 out of the 8 modes listed in Table 1 show an increase in the damping ratios after the interventions.

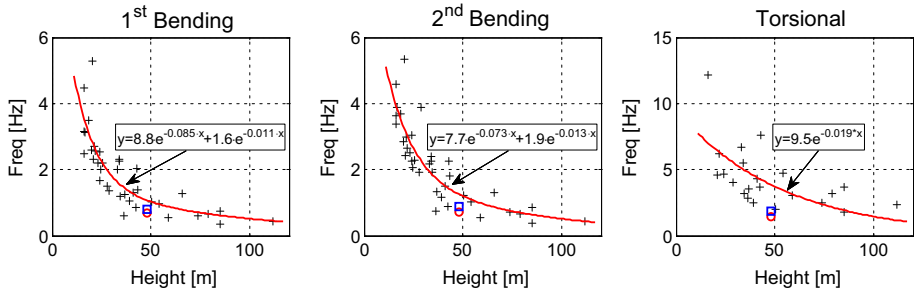
The first three modes of the bell tower were then compared with those of about 40 masonry towers or bell towers from across Europe. This highlighted how the two flexural modal frequencies of the damaged scenario are significantly lower than the typical ones of other bell-towers of comparable height. From these same data it can be inferred that the torsional mode is even more distant from the “ideal” trend of frequency as a function of

height represented by the lines in Fig. 8. This is most probably a symptom of a severely damaged structure, where box-like behaviour has been strongly affected. In fact, stiffness along the plane of the masonry walls is relatively less affected by the presence of cracks than torsional stiffness, which is influenced by the state of the connections between orthogonal wall panels. The full list of bell tower modes, up to the sixth, can be found in Table 2.

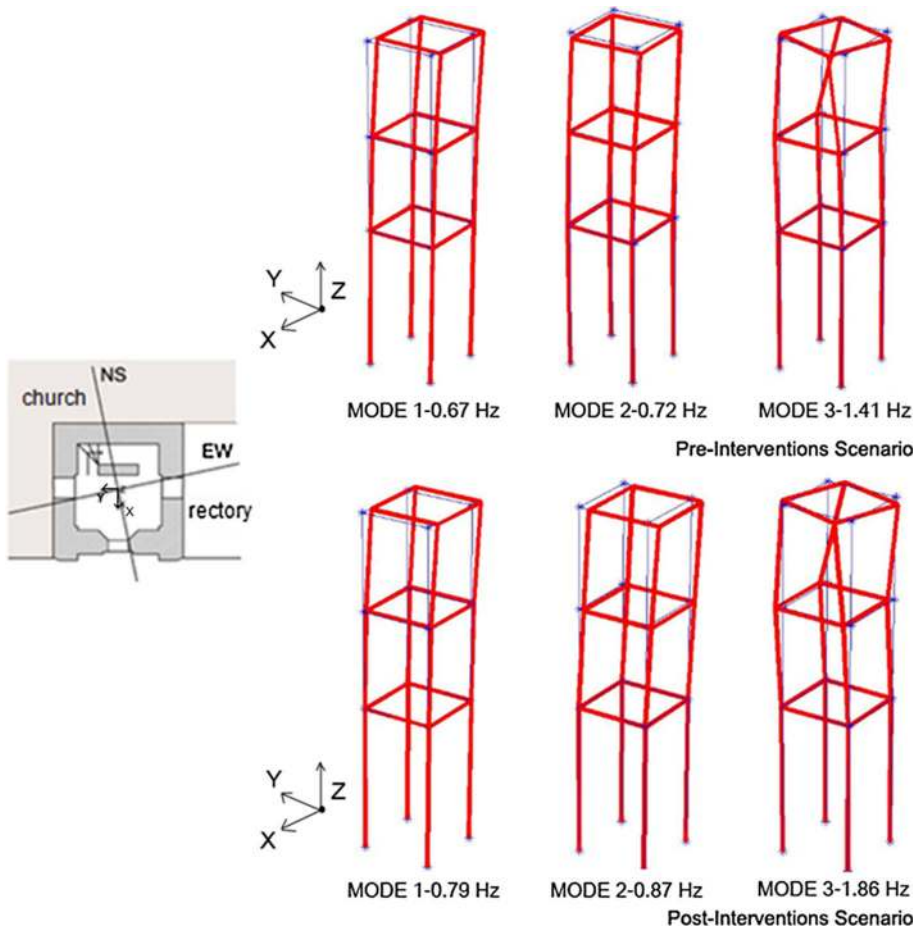
Fig. 9 Bell-tower identified frequencies and modal shapes in the PR-I scenario and the PS-I scenario

It is also worth noting that, in the PR-I condition, the first and the second flexural modal shapes, directed along E–W and N–S directions respectively, show a coupled behaviour and a value of Modal Assurance Criterion (MAC) of 0.495, whereas after the strengthening interventions they appear almost perfectly aligned with the principal axes of the tower, the MAC decreases to 0.001 (Fig. 9).

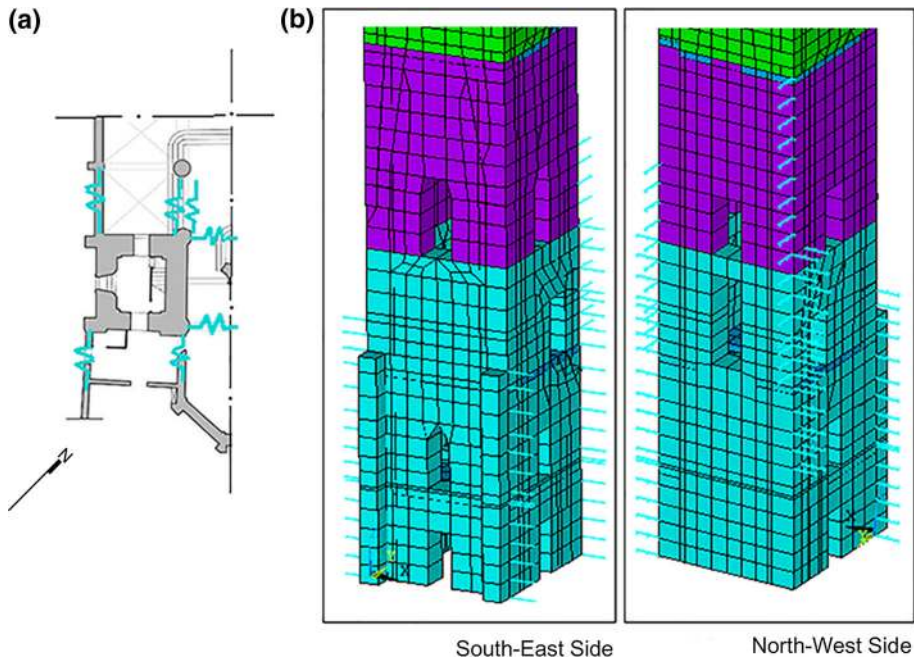
Fig. 11 **a** Idealisation of spring elements as boundary conditions due to nearby buildings. **b** Localization of the 3D-linear spring elements on the FE model

For the boundary conditions of the tower, and specifically its interactions with the adjacent buildings (i.e. the Cathedral of Santa Maria Maggiore and the rectory), linear spring elements were used on each side (East, West and North) in correspondence to the rectory wall, the apse arches and the nave walls, as it is possible to notice in Fig. 11. In the

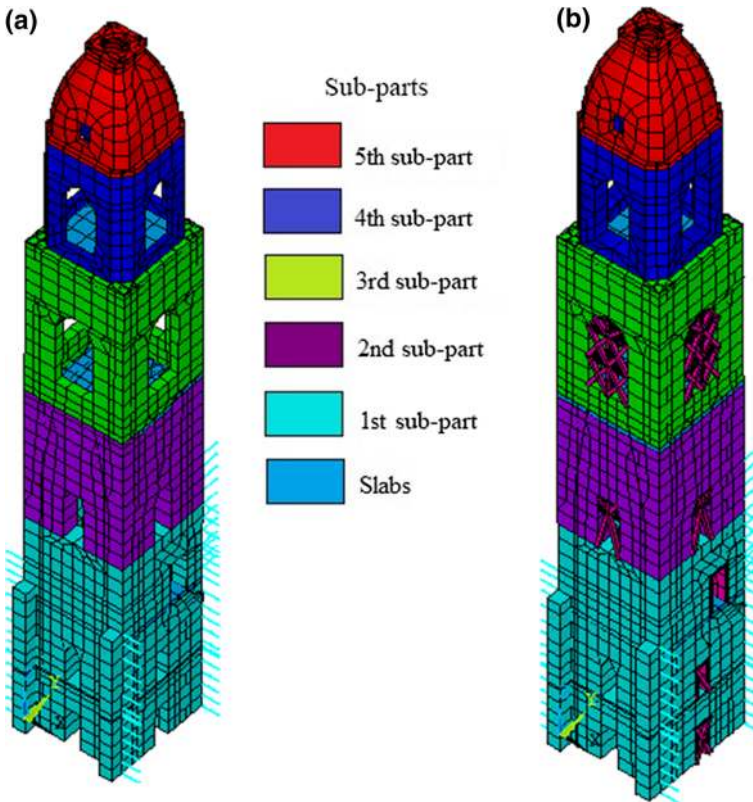
Fig. 12 Baseline FE model of the bell-tower subdivided in sub-parts (a), FE model with safety interventions (b)

In a second phase, the safety interventions were added to the FE model (Fig. 12b). The interventions were modelled resorting to beam and truss type finite elements idealising the wooden falsework installed in the openings of the bell-tower at the different levels (Fig. 5). The material properties (Young modulus: 8 GPa, Shear Modulus: 0.5 GPa, density 370 kg/m^3) assigned to these elements were chosen according to the Italian Fire Department's manual for safety wooden interventions (Ministero dell'Interno and Corpo Nazionale dei Vigili del Fuoco 2011). The metal tie-rods were not modelled with specific finite elements, but the effect of their presence is evaluated indirectly during the model updating phase by the variation of the mechanical properties. If the intervention is effective, the metal tie-rods

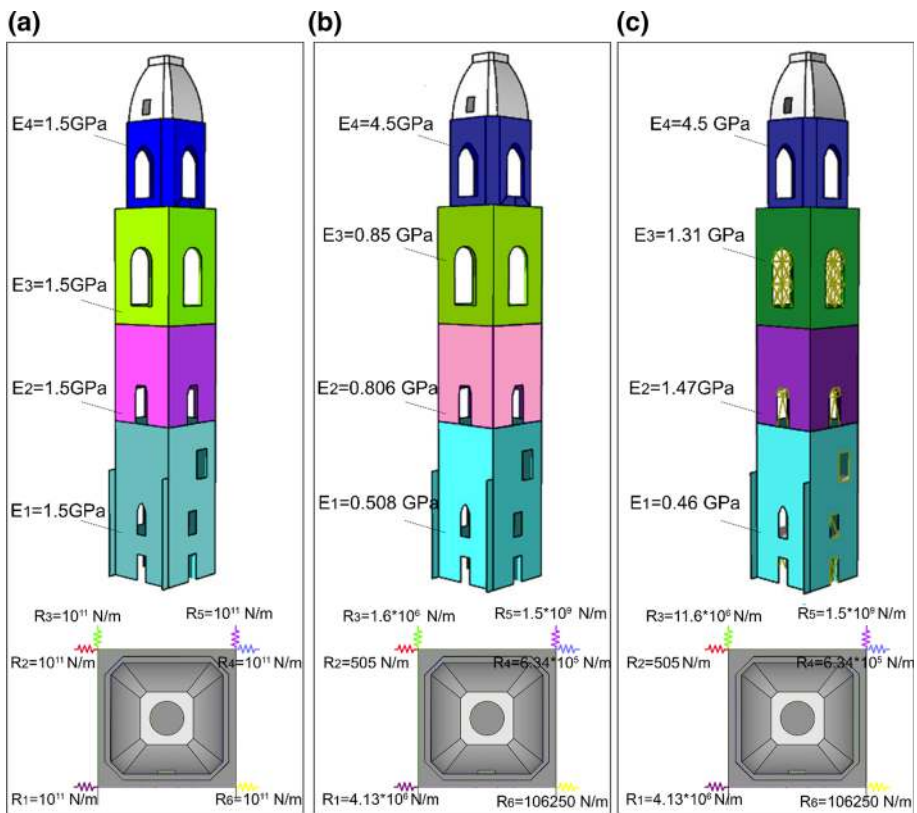
Fig. 14 Model updating results: initial values (a) and the updated values for the pre-intervention scenario (b) and in the post-intervention scenario (c)

The results of the updating procedure provide further information about the bell-tower damage state (Fig. 14b): the value of 0.508 GPa for the Young modulus of the first sub-part and the others of the upper levels, 0.806 GPa for the second level and 0.85 GPa for the third one, refer to heavily cracked regions of the building. Moreover, these results suggest that the first sector is strongly influenced by adjacent bodies, that have stiffened the basement of the tower, especially on the west side, where the spring-element $R_1 = 4.13 \times 10^6$ N/m represent the external wall of the church’s nave; and on the east-side where $R_5 = 1.5 \times 10^9$ N/m, $R_4 = 6.34 \times 10^5$ N/m, $R_6 = 106,250$ N/m model the rectory building.

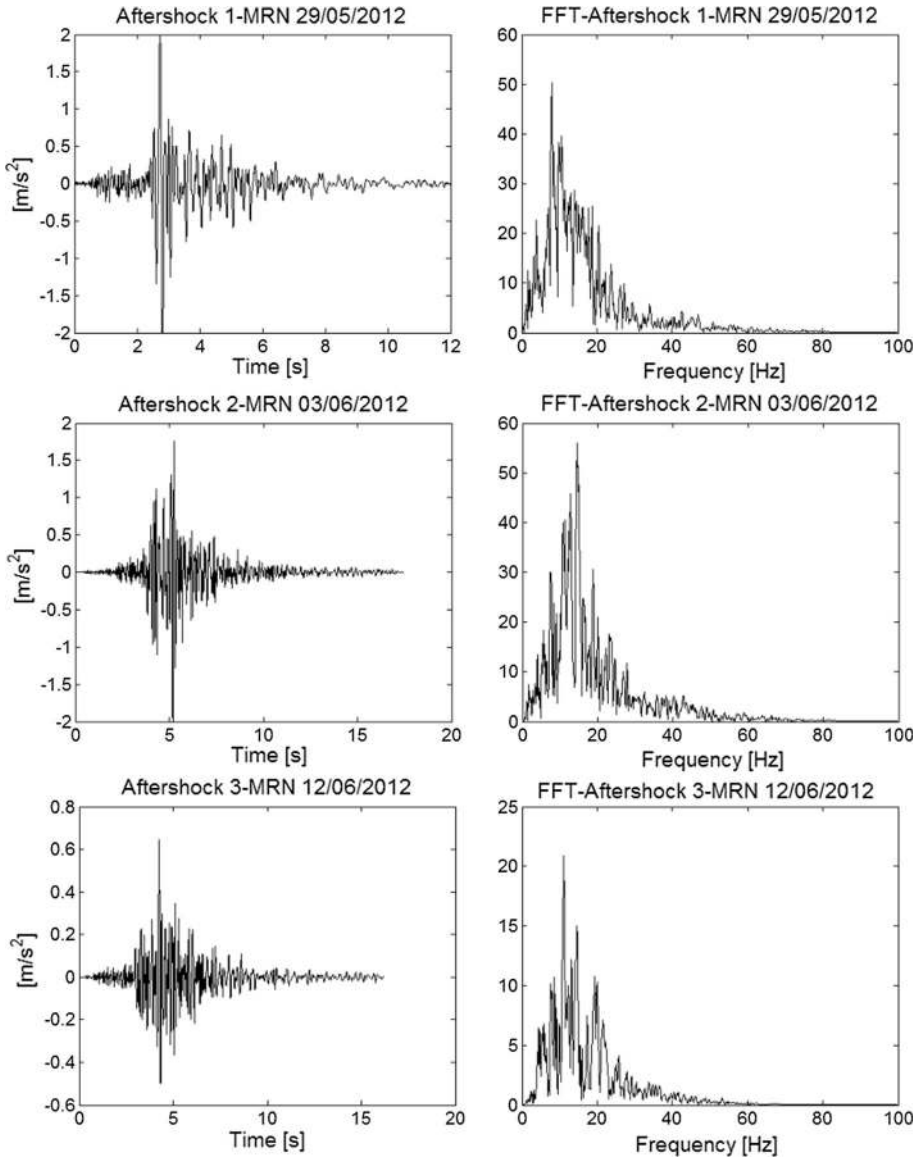
**Fig. 15** Acceleration and frequency response spectra of the three aftershocks related to the respective main direction

Figure 15 shows the aftershock accelerograms used as input for the dynamic analysis and their frequency content. For brevity's sake, only the accelerograms referring to the main direction of the earthquake are reported (which are respectively N–S for the first two and E–W for the third one) but a three component excitation has been applied to the FE model.

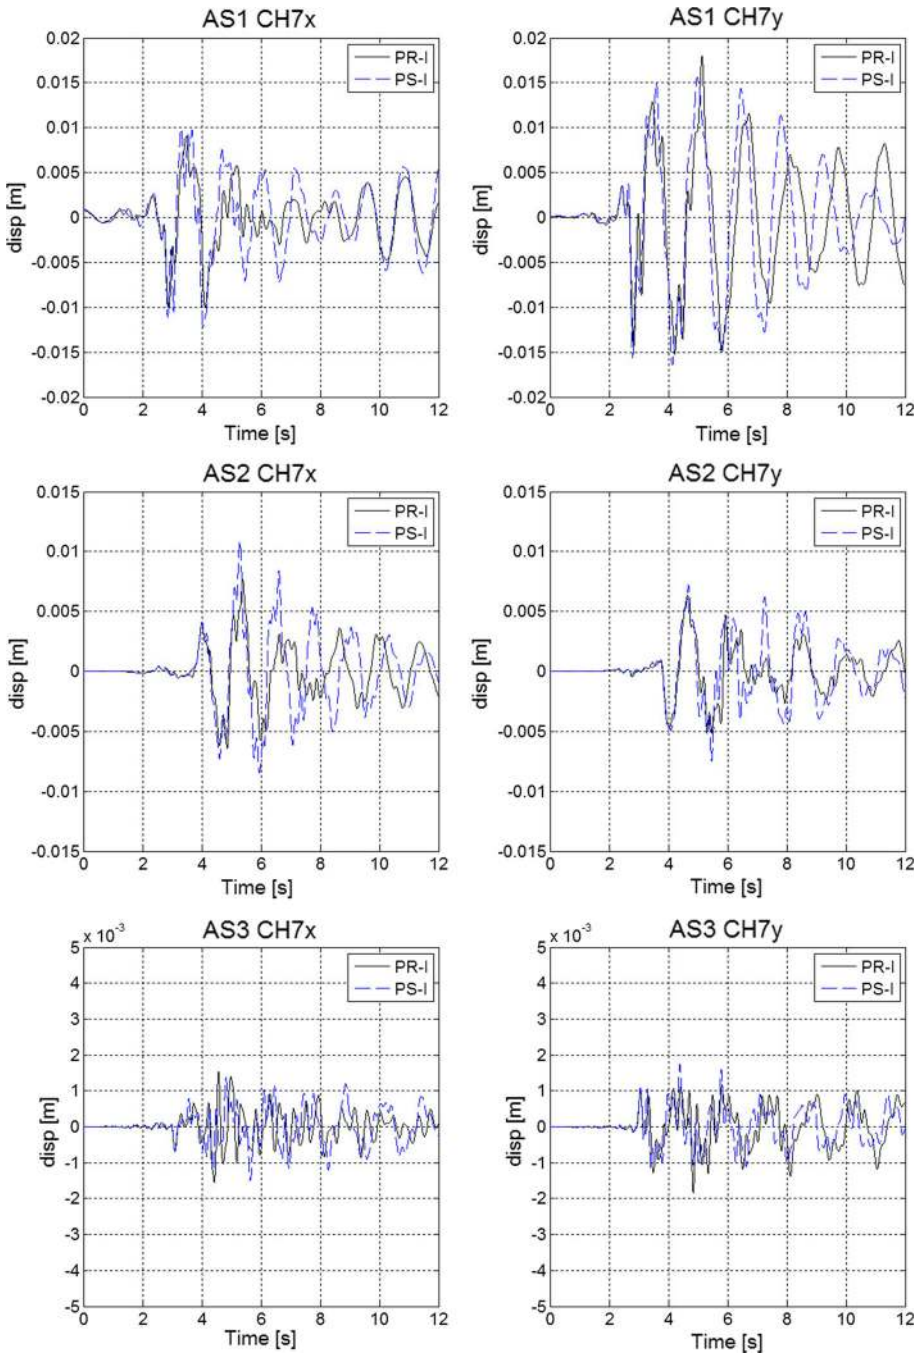
Fig. 16 Comparison between the displacement responses related to CH7-position (direction x —first column, direction y —second column) in the pre (red line) and post (blue line) condition

The maximum displacements values are obtained for the CH-7 position, located in a higher, thus more flexible region of the tower, where the most severe damages were assessed (see Fig. 2). Observing the time-history responses in Fig. 16 and the results in Table 6 it is possible to notice how the amplitude of the response in the PR-I and PS-I configurations is quite similar with all the three aftershocks. As shown in Fig. 16, the response in the direction of the x and y reveals quite similar results between PR-I and PS-I differing only by the time of occurrence of the peak displacement. Only the responses to AS1 and AS3 aftershocks show an improvement of global behaviour when considering the maximum response in terms of displacement.
