NASA TN D-8411

EFFECT OF LOW-VELOCITY IMPACT DAMAGE ON THE COMPRESSIVE STRENGTH OF GRAPHITE-EPOXY HAT-STIFFENED PANELS

*Marvin D. Rhodes, Jerry G. Williams,
and James H. Starnes, Jr.*

*Langley Research Center
Hampton, Va. 23665*

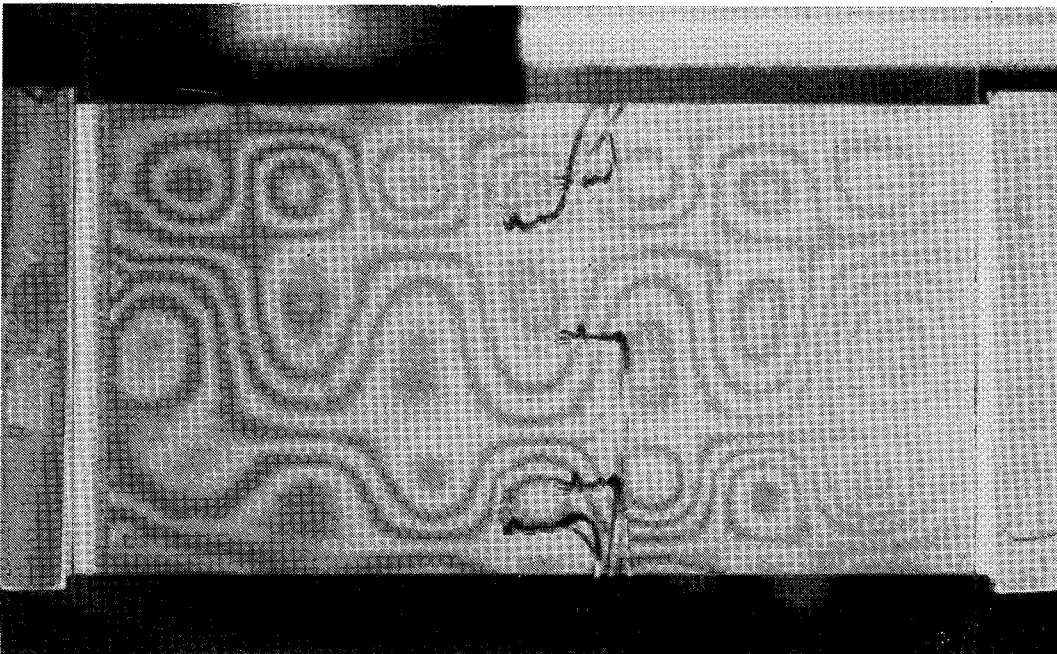
Undamaged panels.- Three panels of design A and four of design B were tested in the undamaged condition to evaluate panel behavior due to applied axial compressive load. The response of each panel to the indicated applied load, or strain, is presented in table II. The design A panels buckled near the design strain of 0.0034 and exhibited postbuckling behavior. The design B panels exhibited strength failure near the design strain of 0.0080 prior to buckling. Photographs of a typical normal displacement field as indicated by the moiré-fringe pattern for both design configurations are shown in figure 3. Test panel A1 (fig. 3(a)) has a fully developed buckle pattern at an imposed strain of 0.0036. Test panel B2 (fig. 3(b)) is shown at an imposed axial strain of 0.0079 which is near the strain at which the panel exhibited failure. The pattern seen at the ends of the panel is the result of in-plane restraints imposed by the flat-end test condition (ref. 2).

(a) Panel A1 designed for strain of 0.0034
loaded to strain of 0.0036.

Figure 3.- Photographs of moiré-fringe patterns for typical undamaged panels during compression tests. L-77-142

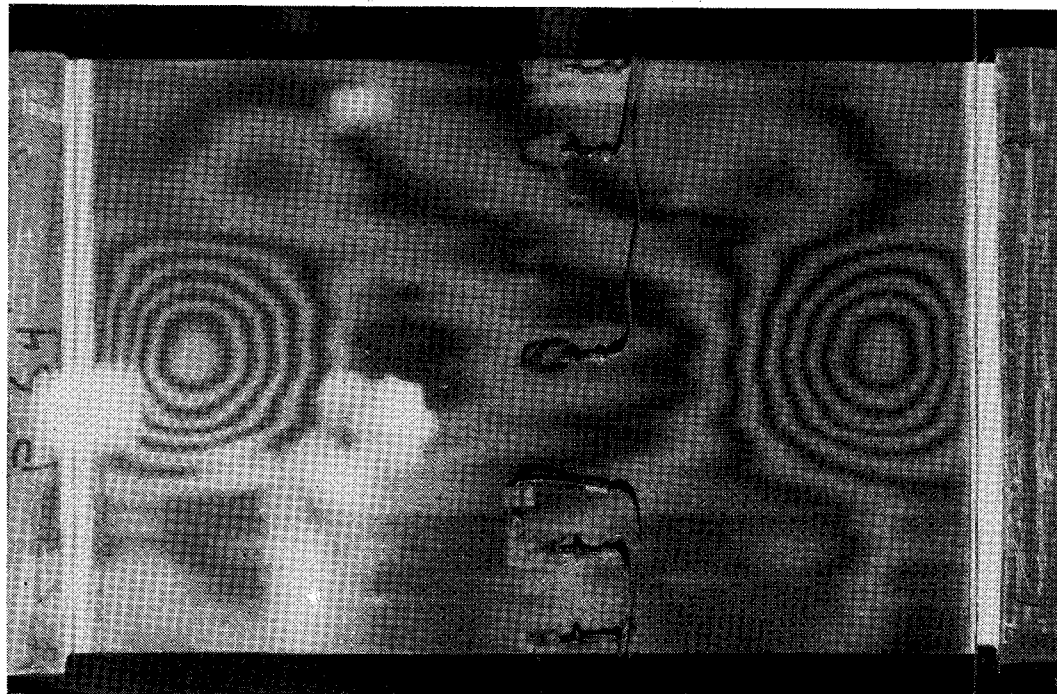
(b) Panel B2 designed for strain of 0.0080
loaded to strain of 0.0079.

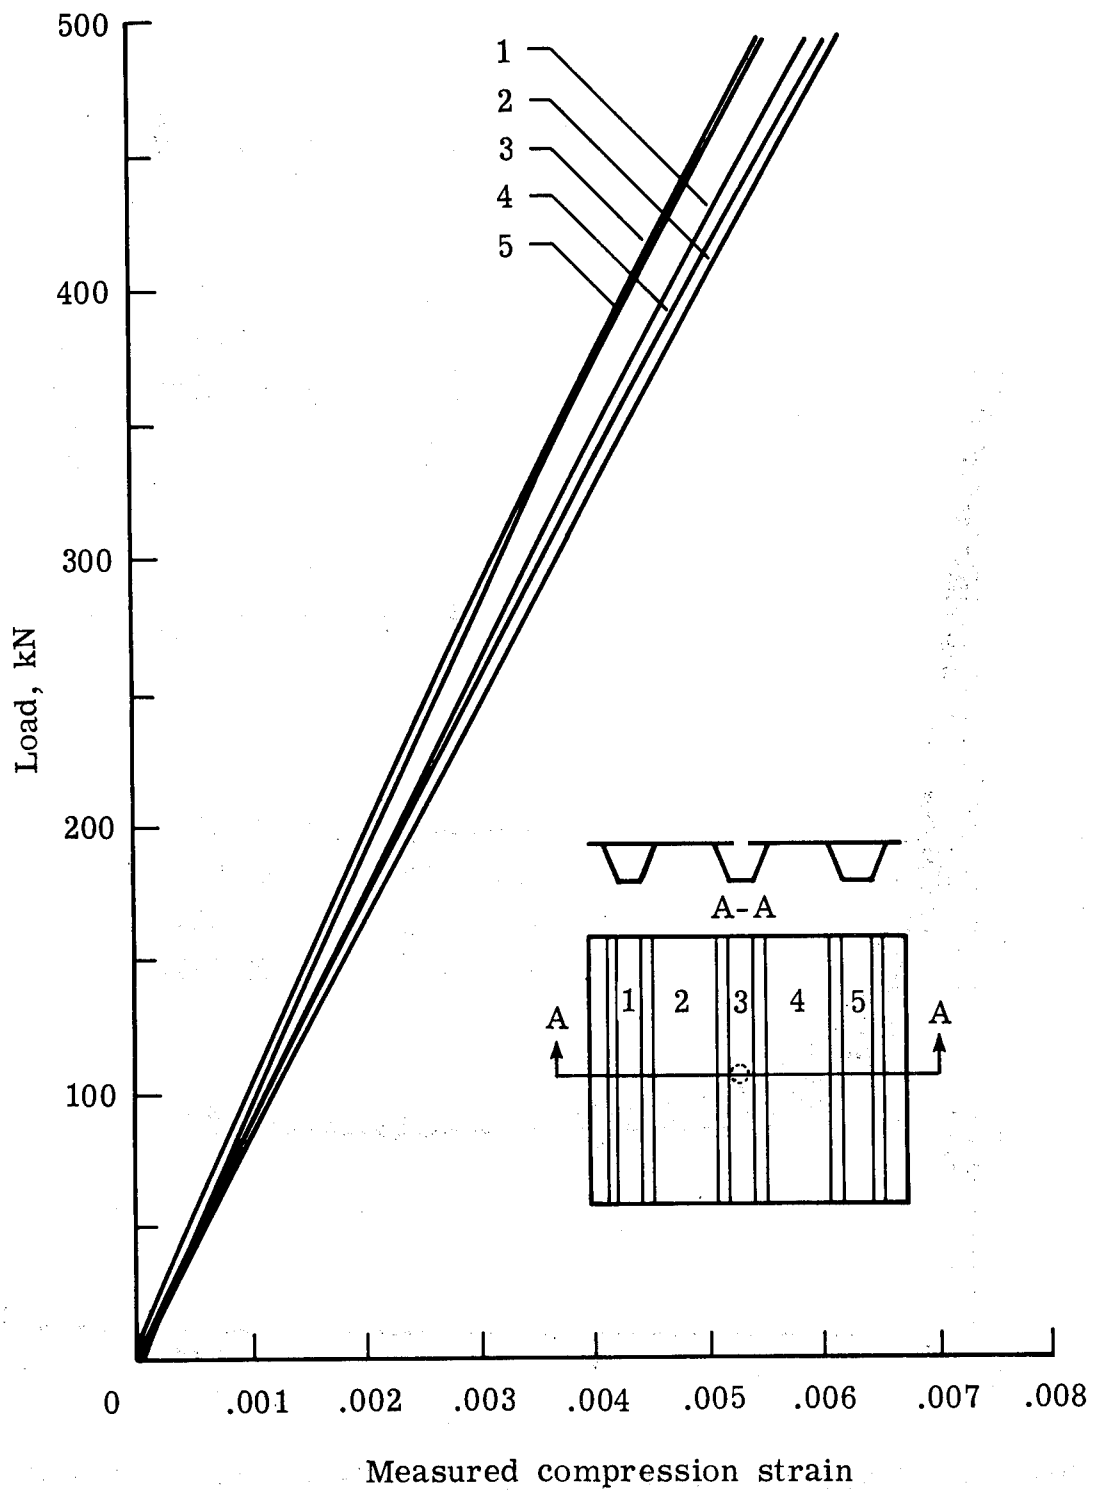
Panel with a cutout.- Panel B5 with the 1.27-cm-diameter cutout was loaded to failure in axial compression. Far-field axial strains were measured during the test by five strain gages located on a line across the panel, 6.35 cm from the cutout center. The locations of those gages and the strains as a function of load are shown in figure 4. These data indicate a nearly uniform far-field axial strain distribution across the panel and a linear load-strain relationship to failure. The average of these gages is referred to in this paper as the applied strain. Panel failure occurred at an applied strain of 0.0058 (applied load of 496 kN) which is 73 percent of the 0.0080 design strain.

Figure 4.- Compression load-strain curves at five locations across panel B5 which has 1.27-cm-diameter cutout in high-axial-stiffness region of center stiffener.

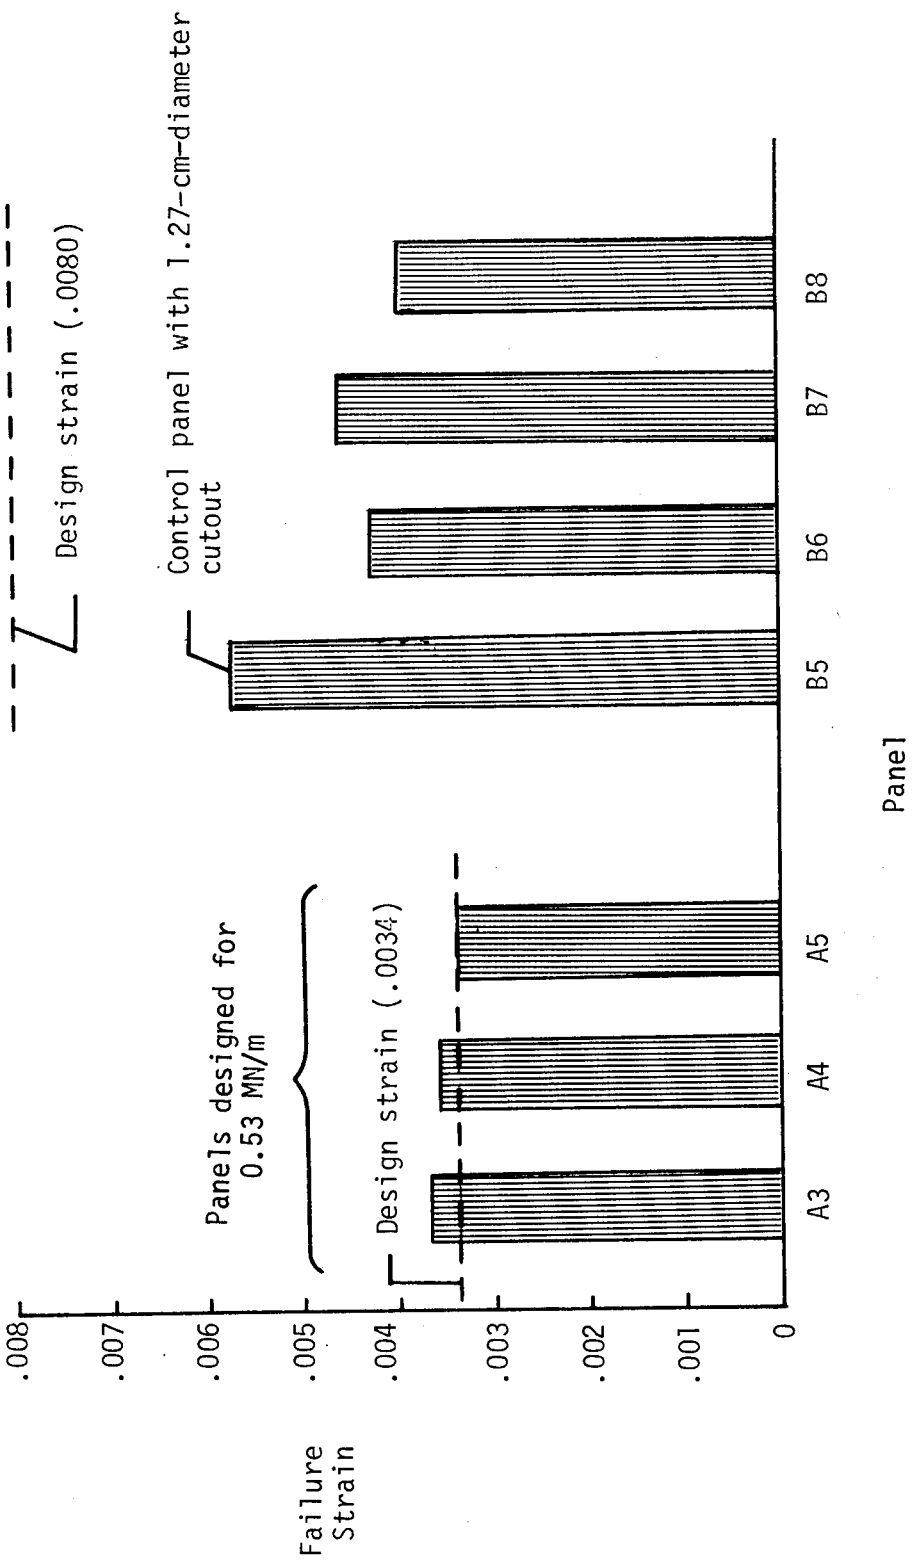
Impact-damage characterization: A comparison of test results for impact damage in the high-axial-stiffness region indicates both similarities and differences in the results for panels of design A and design B. The extent of local damage induced by impact increased with the magnitude of applied axial-compression strain for both designs. The design A panels satisfied the design-strain requirements with the presence of impact damage and also exhibited post-buckling behavior. The design B panels, however, failed due to impact damage at applied axial strains between 50 and 58 percent of the design strain level. Failure strains for impact-damaged panels and the control panel with circular cutout can be compared in figure 12. Limited local impact damage that was not noticeable by visual inspection (panel B6) reduced the ultimate strength of the design B panels as much as extensive visible localized damage (panel B7). All three of the design B panels damaged by impact failed at lower applied strain levels than the control test panel with the 1.27-cm-diameter cutout. The damaged region caused by impact, however, was larger than the cutout. For all design B panels the damage in the high-axial-stiffness region precipitated failure at an applied strain well below the design strain level.

Figure 12.- Failure strains for panels damaged by impact in high-axial-stiffness region and for control panel.
