EXPERIENCE IN IN-SITU REPAIR WELDING OF STEAM TURBINE SHROUDS AND BLADES

S.K. Albert, V. Ramasubbu, C.R. Das, A.K. Bhaduri, S.K. Ray and Baldev Raj
Metallurgy and Materials Group, Indira Gandhi Centre for Atomic Research,
Kalpakkam 603 102, India

Abstract

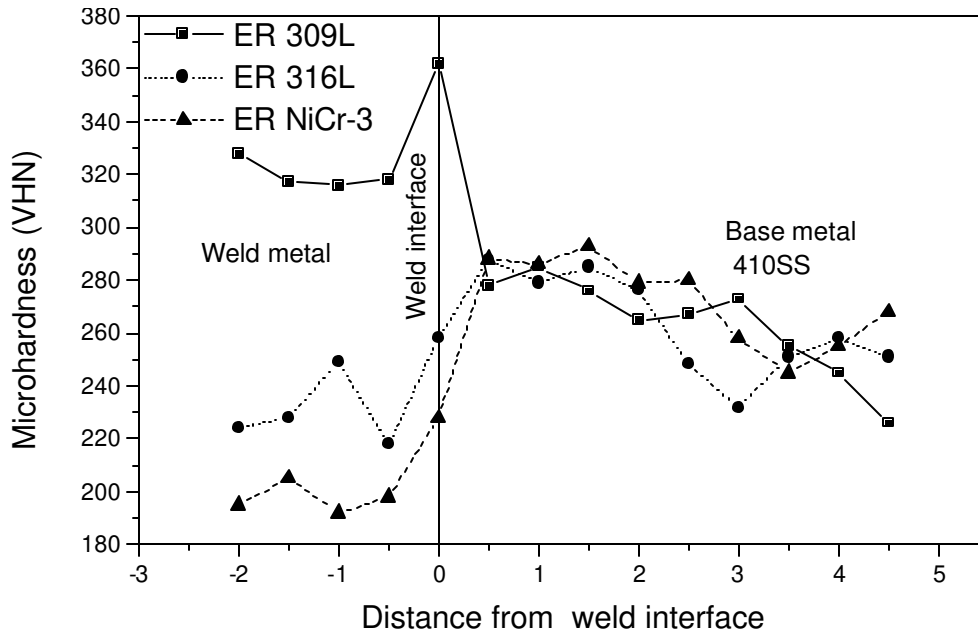
fractured in the base metal, (except in one case), while those made with the other two filler metals failed in the weld metal showing lower ductility values. On the other hand, after PWHT, the joint made using 316L filler wire failed in the base metal. However, the weld joint made with 309L filler metal failed during the bend test, while the weld joint made with the other two filler metals passed the bend test without any cracking. The hardness profiles across the fusion boundary after 873 K/1h PWHT for all the three weld joints, (Fig. 2), show that the hardness of the 309L weld metal is higher than that of the HAZ after PWHT. This can be attributed to the dilution of the 309L weld metal by the base metal, which leads to the formation of highly alloyed martensite phase in the weld metal with the martensite remaining untempered even after PWHT. The formation of this highly alloyed martensite is also responsible for the 309L joint failing in the bend test. In the case of the ER NiCr-3 joint, the weld metal hardness is much lower than that of the base metal. For the 316L joint also, the weld metal hardness is lower than that of the base metal; but the difference is not as high as that in the ERNiCr-3 joint. Hence, after PWHT, the 316L joint has the minimum hardness mismatch between the weld metal and base metal, (about 30 VHN). The results of tension tests, (Table 2), show that the location of fracture in 316L weld joint shifts from the weld metal in the as-welded condition to the base metal after PWHT. The 873 K/1h PWHT of the 316L joint also results in significant improvement in ductility accompanied by a decrease in its yield strength due to tempering of the HAZ. Based on all these results, a welding procedure involving the use of ER 316L filler wire and a PWHT of 873 K/1 h was chosen for repair of shroud cracks [2,3].

Fig. 2: Hardness profile after 873K/1h PWHT across the fusion line for welds prepared using three different welding consumables during procedure development.

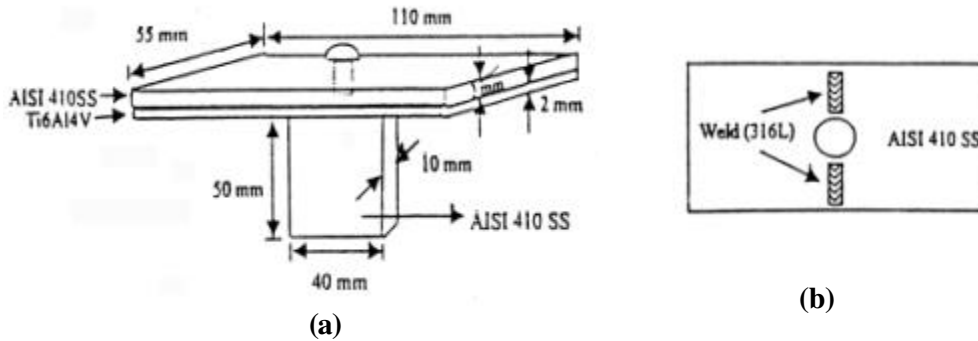
demonstrate that during repair welding, no inadvertent welding of the shroud piece with either the blade or the understrap takes place. For this purpose, a mock up assembly that simulates the presence of understrap, blade and tenon hole in the shroud, as shown in Fig. 3(a), was prepared. Welding was carried out using the optimised parameters on top of this assembly as shown in Fig. 3(b) and it was possible to successfully demonstrate that repair welding can be carried out by a skilled welder without causing any damage to both the understrap and blade by carefully controlling the welding parameters.

Fig. 3: *Mock-up for welding of the shroud at a location where blade and understrap are riveted: (a) mock-up assembly; and (b) top view of the assembly after welding.*

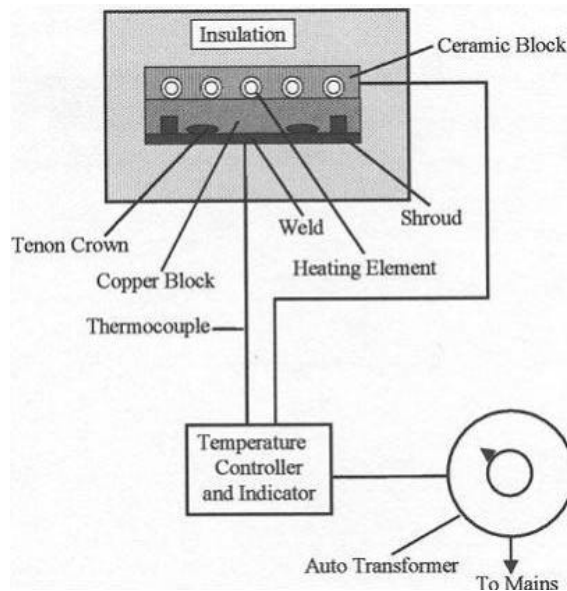
As already mentioned, in-situ PWHT of a repair-weldment requires a small electric resistance furnace, which transfers heat from one side with maximum heat transfer from the heating elements to the location of the weldment through copper block on the shroud and minimum heat loss to the environment. In the case of shrouds, a copper block with its bottom surface contour closely matching the top of the shrouds and the tenons projecting out of the tenon holes, and its top surface contour matching that of the furnace was used to facilitate the heat

transfer to the weldment. Good insulation all around the heater and the location of the heat treatment were employed to minimise heat loss to the atmosphere. A schematic of the heat treatment set-up employed for localised in-situ PWHT is shown in Fig. 5(a), and a typical on-site heat treatment cycle used is shown in Fig. 5(b). A similar set-up was used for PWHT of the repair welds of the blades. As the repair weld was in a relatively flat portion of the blade, it was possible to remove the blade from the turbine for repair, and thus both repair welding and PWHT was much easily executed for the blades than for the shrouds.

Fig. 5(a): Schematic of the heat treatment set up used for localised in-situ PWHT of a shroud repair weld

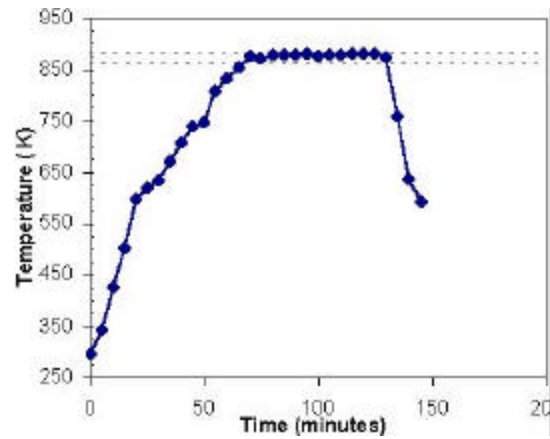
Fig. 5(b): A typical heat treatment cycle employed during onsite localised PWHT of a repair weld
