Failure Investigation and Restoration of Two Cellular Sheetpile Structures

FAILURE INVESTIGATION AND RESTORATION OF TWO CELLULAR SHEETPILE STRUCTURES

ABSTRACT

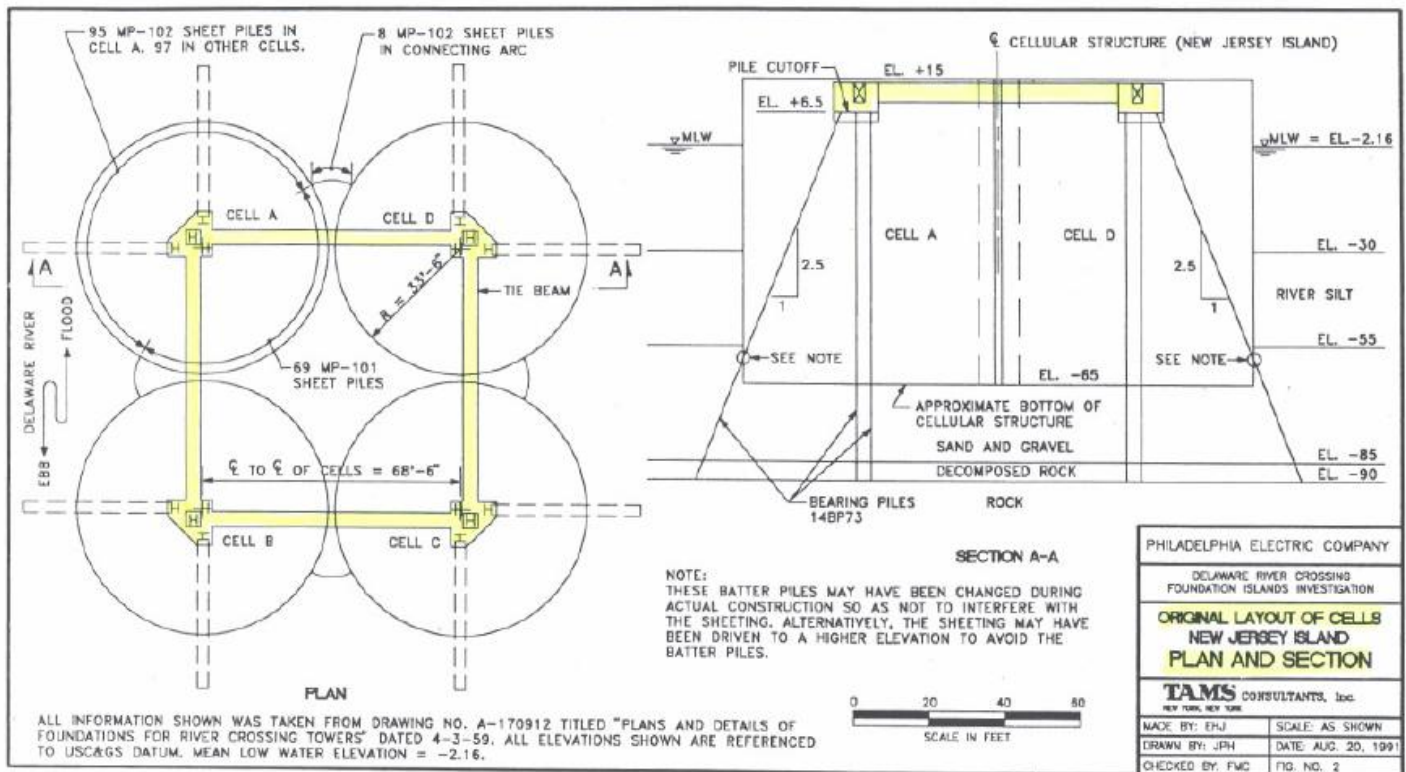
Fig. 2: Plan and Elevation of New Jersey Island

Corrosion Probe, Inc. performed ultrasonic thickness testing of the sheetpiles and evaluated the condition of the cathodic protection system. The cathodic protection system on the New Jersey Island was not operational. An overload trip feature probably deactivated the system when the cables from the H-pile groups to the anodes in the two failed cells were ruptured due to the large displacements of the cell fill. Potential measurements indicate that all structures on the New Jersey Island, including the sheetpiles, H-piles, pile caps and electrical grounds were electrically continuous. This appears to corroborate calculations and oral recollections which indicated that the batter H-piles on that island intersected the sheetpile cells, as shown on Fig. 2. The cathodic protection system on the Pennsylvania Island was operational and in service.

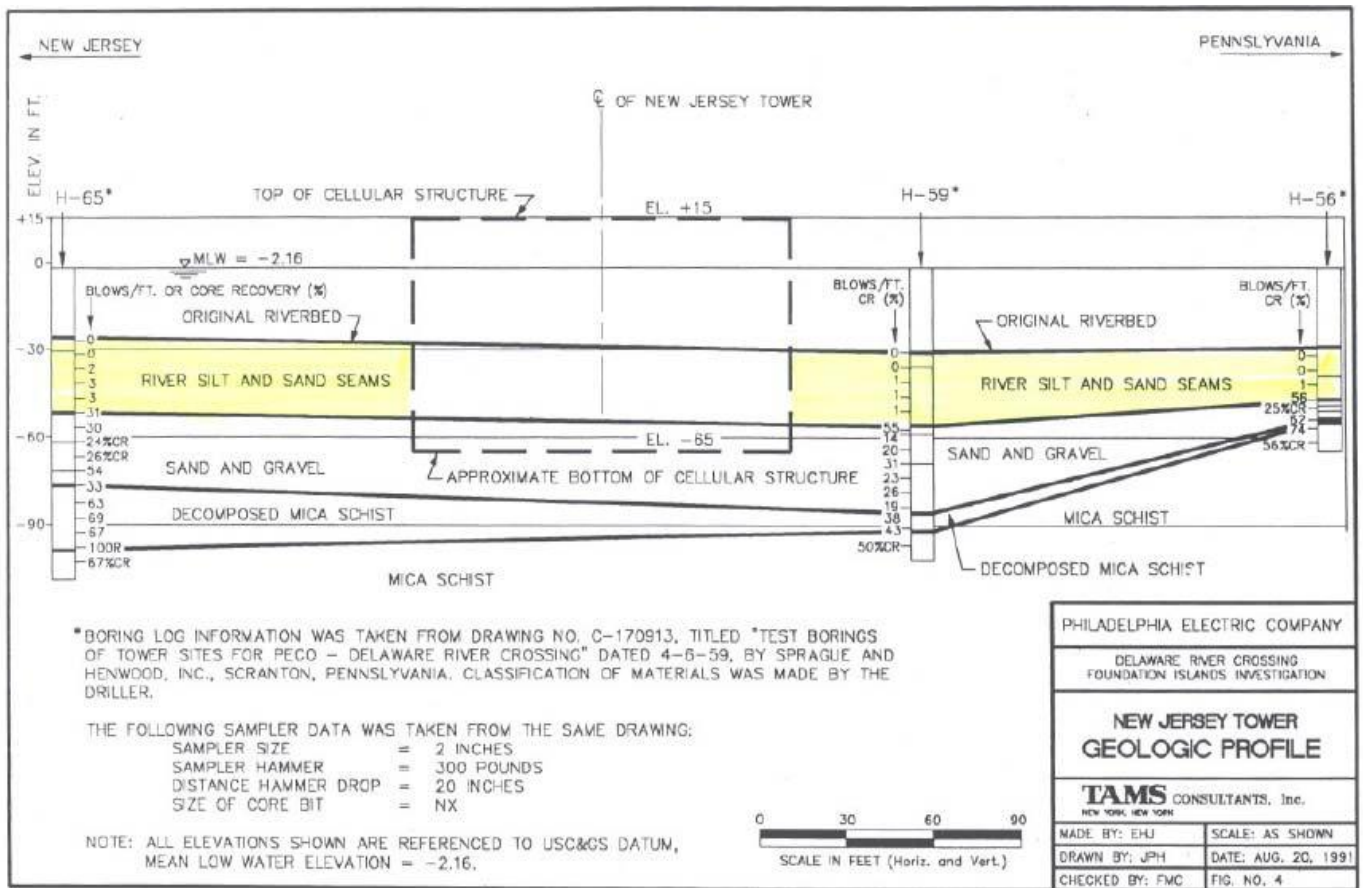
Fig. 4: Idealized Soil and Rock Profile

The soil profile in Fig. 4 shows that the sheetpiles were driven through the soft riverbed silt into an underlying sand and gravel layer. This layer is medium dense to dense and could have caused substantial resistance to penetration of the driven sheetpiles. In overcoming this resistance the sheetpiles, being long flexible members, were vulnerable to damage by tearing of the webs or deformation of the interlocks.
