Fault rupture–foundation interaction: selected case histories

E. Faccioli · I. Anastasopoulos · G. Gazetas ·
A. Callerio · R. Paolucci

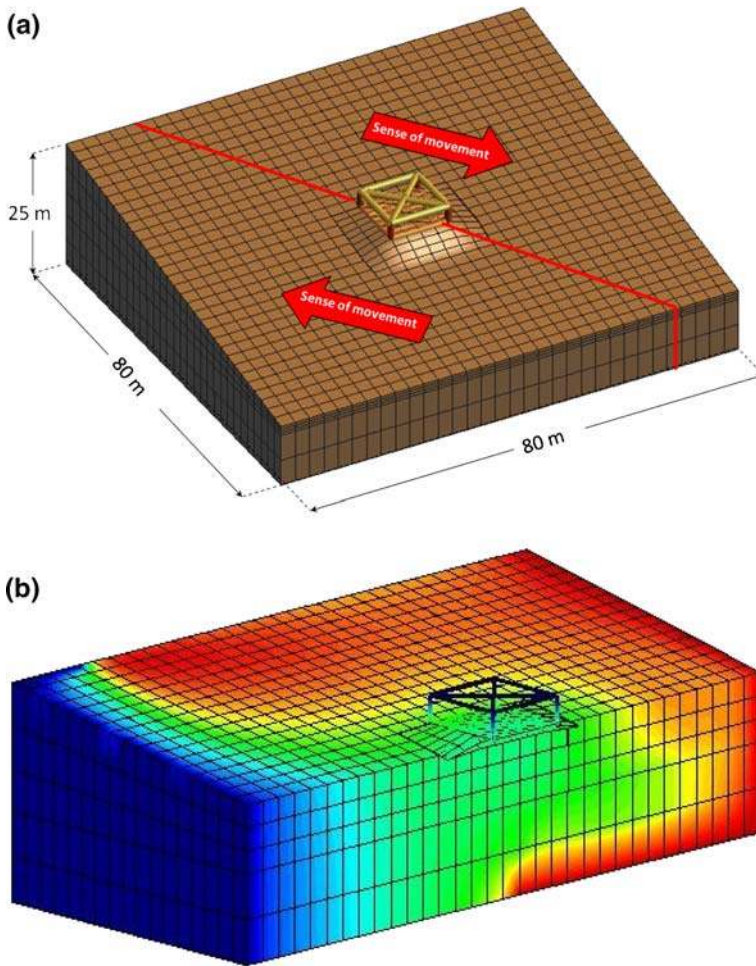
clockwise rigid-body torsion around its vertical axis (Fig. 6). Both the simulation results and the field observations are in qualitative agreement with the work of [Berrill \(1983\)](#), who studied analytically the behaviour of buildings on continuous–rigid shallow foundations, subjected to strike-slip faulting.

Fig. 6 Mt. Etna—Pernicana strike-slip fault—3-D finite element analysis of the 1-story building of Fig. 4: **a** 3-D mesh layout, and **b** horizontal displacement contours. Due to the rigidity of the foundation, the fault rupture is diverted, with the structure being subjected to rigid-body rotation. Analysis results can be seen to be in qualitative agreement with field observations

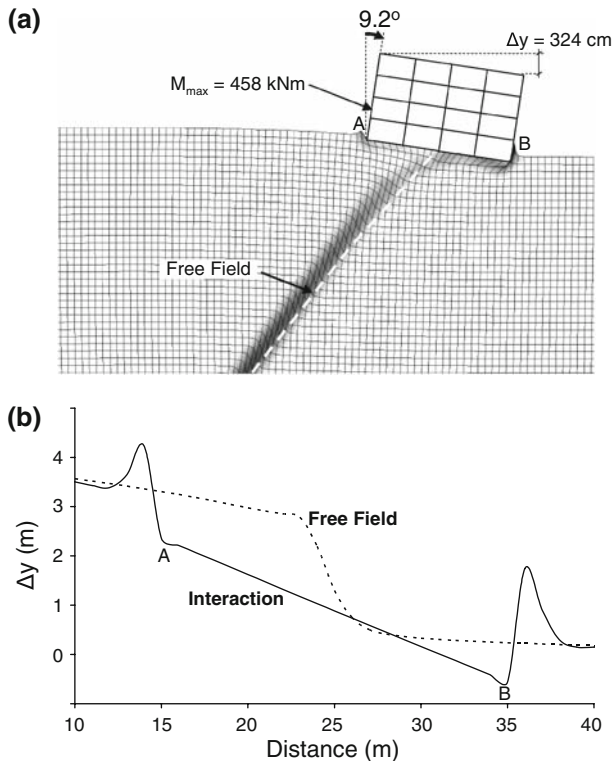
of seismic refraction measurements (Dong et al. 2003). While the idealised superstructure was simulated with beam elements, the soil–foundation interface was modelled with special gap elements, allowing for detachment and slippage. As illustrated in Fig. 8, the 4-story model experienced a rigid-body rotation of 9.2° (compared to the 10° observed in reality), without excessive stressing: the maximum bending moment M_{max} in the superstructure did not exceed 458 kNm. The vertical displacement Δy of the ground surface clearly indicates that the building rotates as a rigid body (tilting without significant distortion): region AB in Fig. 8 is of constant inclination. The numerical results are in good agreement with field observations.

Fig. 8 Chelungpu thrust fault, Chi–Chi, Taiwan 1999 earthquake—Chung-Cheng Park, Fung-Yan City—s2-D finite element analysis of the 4-story building of Fig. 6 ($h = 4 \text{ m}$): **a** Deformed mesh and plastic strain, **b** Vertical displacement Δy at the ground surface. The structure is subjected to rigid-body rotation, without excessive stressing. Analysis results can be seen to be in qualitative agreement with field observations

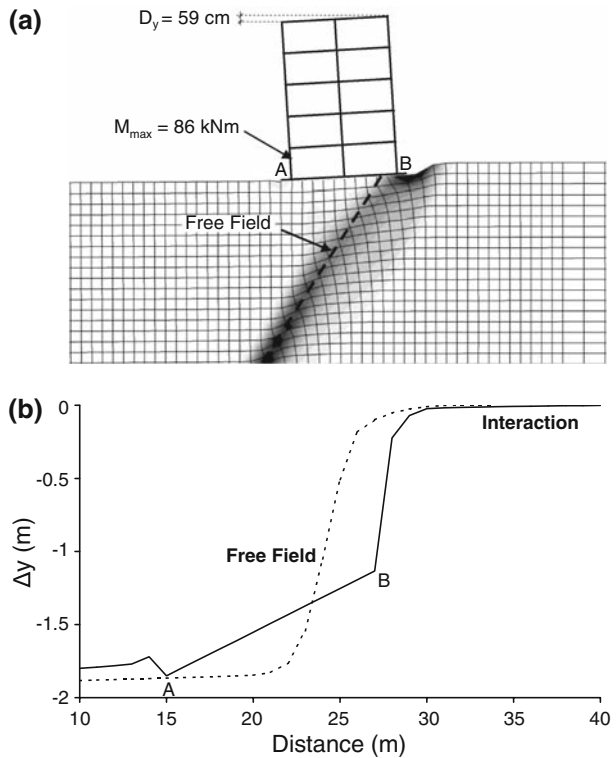
The same method was applied to analyse this case-history: a bedrock offset of vertical amplitude $h = 2$ m was imposed on an idealised soil deposit of thickness $H = 40$ m. As described in (Anastasopoulos and Gazetas 2007b, the thickness of the soil deposit was estimated based on microtremor measurements by Arai et al. (2000). As illustrated in Fig. 10, the rupture path is clearly diverted towards the footwall as it approaches the ground surface. The building is subjected to some rigid-body rotation resulting in a differential settlement $D_y = 59$ cm, without being distressed: $M_{max} = 86$ kN m. As in the two previous cases, the rigid and continuous foundation is responsible for this favorable response. The analysis compares well with field observations, except that in reality the rotation was less conspicuous.

Fig. 10 Normal fault east of Gölcük, Kocaeli, Turkey 1999 earthquake—Denizevler—2-D finite element analysis of the 5-story building of Fig. 9 ($h = 2$ m): **a** Deformed mesh and plastic strain, **b** Vertical displacement Δy at the ground surface. Due to the rigidity and continuity of the box-type foundation, the fault rupture is diverted towards the footwall; the structure is only subjected to limited rigid-body rotation, without significant stressing. Analysis results are in qualitative agreement with field observations

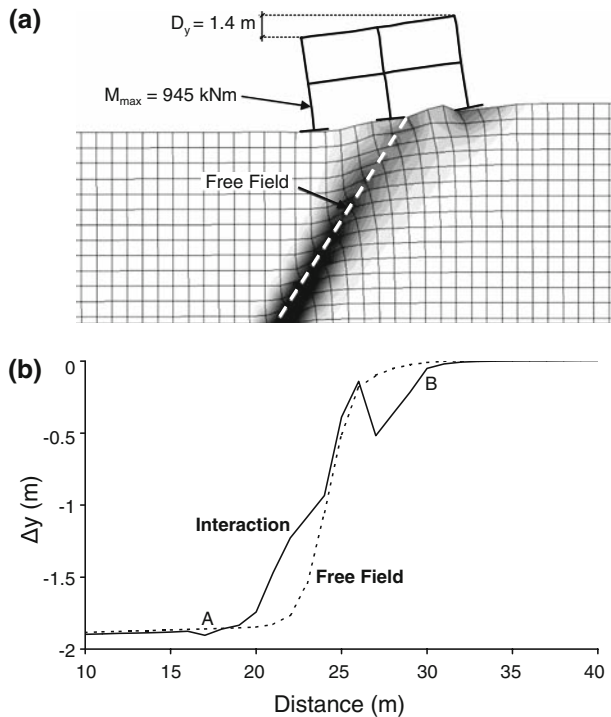
the Mosque, in the form of a diffuse failure zone, causing the structure to tilt towards the hanging wall with a differential settlement $Dy = 1.4$ m. However, not all of the imposed deformation is converted to rigid-body rotation, and the Mosque was substantially distressed (computed $M_{max} = 945$ kN m). In general, the results of this analysis are in agreement with the observed performance.

Fig. 16 Normal fault east of Gölcük, Kocaeli, Turkey 1999 earthquake—Denizevler—2-D finite element analysis of the Mosque, Fig. 14a ($h = 2$ m): **a** Deformed mesh and plastic strain, **b** Vertical displacement Δy at the ground surface. Due to the discontinuity and flexibility of its foundation, the superstructure of is subjected to excessive stressing, in accord with the observed performance
