NBSIR 73-135

Fire Endurance Tests of Steel Sandwich Panel Exterior Wall and Roof/Ceiling Constructions

December 1972

Final Report

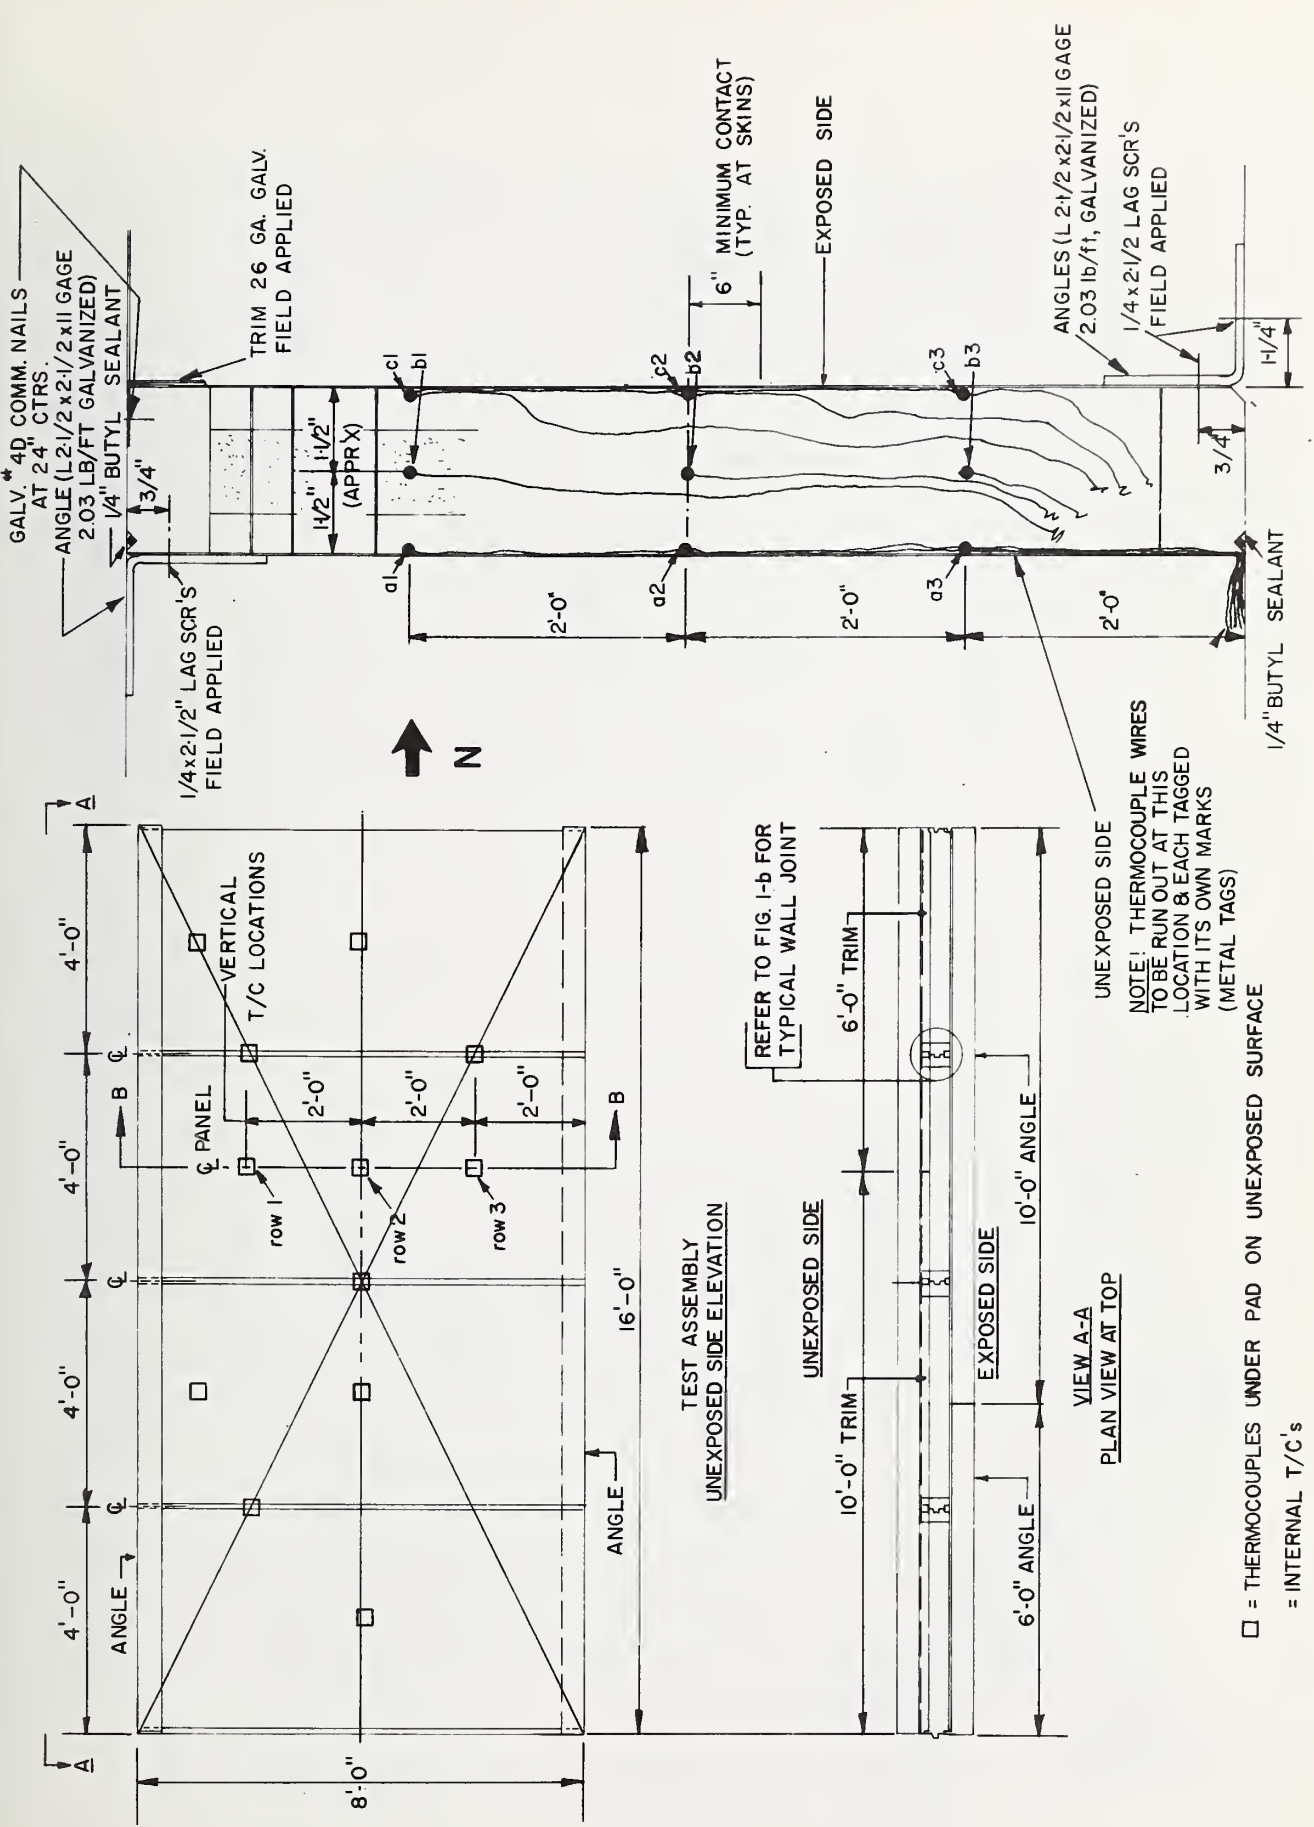
Figure 1-a Test Specimen and Location of Thermocouples on Wall Assembly.

A total of 12 thermocouples was applied to the unexposed surface of the wall, four on joints and eight at locations away from the joints between the panels, at the center of the core and under each of the two facing sheets (disposition indicated in Figure 1-a).

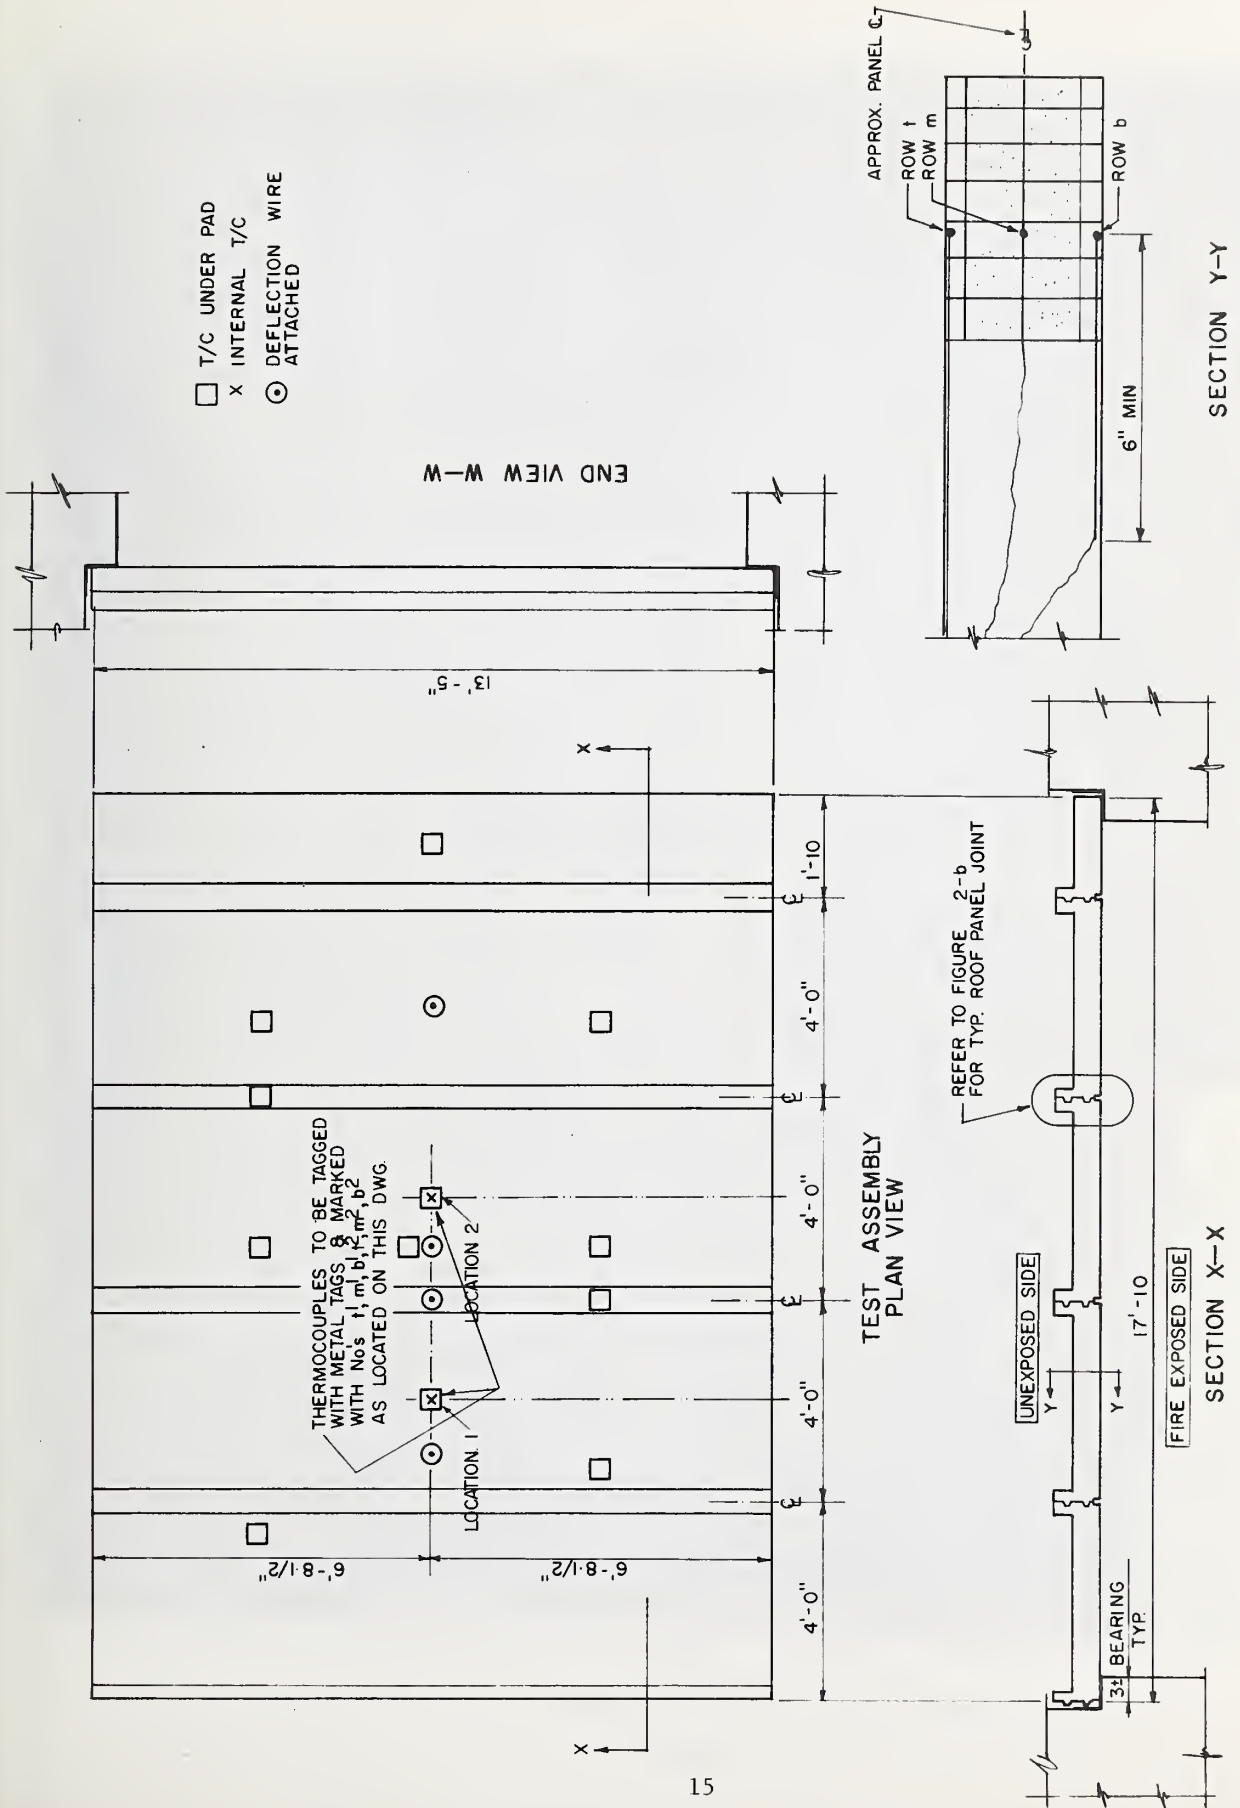
Figure 2-a Test Specimen and Location of thermocouples on Roof/Ceiling Assembly.

For the roof/ceiling assembly, 18 thermocouples were used, two on joints and 10 away from the joints on the unexposed surface. and six within two of the panels at three different levels. (See Figure 2-a.)

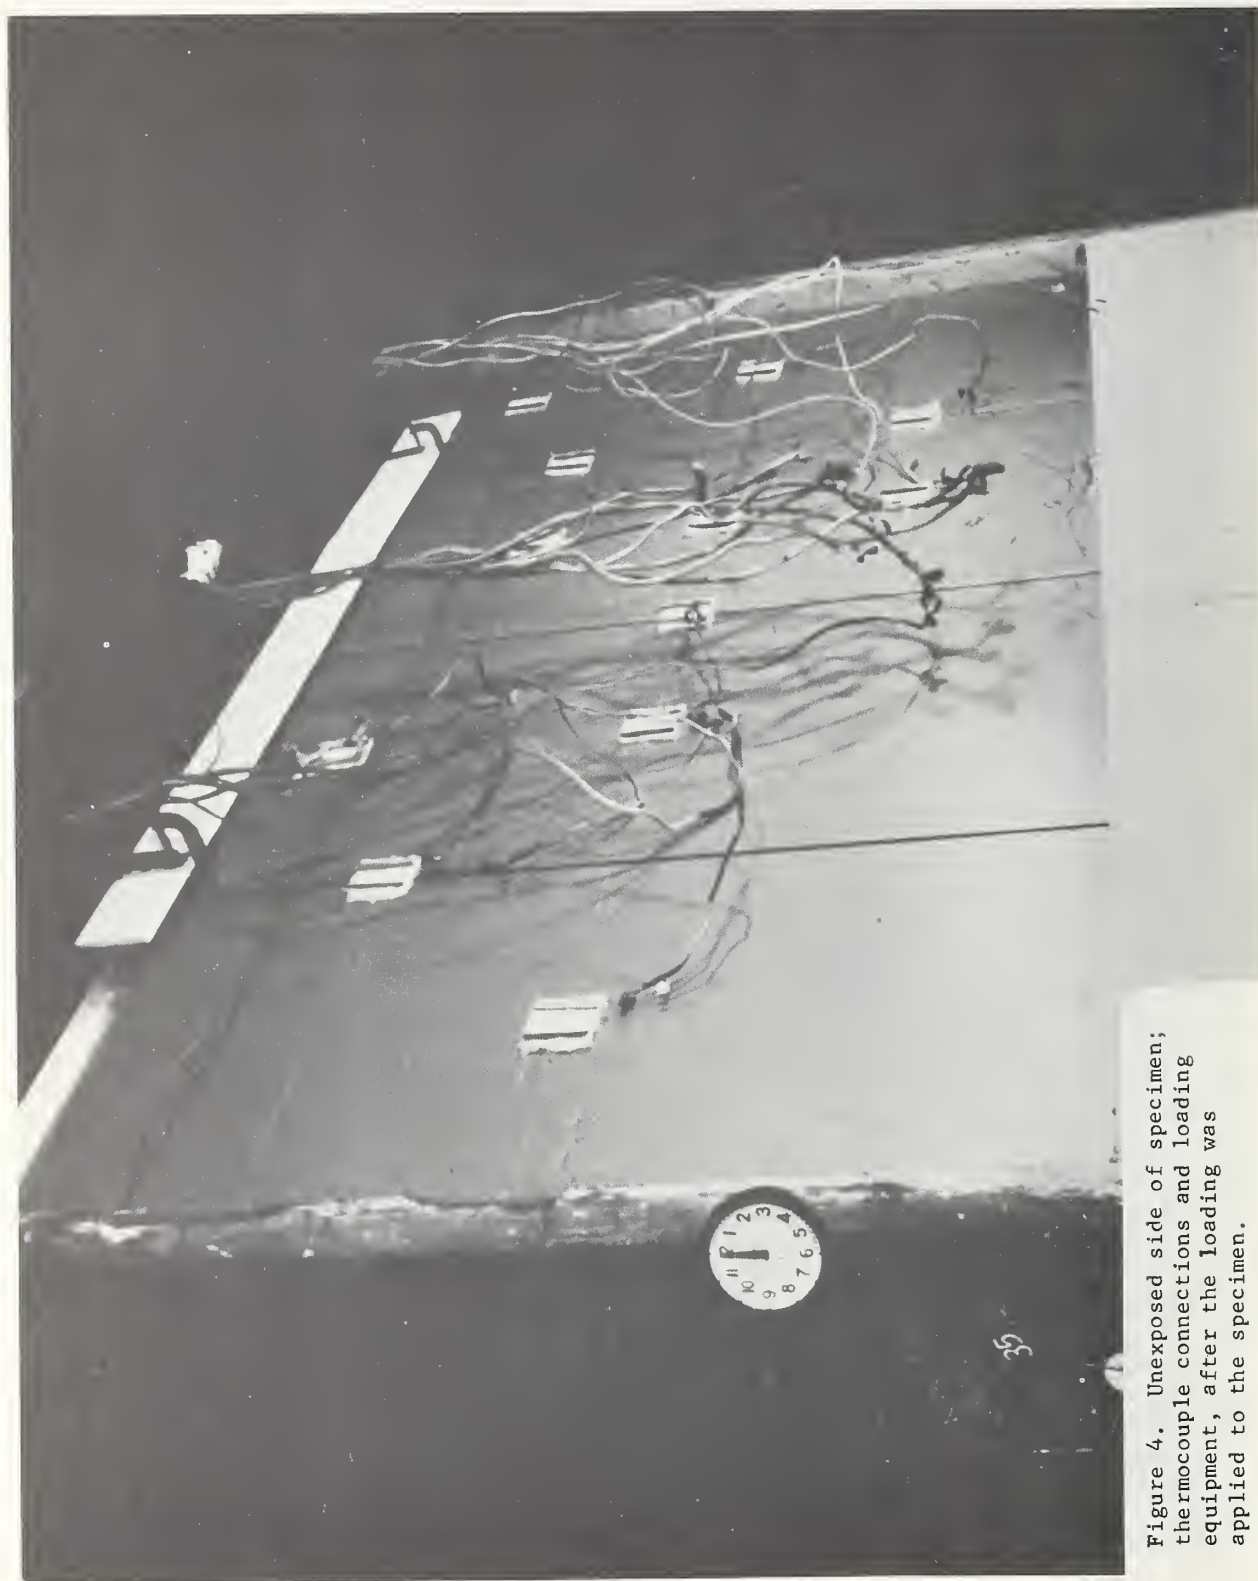
A calculated load of 237 plf was applied to the wall specimen through four hydraulic jacks 5 min. before the test started. The loading represented the weight of the roof (30 plf) and the roof live load (207 plf) Figure 4 shows the unexposed surface of the wall, the thermocouple connections and the loading equipment with the test frame in place as a wall of the panel testing furnace.

Figure 4. Unexposed side of specimen; thermocouple connections and loading equipment, after the loading was applied to the specimen.
