Floating Breakwater Field Experience, West Coast

by
Eugene P. Richey

MISCELLANEOUS REPORT NO. 82-5

JULY 1982

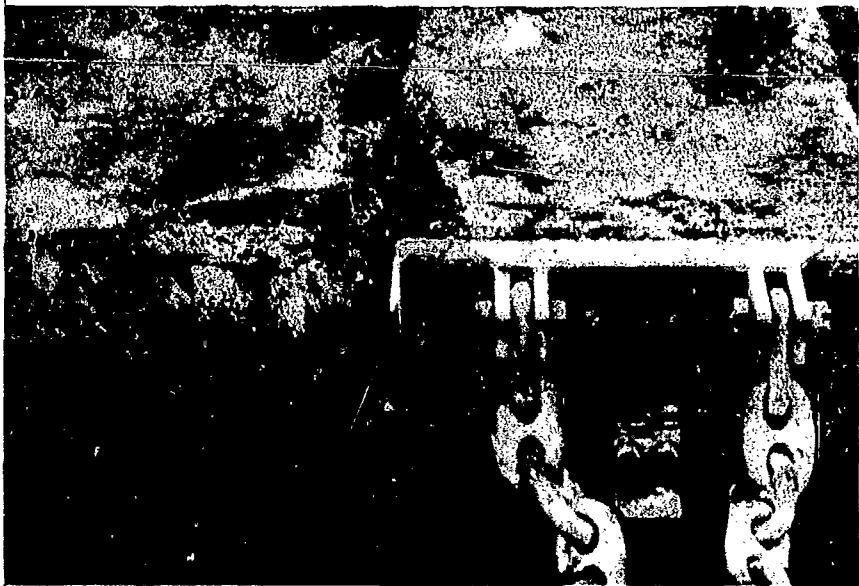
b. Module connection.

(3) Performance. The users are satisfied with the protection afforded by the breakwater. Prior to its installation, winter moorage was risky and the boats often had to be moved to more sheltered waters during storms. The outer chain on the base of the V-section in the initial breakwater layout broke during a storm (D. Miller, personal communication). This connection has been eliminated by the new alignment and new connectors have been installed (see Fig. 12,b).
