Fractographic Analysis of the Low Energy
Fracture of an Aluminum Alloy

National Aeronautics and Space Administration
Research Grant NGR 39-087-300

NASA Technical Report No. 1

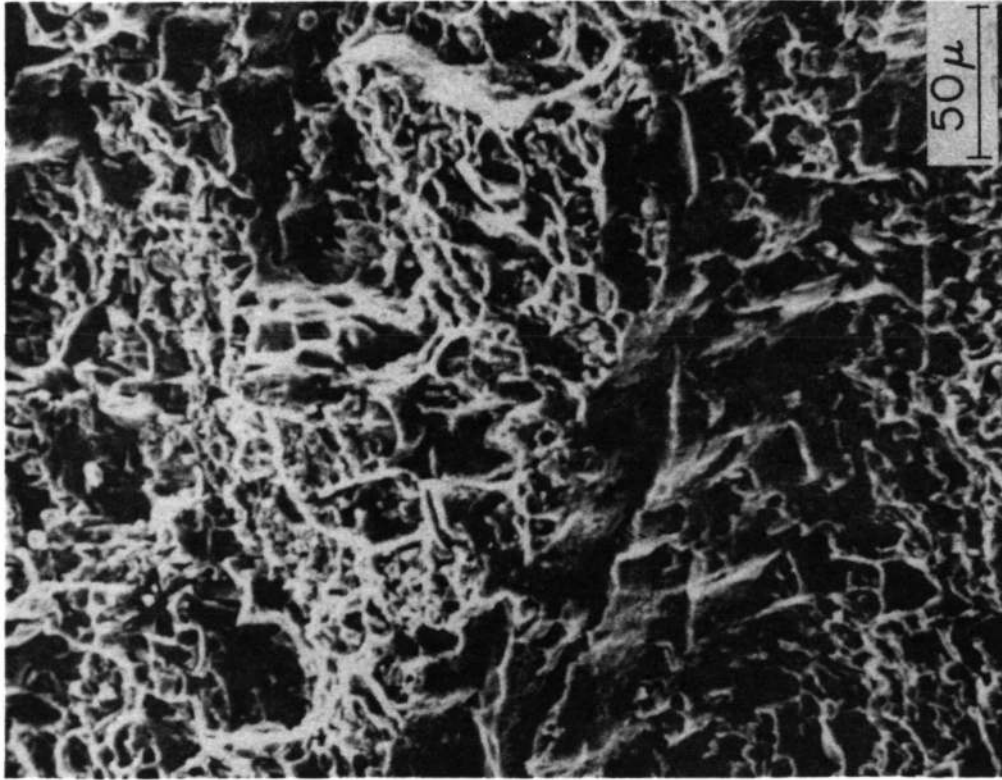
Fig. 7 Low Magnification Scanning Electron Micrograph Taken with Secondary Electrons, to Compare with Back Scattered Electrons in Fig. 8

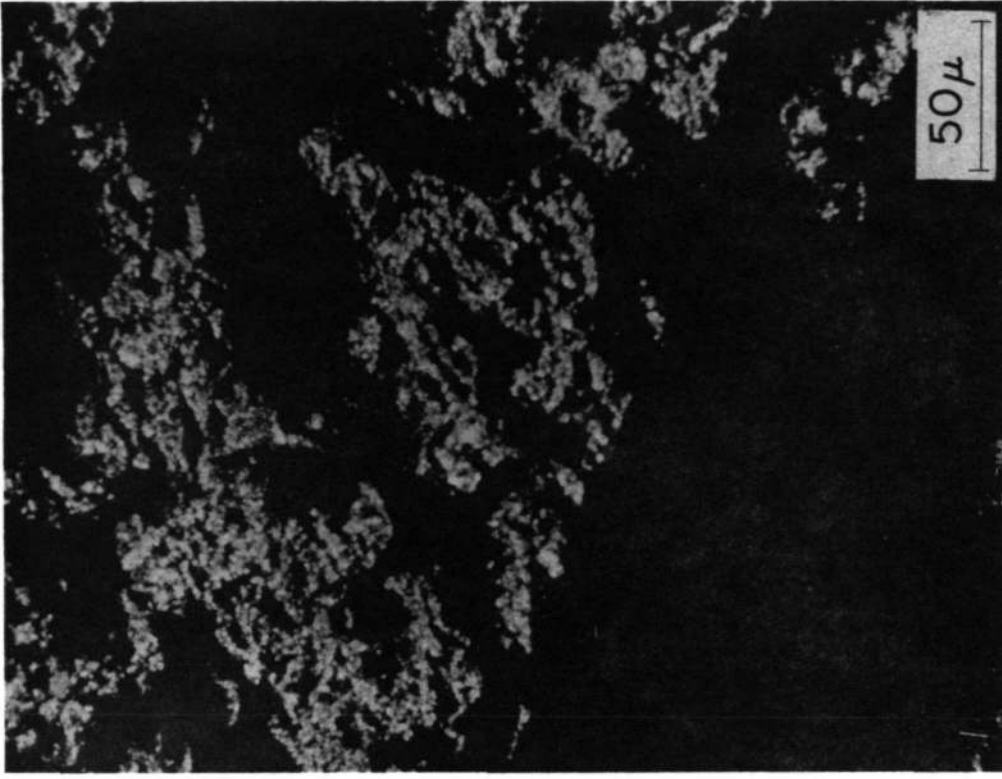
Fig. 8 Same as Fig. 7 Taken with Back Scattered Electrons

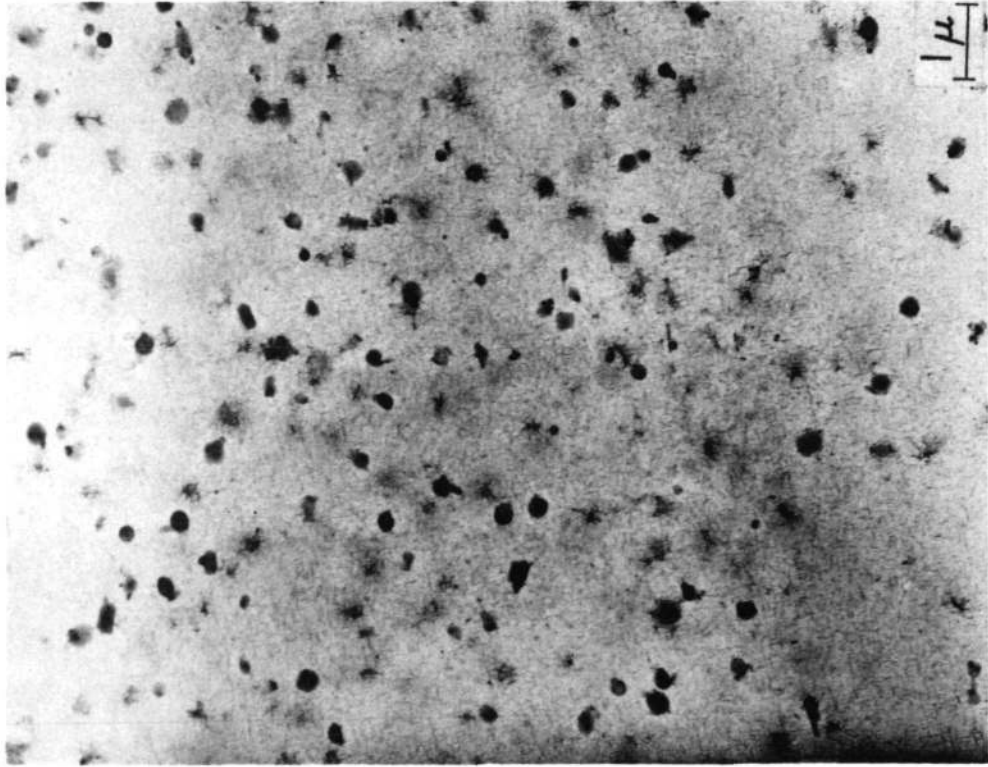
The small size dimples seen on the fracture surfaces were very likely nucleated at particles too small to be observed with the optical microscope. Moreover the observation that some in grain boundary cracking occurred without showing typical intergranular fracture appearance in the fractographs, suggested that a precipitation free zone around grain boundaries might exist in the alloy. This is known to lead, in some cases, to grain boundary failure with a dimpled fracture topography⁽²⁾. With this in mind, thin films of the alloy were examined in the electron microscope. The thin films were prepared by a jet electropolishing technique⁽³⁾ using a mixture of 2/3 Methanol and 1/3 Nitric Acid. Figure 15 shows a typical transmission electron micrograph. Small particles about 0.1 to 0.2 microns in diameter a distance of about 0.5 to 1 micron apart are clearly seen. Because of their size and distribution, these should be regarded as a dispersion which strengthens the matrix. The work hardening characteristics of the alloy should be especially affected by them⁽⁴⁾. This coarse dispersoid, which contributes significantly to the strength of the alloy in addition to the fine θ precipitate, has been identified as $Al_{12}(Mn, Fe)_3 Si$ ⁽⁸⁾.

Fig. 15 Transmission Electron Micrographs Showing
a Fine Dispersion of Particles

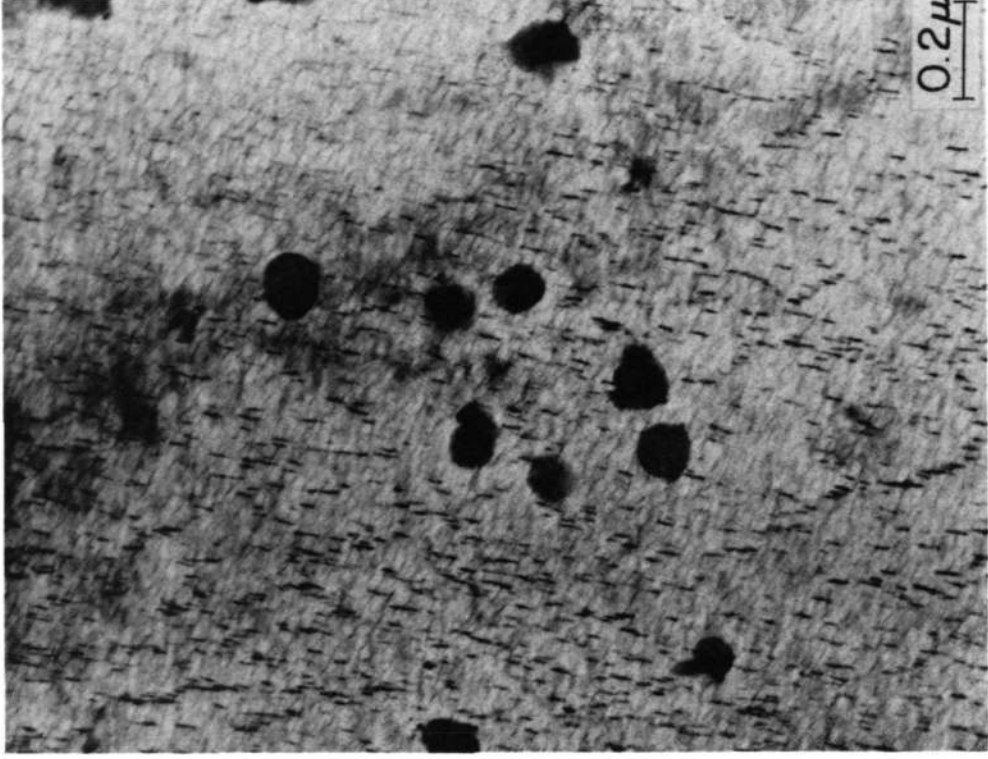
At higher magnifications, Figure 16, the matrix shows a structure formed by a fine elongated precipitates 0.01 to 0.05 microns long which are believed to be the principal hardening precipitates. No precipitation free zone was found around grain boundaries but elongated inclusions 0.3 to 0.5 microns long were observed, Figure 17. This finding may well explain the grain boundary cracking observed in the bending and tensile specimens. The fact that the fracture topography was of the dimple type and did not show any evidence of grain boundary interface failures may also be understood. In effect, the existence of grain boundary failure showing a dimpled topography

Fig. 16 Transmission Electron Micrograph Showing
Dispersed Particles and Hardening Precipitates

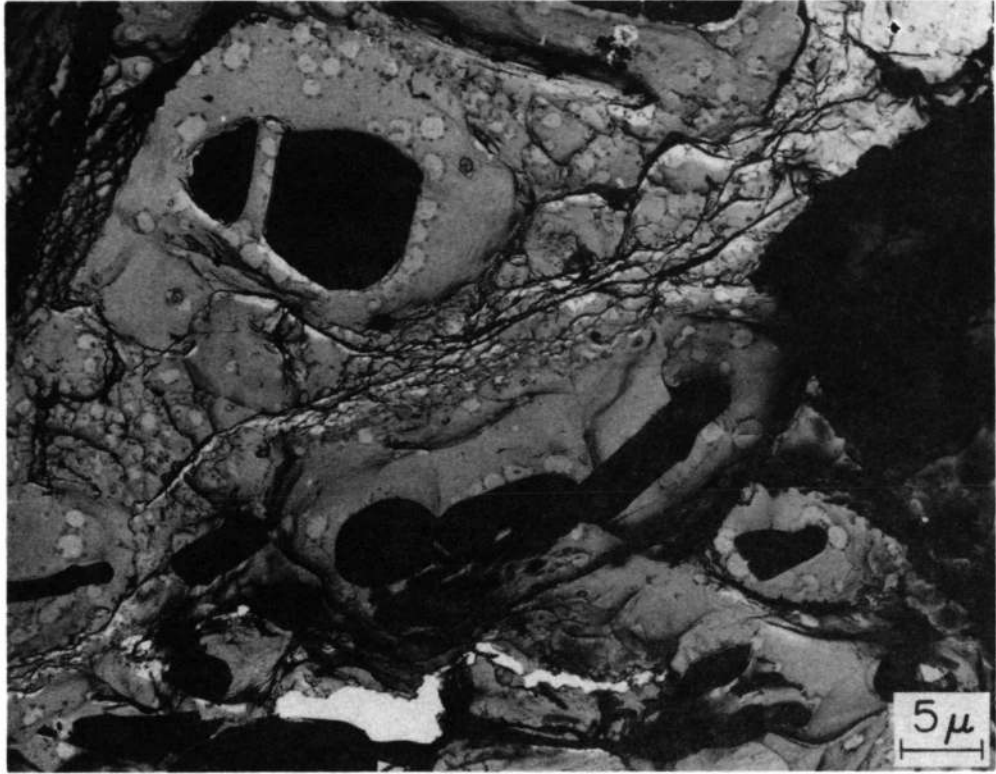
Extraction replicas of the fracture surface were then analysed to compare with these results on polished surfaces (a description of the technique used to extract the particles is found in the appendix). Figures 19 and 20 show

Fig. 19 Electron Microscope Micrograph of an Extraction Replica
