## **Fundamentals for remote structural health monitoring of wind turbine blades - a preproject. Annex E. Full-scale test of wind turbine blade, using sensors and NDT**

# **Fundamentals for Remote Structural Health Monitoring of Wind Turbine Blades – a Preproject**

## **Annex E – Full-Scale Test of Wind Turbine Blade, Using Sensors and NDT**

**Abstract** A 19.1 metre wind turbine blade was subjected to static tests. The purpose of the test series was to verify the abilities of different types of sensors to detect damage in wind turbine blades.

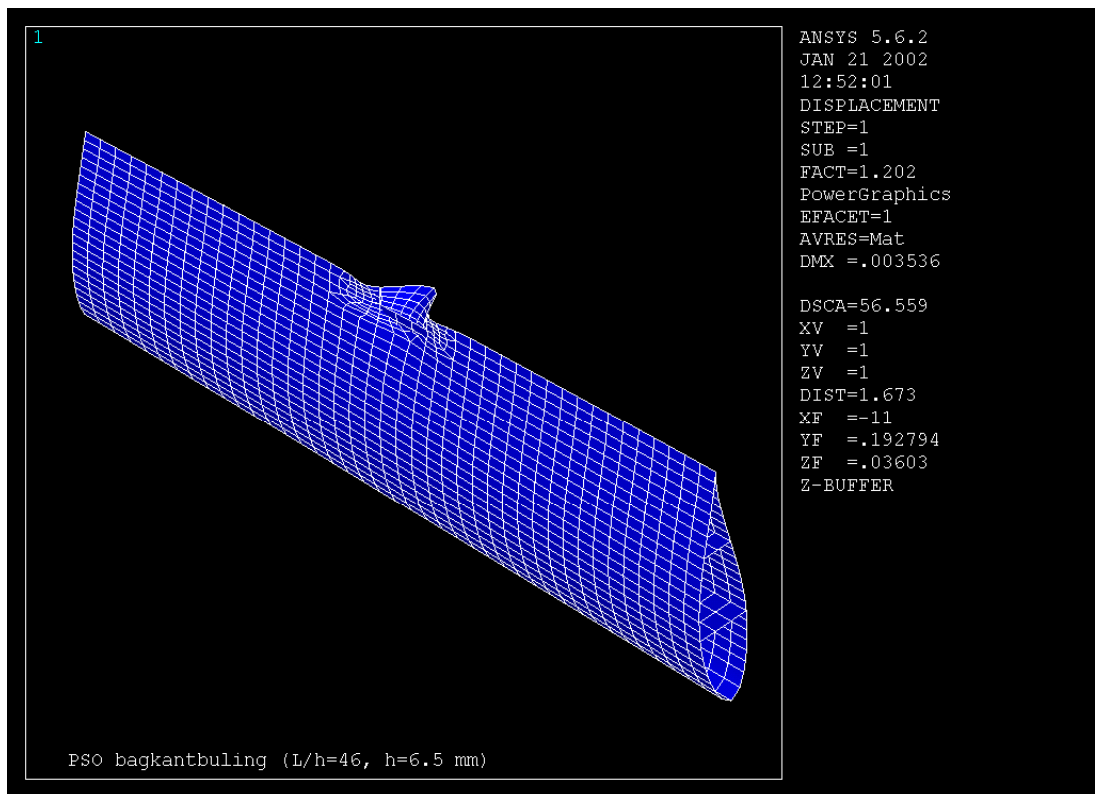
The suggested value of damage extent is 300mm and skin thickness is estimated to  $h=6.5\text{mm}$ . This gives  $L/h=46$  and buckling is expected to occur at  $P=1.20*48\text{kN}$  (reaction force at  $Z=13.1\text{m}$ ). The buckling mode for these values is shown in Figure 5.

Figure 5. Buckling mode for  $L/h=46$  and  $h=6.5$  mm.

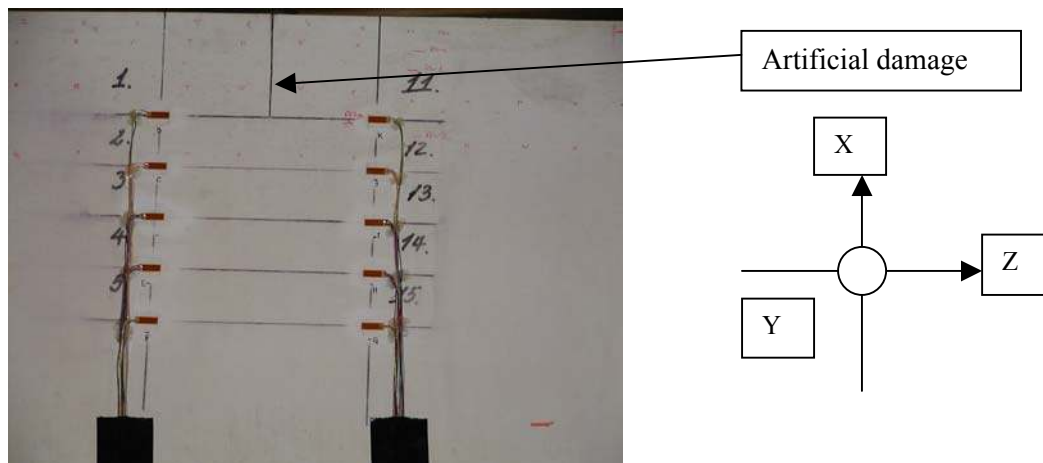
Figure 7. Up-wind surface of blade, damage no. 1. Tip-end direction to the right.

The size of the initial damage was determined to 98 mm and ended just before the line of the two strain gauges closest to the trailing edge, see Figure 6 and Figure 7. The SG numbering is made as lowest numbers on up-wind surface, and lowest numbers nearest to the root intersection.

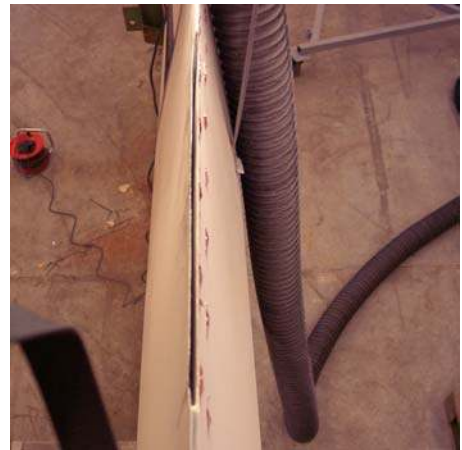
The second damage was a removal of the glue in the joint in the trailing edge. An angular grinder was used to remove the glue. All glue in the trailing edge joint was removed over a distance of 0.40 meter. The artificial damage was made in a position 11 metres from the root intersection. Due to the slim size of the trailing edge the blade chord was shortened a little when the glue was removed, see Figure 11 and the trailing edge of up-wind and down-wind shells became very thin where the damage was made.

Figure 12. Damaged trailing edge

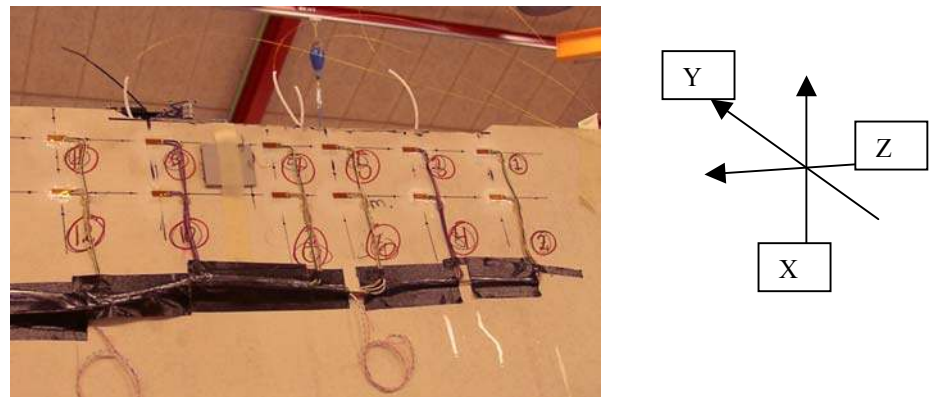
Figure 18. Down-wind surface of blade, damage no. 2. Tip-end direction to the left.

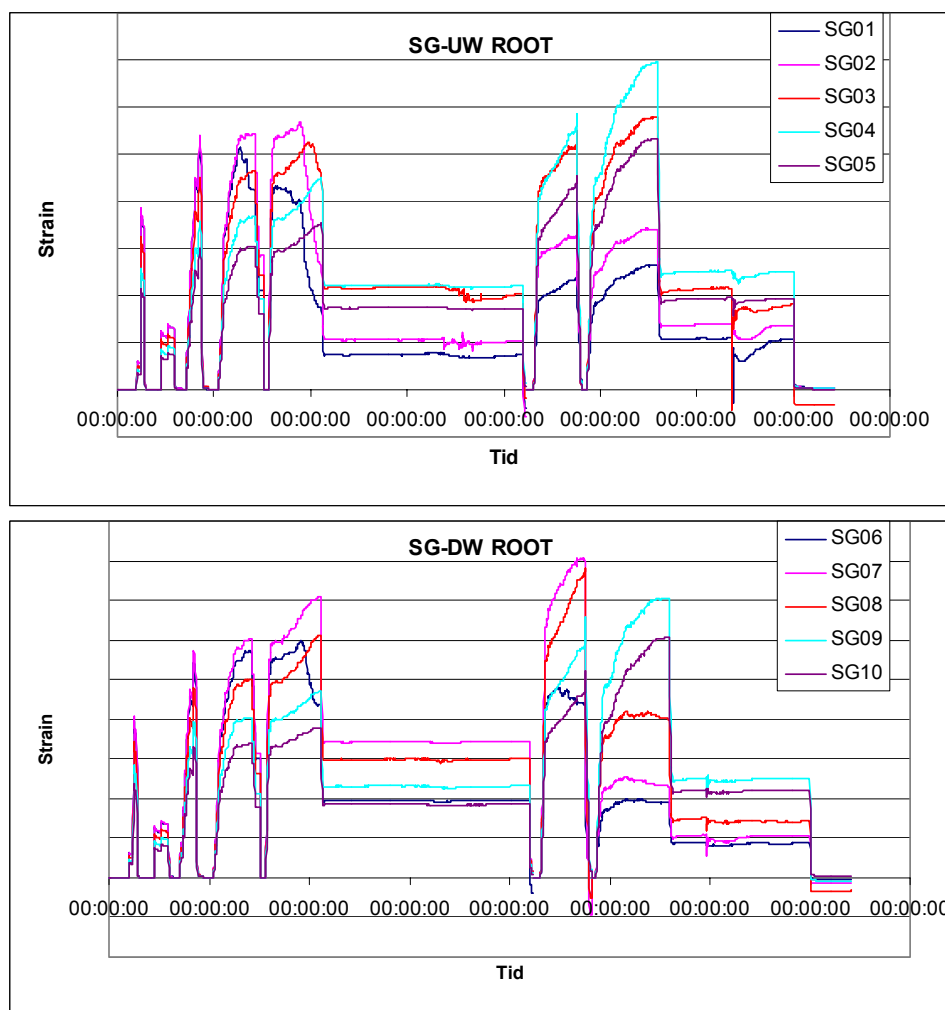
Figure 26. SG-measurements from test WING001 – WING008, Damage no. 1.

As the load was applied to the blade a linear related increase in strain level was measured on all the strain gauges. The relation in strain level between the strain gauges was also linear in correspondence to the distance from the neutral line of the blade, except for the 4 strain gauges (SG-no. 1, 6, 11, 16) in the line of the tip of the damage, which showed a lower strain level. The linearity ruled for tests “WING001 to “WING003”. During test “WING004” the strain level for the gauges (SG-no. 1, 6, 11, 16) nearest the trailing edge decreased while the next gauges (SG-no. 2, 7, 12, 17) were increasing in strain level, this change is indicated in the red arrows in Figure 26. The change in strain level was highest on the up-wind side of the blade; this corresponds with the growth of the damage during this test. This change in strain level between the strain gauges corresponded to the propagation in the crack length.

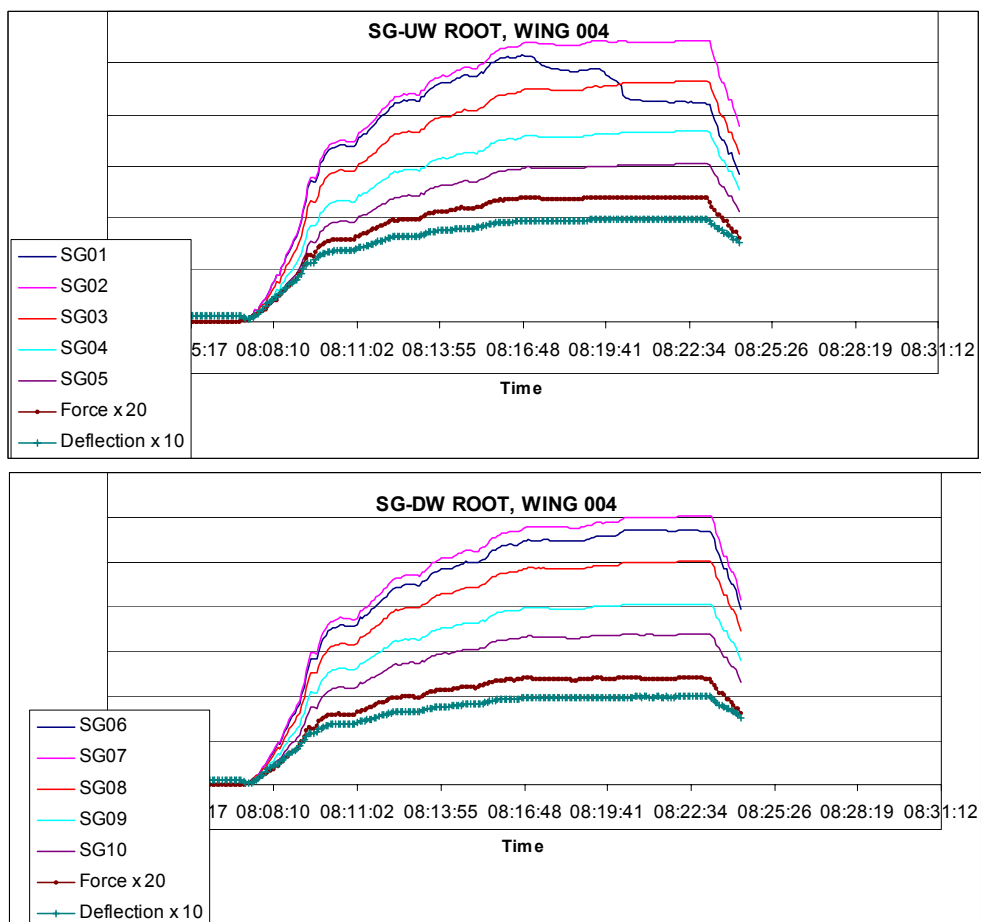
Figure 28. Measured strain, force and deflection as a function of time during “WING004”

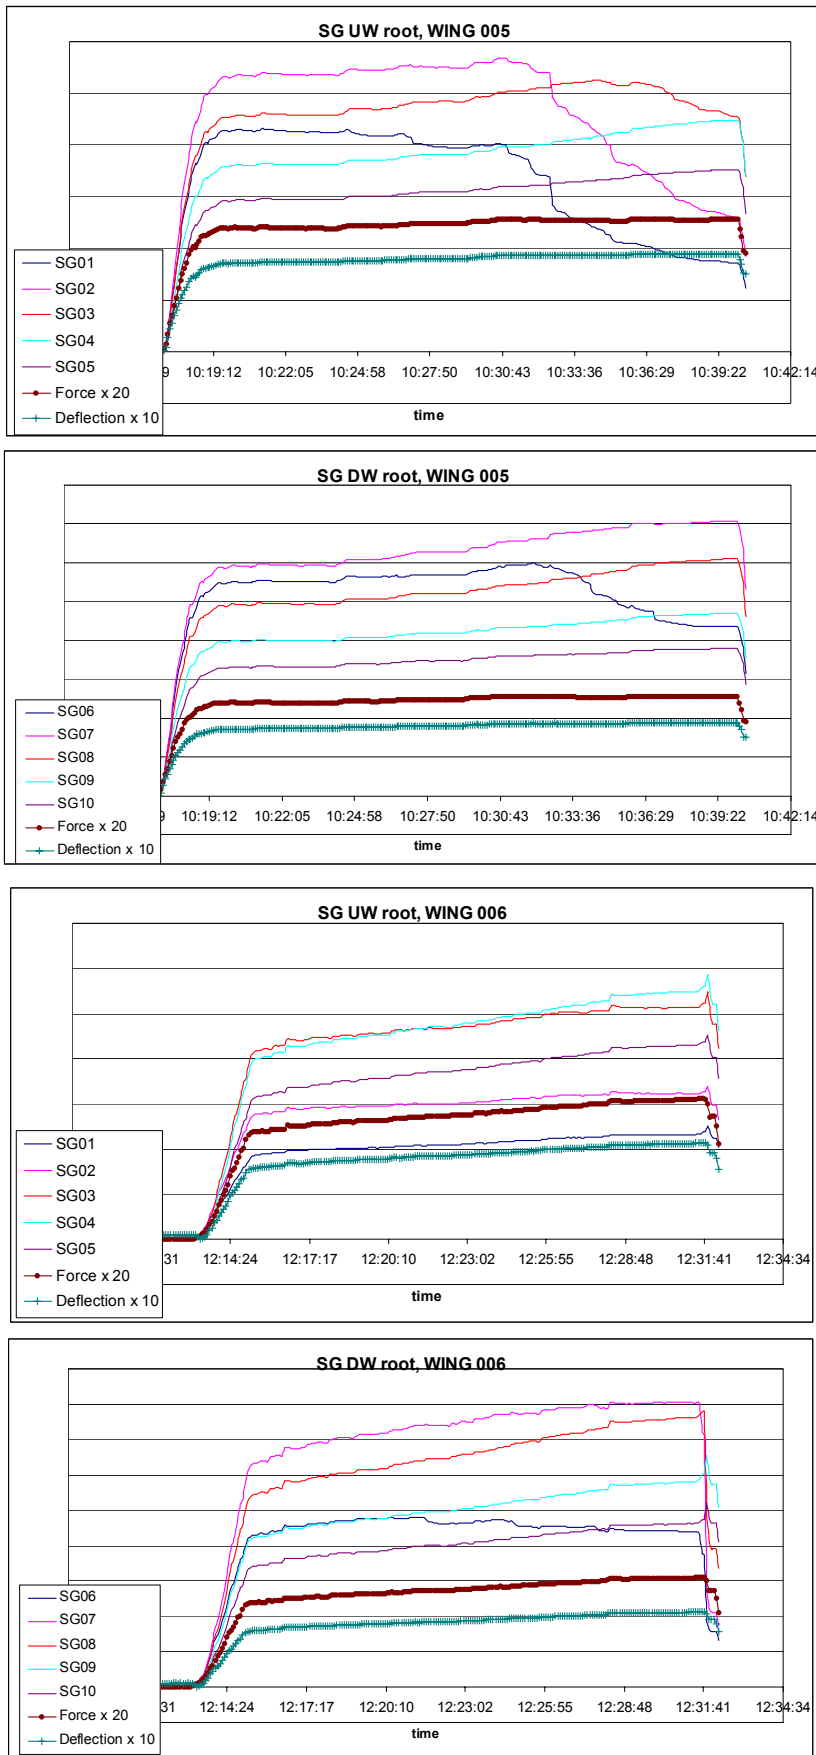
The major difference between WING005 and WING006 is the duration of the crack propagation. During WING 005 the crack propagated over a little less than 10 minutes, and during WING 006 the same size of damage propagation happened within the same minute. This is seen as a very steep change/decrease in the strain level for strain gauge no. 08 at the end of WING 006. Note, that the decrease in strain level appears prior to the unloading/decrease in load level.

Figure 33. Strain measurements during WING 005 and WING 006

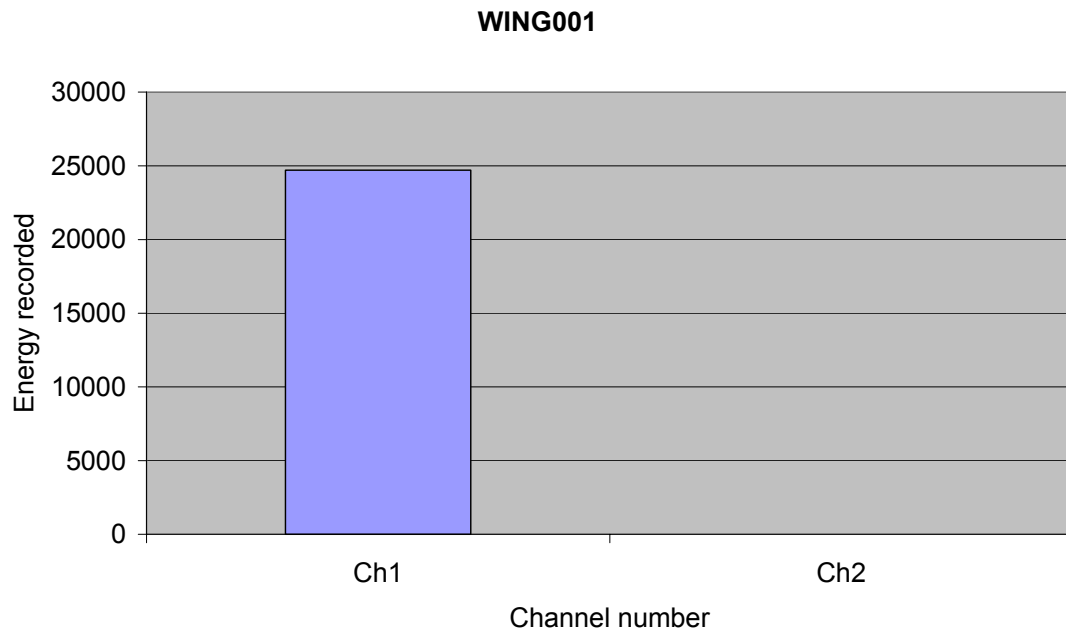
Here one sensor (channel 1) was placed directly adjacent to the initiator crack and the other was placed at a point on the structure far from any anticipated sources. This short test (WING001) lasted only 13 minutes and produced no actual crack growth; in fact it produced no damage detectable with either visual inspection or ultrasonic and X-ray NDT. However the AE sensor placed adjacent to the crack initiator recorded 1949 AE hits with a total energy content of 24027, (Figure 34), while the sensor (channel 2) placed away from the crack initiator recorded no activity.

Figure 34. Zonal location for WING001

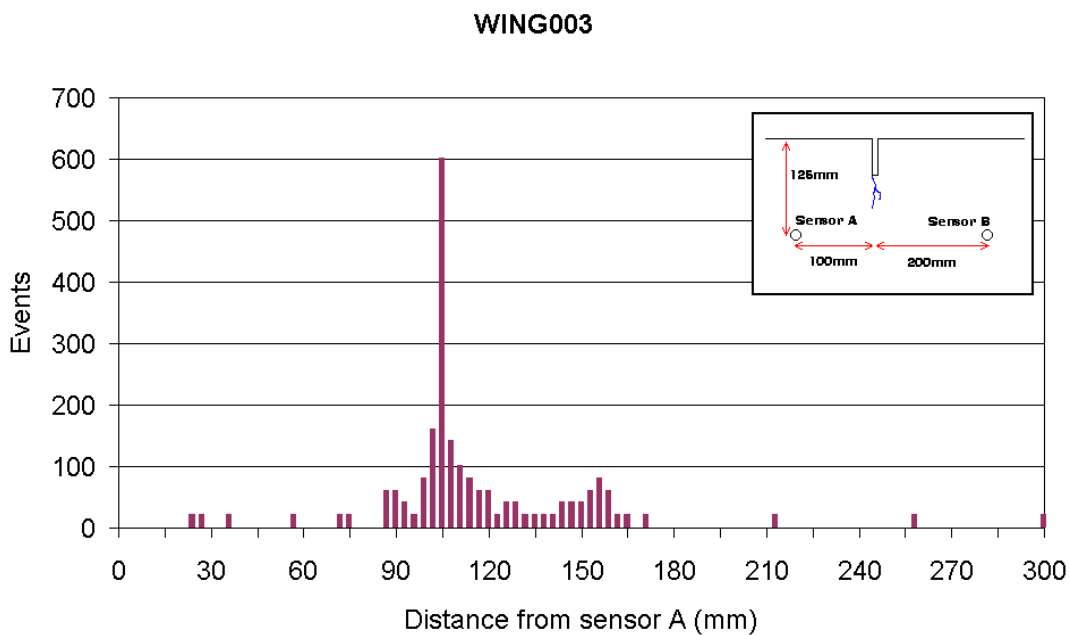
Figure 35. Linear location of AE events for WING003 at end of test

This graph clearly shows a high concentration of AE "events" between the two sensors at precisely the position of the crack.

It is interesting to note in Figure 36 that a second peak has developed to the root side of the main source corresponding to the crack tip. Indeed this secondary source is the more active at the beginning of the test. The presence of this secondary source is also discernible, although not so strongly, in Figure 35. Photographs subsequently taken of the damage shows crack branching on the downwind side that is in agreement with a secondary source.

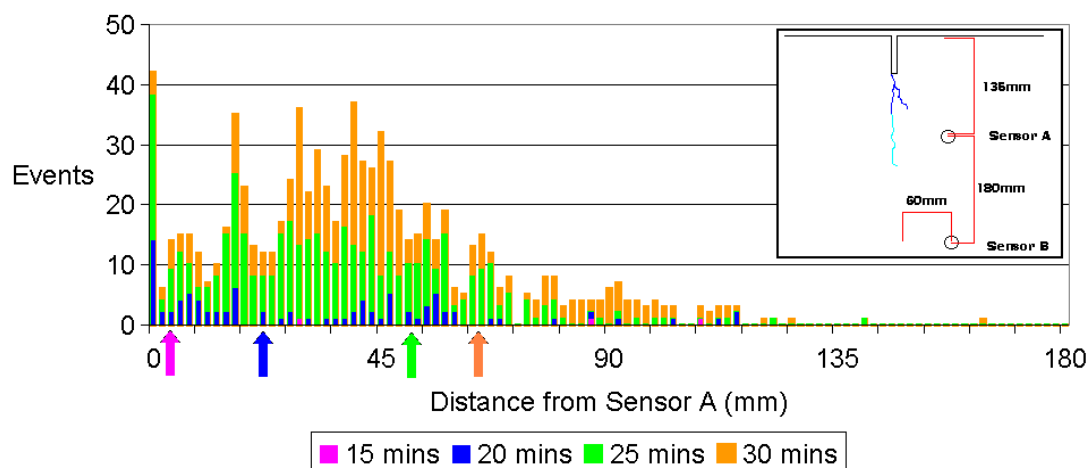
Figure 37. Linear location of AE events over time in WING005 (arrows indicate crack tip positions taken from video images)

During this test the crack advanced 81mm on the upwind side, where the AE sensors were positioned. During the early part of this test the crack front was above the sensor array, and as the graph shows very few hits were recorded by the location array during this time. However, as the crack moved downwards into the area monitored by the sensors (from the left in this graph) the AE events become more frequent and track to the right as the crack advances. The general location of the crack front at four time intervals and the graph display at that time are indicated by colour coding.

It is clear from Figure 37 and Figure 38 that the AE events are not only being generated at the cracktip, this is agreement with visual observations. In a cracking composite material (unlike metals) the crack wake also contains multiple sources of damage such as fibre pullout. There is therefore *a long damage zone*

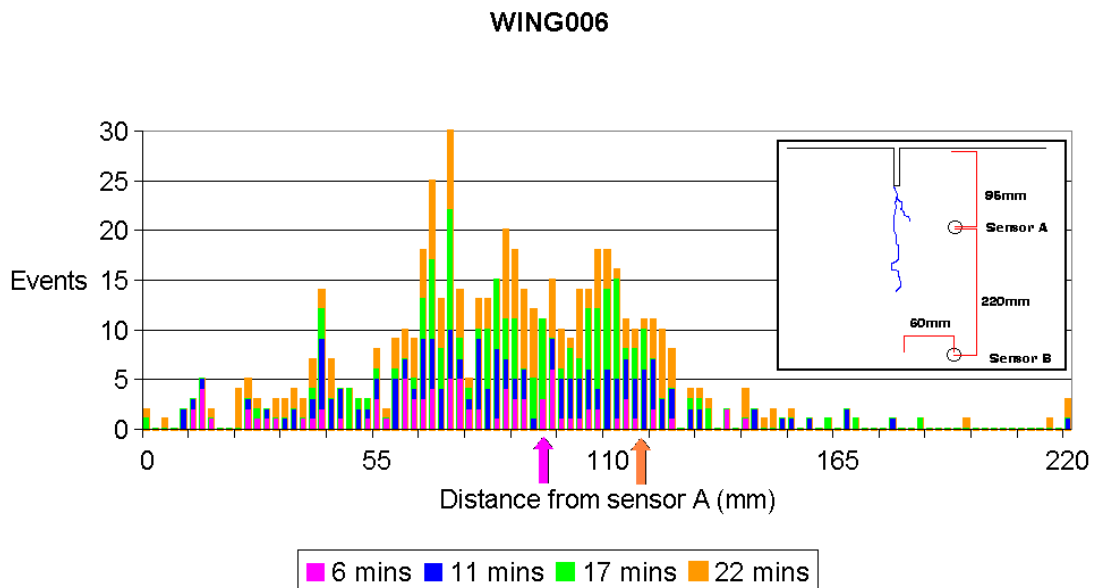
Figure 38. Linear location of AE events over time in WING006

The test was repeated in WING006, but this time the sensors were positioned so that the crack tip began within the monitored area, some 75mm from the sensor nearest the trailing edge. Figure 38 shows a broad source of AE events at the crack tip, it should be noted that the crack advanced only 14mm during this test.

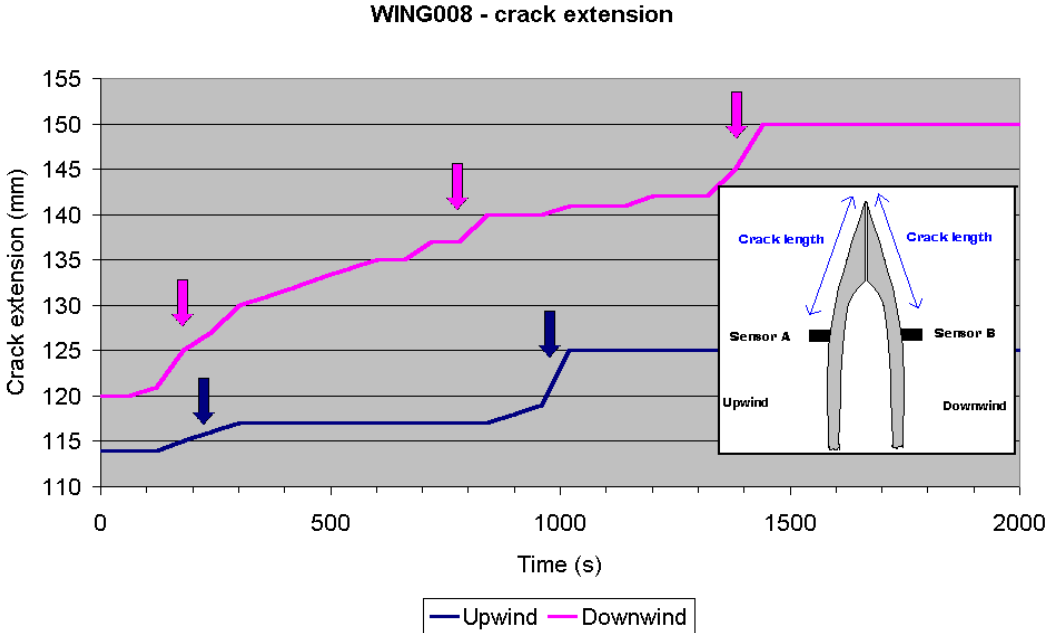
Figure 39. Crack extension on either face over time during WING008 test

Video images during the test confirmed that the crack advance on each side was not symmetrical. The Upwind (pressure side) crack advanced 11mm during WING008 and the Downwind (suction side) crack advanced 30mm. A rough indication of the crack growth visible on either side of the blade is shown in Figure 39. These readings are only estimates based on viewing of the surface recorded on the test video.

In general the crack growth was at a steady rate, however there are occasions when the crack was seen to grow a few millimetres comparatively quickly. These instances have been highlighted on the graph with colour coded arrows.

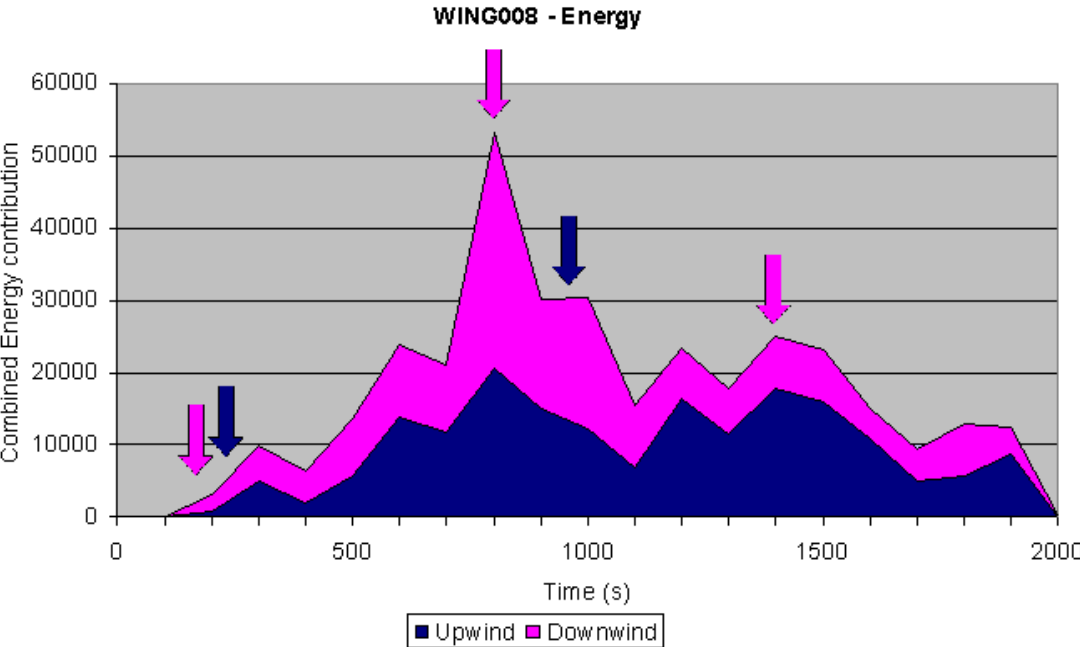
Figure 40. Accumulated energy detected from both sensors during test WING008

Figure 40 shows the combined energy received by the two AE sensors during the course of WING008. The crack growth indicators established in Figure 39 are shown again here. As might be expected the periods of highest combined energy generally correspond to the periods of crack advance established in Figure 39.

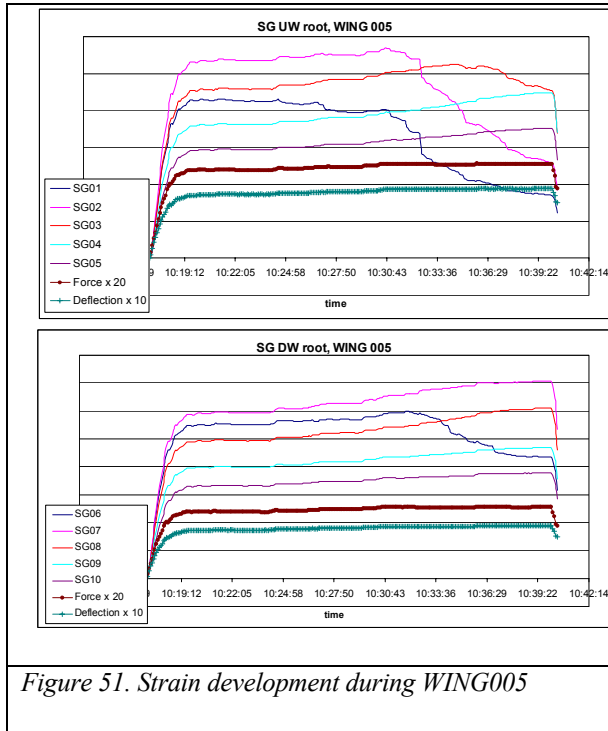
Figure 51. Strain development during WING005

The AE results and the strain gauges measurements show good capability in determining the crack propagation and give good visualisation of the speed of crack propagation. The major growth in crack length during WING005 happens in the last third of the test. This is very visible in the change in strain-level in the strain graph in top of Figure 51. In Figure 52 it is visible that the major part of AE-hits appears in the last third of the test.

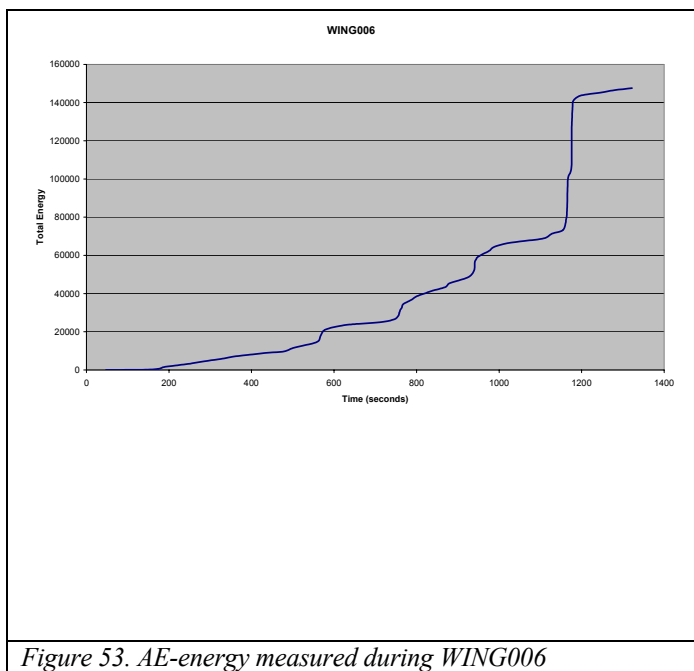
Figure 53. AE-energy measured during WING006

In Figure 53 it is seen that in the very end of test WING006 there is a significant increase in acoustic emission this correlates well with the strain measurements in the lower part of Figure 54. By watching the VCR monitoring of the blade it is seen that the damage propagates very much within a very short period of time in the end of test WING006.

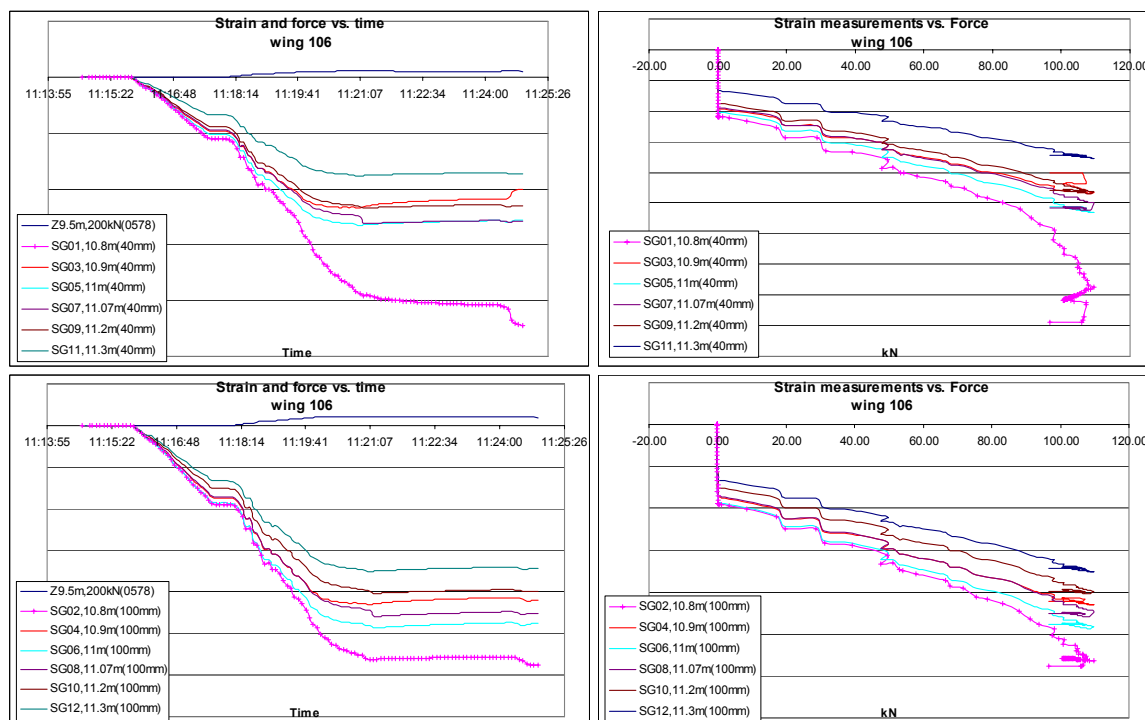
Figure 61. Measured strain, force and deflection during “WING 106”

As the load was applied to the blade a linear related increase in strain level was measured on all the strain gauges. The relation in strain level between the strain gauges was also linear in correspondence to the distance from the neutral line of the blade. The linearity ruled for tests “WING 101 to “WING 105”. During test “WING 106” the strain level for gauge no. 3 decreased in strain level as the rest of the gauges were still increasing, see Figure 61.

This indicates buckling which is also very visible on the video. This buckling in the area of gauge no. 3 appeared in all the tests. The change in strain level between single gauges does not correspond to the crack propagation. It is impossible to determine the crack propagation from the strain gauge measurements.

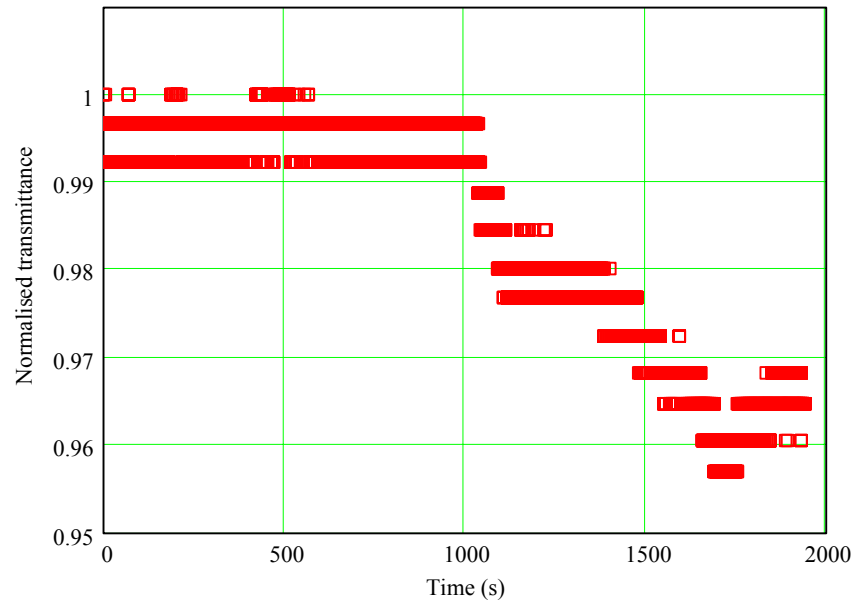
Figure 62. Micro bend displacement transducer measurements during WING114

The first 1000 seconds the load on the tip was increased, the load in the centre yoke was gradually increased and the crack started growing. The deformation of the blade had apparently no impact on the transmittance of the transducer. The transducer started to change transmittance at a time when the transducer is reached by the crack tip. The load was still increased, causing a large crack opening, and a still lower transmittance. After 1700 s the load is gradually removed. The entire load was removed after 1900 s. Figure 62 shows that the transducer only partially resumes its initial transmittance. A permanent crack opening is apparently created.

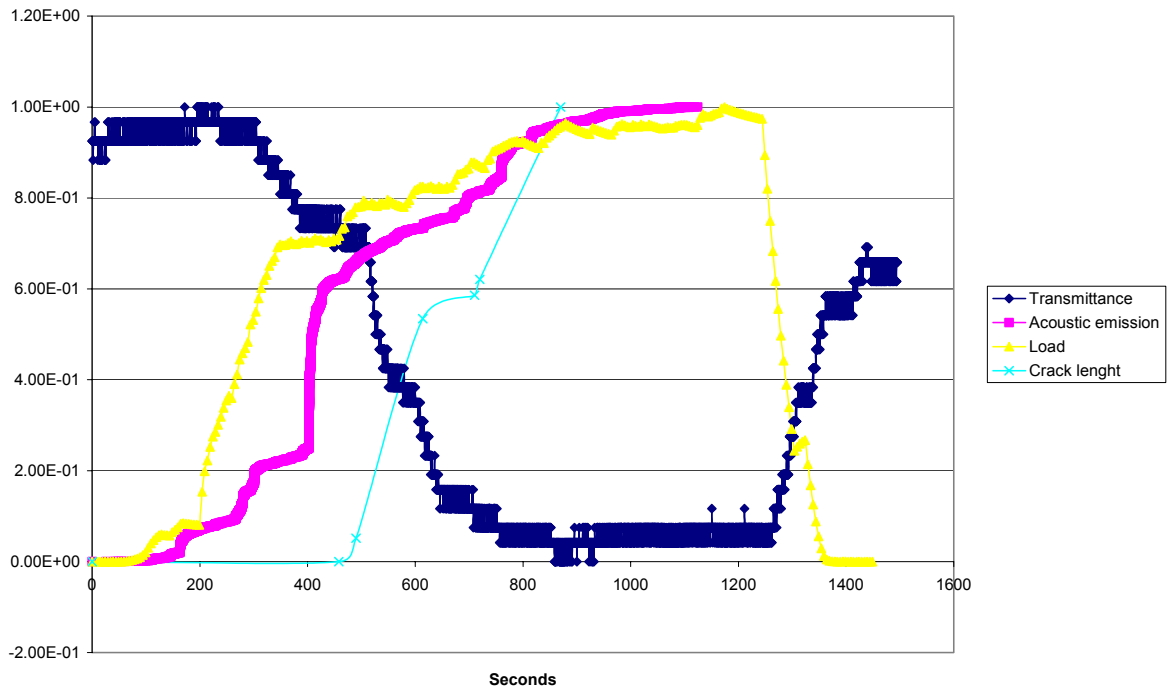
Figure 63. Transmittance of micro bend transducer correlated with normalised values of force, acoustic emission energy and crack propagation during WING115.

In WING115, the load was still more increased with a 10 % decrease in transmittance as a consequence, see Figure 63. The load was increasing until 1200 s, but apparently the deformation of the sensor reached a maximum. After 1200 s the load is removed and the transducer resumes most of its original transmittance.

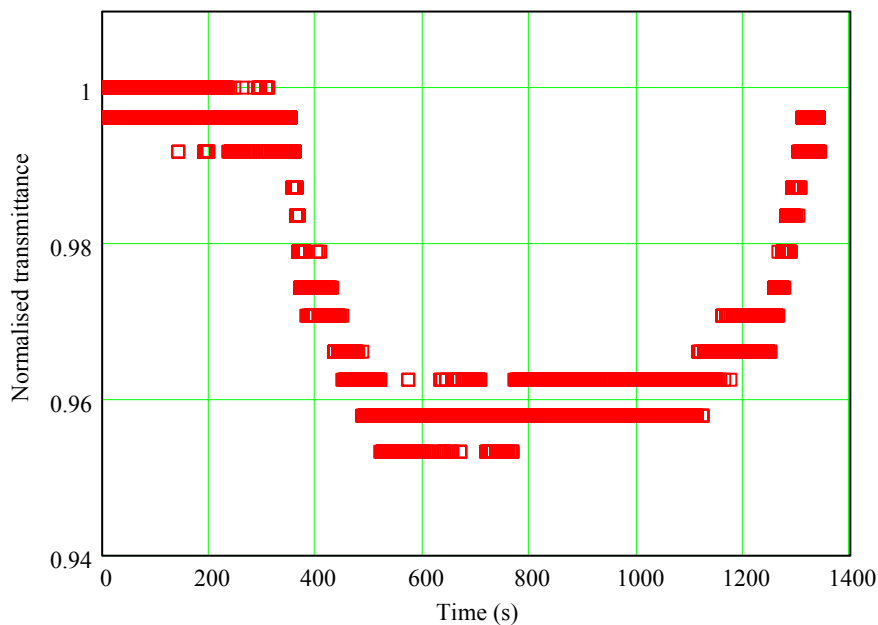
Figure 64. Micro bend transducer signal during WING116

Figure 64 shows, the transmittance decreases once more, but only a few percent, even though the crack with almost certainty passed the transducer, and the gap was large. The transmittance did not fall to zero, as expected for a crack width larger than 200  $\mu\text{m}$ .

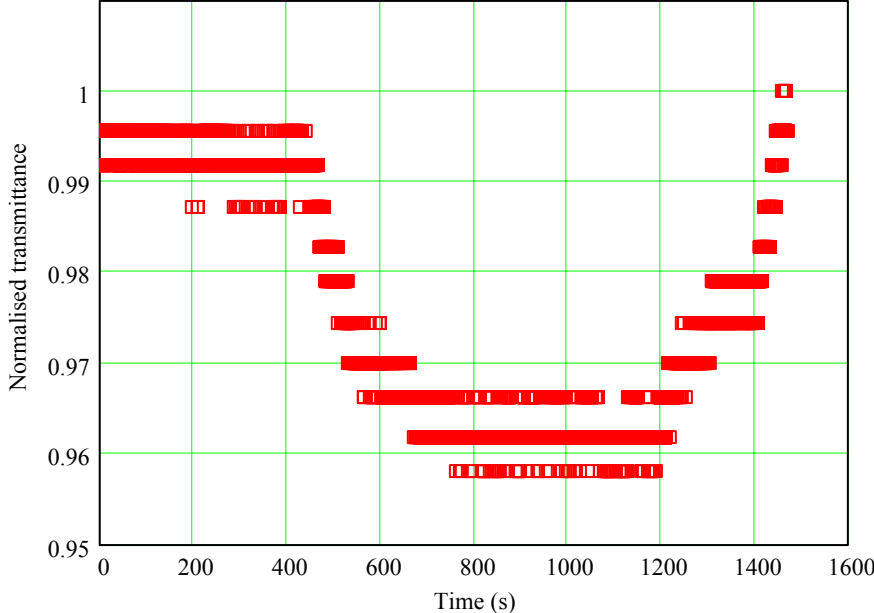
Figure 65. Micro bend transducer signal during WING117

This new test was apparently a repetition of the test before. There was a decrease in transmittance until a certain point. The crack had now passed the transducer and the crack was at maximum load several mm wide. A blade was inserted in to the crack, at the location of the transducer, and pushed to the bottom of the adhesive region. There was no detectable contact between the transducer and one of the shells. The crack was in the interface between one of the shells and the adhesive layer and the transducer was fully contained in the adhesive. The surface, which initially was glued to the shell, was now almost completely loosened. This conclusion was reached after direct visual inspection, through the crack opening, and by use of a blade. The change of transmittance indicates that there was some contact, but maybe only through a number of loosened glass - fibres, that had been torn out of the fibreglass composite.

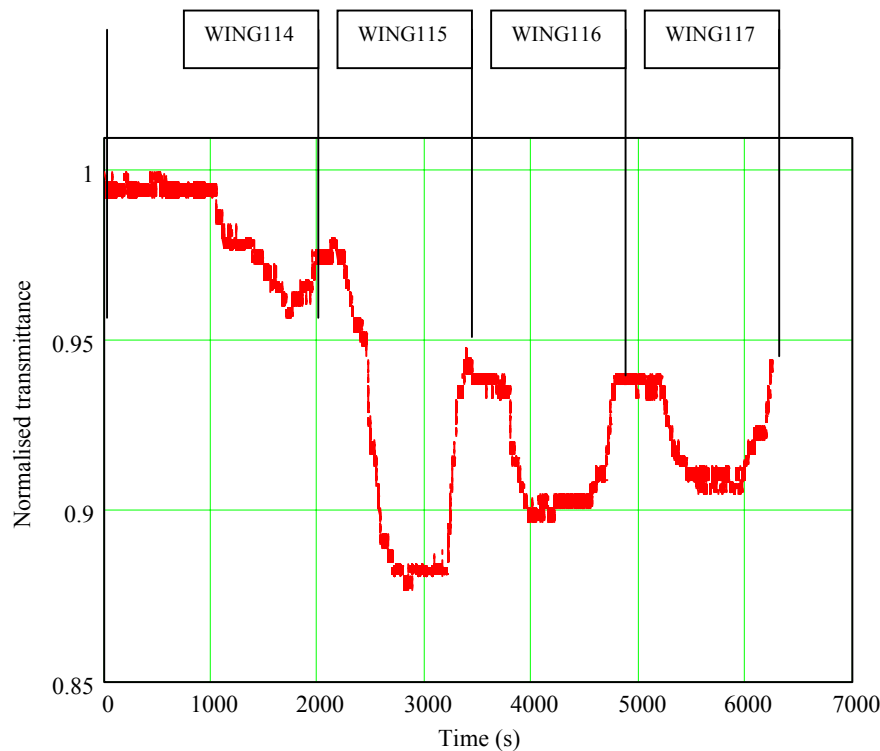
Figure 66. Micro bend transducer signal during WING114- WING117.

The variation of the transmittance through all 4 tests is displayed in Figure 66. The normalised transmittance is here defined as the ratio between the power and the largest power in all four series. The maximum decrease in transmittance was 12.3%, which corresponds to a deformation of the transducer of  $12.3\% / (0.5\% / \mu\text{m}) = 25 \mu\text{m}$ . The first deformation is apparently irreversible and the initial transmittance was not reached again. This agrees well with the circumstance that the transducer permanently loosened most of its contact to one of the shells.

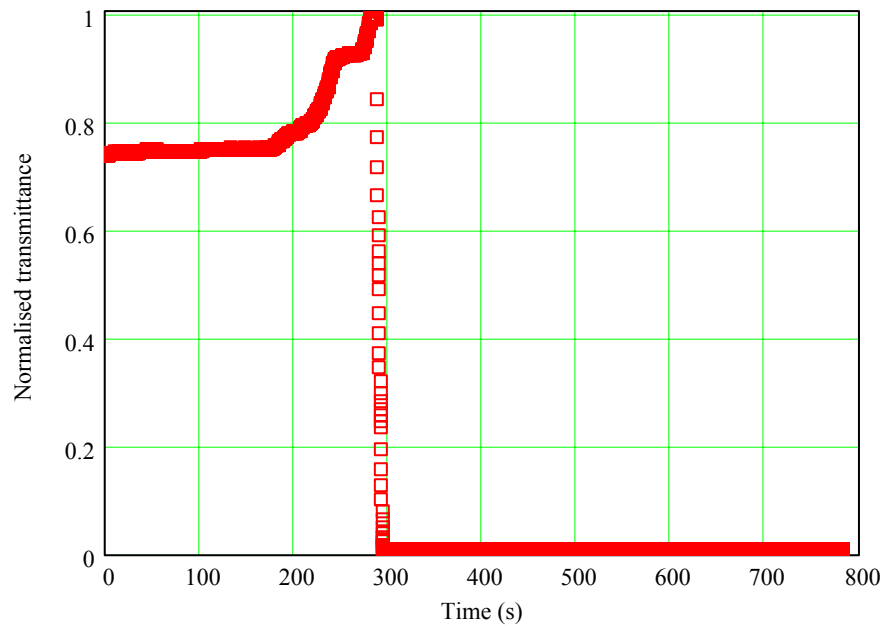
Figure 67. Change in transmittance during WING118.

As Figure 67 shows there is a small increase in transmittance, after which the transmittance drops to zero over a short period of time. Hereafter the wedge is removed and the load on the yoke nearest the tip is removed. The movement of the wedge and the unloading of the blade did not change the transmittance. The fiber is probably squeezed into two or more pieces inside the transducer, because all will be carried by the optical fiber, when the deformation of the transducer is more than 200  $\mu\text{m}$ .
