GANSBAAI FISHING HARBOUR - THE DESIGN AND CONSTRUCTION OF A BREAKWATER
ON A HOSTILE COAST

ABSTRACT

This paper describes the design and construction of a fishing harbour on a rocky coastline exposed to the prevailing south westerly swell of the South Atlantic and to severe westerly gales.

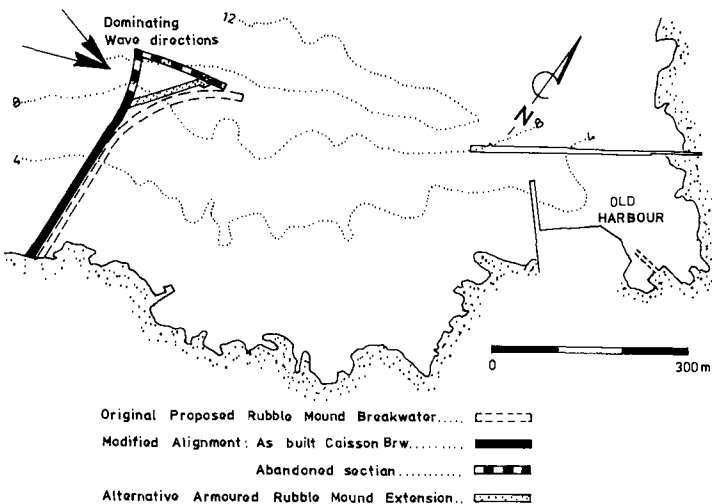
Fig 3. Layout of Breakwaters - Phase I

The alignment of a breakwater required to effectively protect the entrance to the old harbour, presented difficulties because it would have to extend into or across the deep channel, as shown in figure 3. Such a breakwater would be expensive and could create the same problem as that caused by the existing northern breakwater, i.e. forcing incoming boats into the shoaling water on the opposite site of the channel. Reflection of wave energy by the new breakwater could also create turbulent conditions in the entrance channel.

When the caisson wall was incorporated in the model the excessive overtopping of the wall and the reflection of waves from the vertical face was clearly demonstrated. It was evident that the reflection of waves from west north west and north west off the last section of the breakwater would result in extremely rough conditions in the access channel to the old harbour. Various remedial measures were considered but eventually a revised alignment was proposed whereby the wall would initially curve westwards and then at chainage 360, bend sharply eastwards so that the first section would reflect waves to the south western shore and the second section would be almost parallel to the direction of the waves (see figure 3).

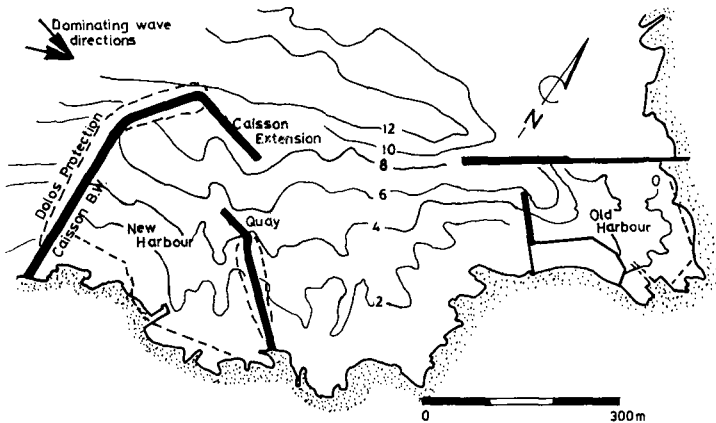
Fig 8. Revised layout of new harbour

Many different alignments, sections of breakwaters and absorbing structures seaward of the caisson wall were tested under all recorded wave directions, heights and periods, as small variations in these parameters affected the focussing of waves along the breakwaters considerably. A solution was found for the safeguarding of the existing new breakwater and an extension of this breakwater to create satisfactory entrance and mooring conditions in the "new" harbour was successfully tested. No really successful solution was found for the combination of the old and new harbours because of the distance between the ends of the main breakwaters of the two harbours. One layout tested involved the construction of a T-breakwater halfway between the two harbours. The cost of this scheme, however, rendered it unacceptable. Even the most favoured scheme involving the extension of the north breakwater of the old harbour was not justifiable. The main part of the model study was completed in 1978 but additional tests involving mainly construction techniques continued up till 1981.
