## GEOTECHNICAL RECONNAISSANCE OF THE 2010 DARFIELD (CANTERBURY) EARTHQUAKE

Editors: **Misko Cubrinovski<sup>1</sup>, Russell A. Green<sup>2</sup>**

This paper summarizes the observations and preliminary findings from this early reconnaissance work.

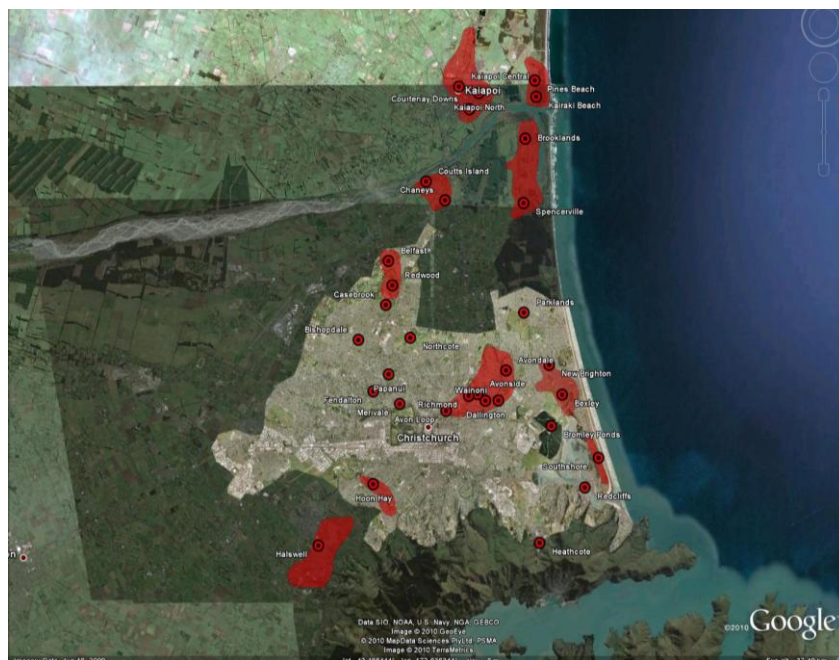
**Figure 4.3:** Areas of observed liquefaction (red shaded regions and red points) in Christchurch due to the 2010 Darfield earthquake (the liquefaction map is based on surface manifestation of liquefaction visible in aerial photographs and compiled evidence from ground surveying).

Limited or partial liquefaction was observed at numerous locations across the city, which manifested as scattered and relatively small (or within limited area) sand boils. In these places there was damage to roads, footpaths, and driveways as well as some house damage, but the liquefaction effects were moderate or mild. Figure 4.12 shows typical manifestation of limited liquefaction in CBD (Peterborough St) and in the backyard of a power sub-station on Greers Rd in Bishopdale. Other areas where liquefaction of limited extent was observed include Belfast (Engelfield Rd, near Main North Rd), Redwood (Barnes Rd, near Main North Rd), Fendalton (Queens Av), vicinity of English Park in St Alban's (Cranford St, Westminster St, Courtenay St, Trafalgar St, Sheppard St) and Burwood (DeVille Pl and DeBlog Pl). These areas of partial/limited liquefaction are shown in the liquefaction map in Figure 4.3.

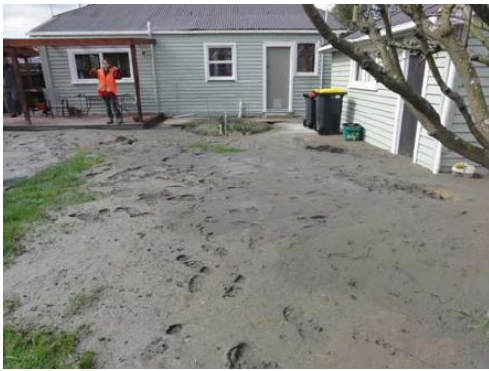
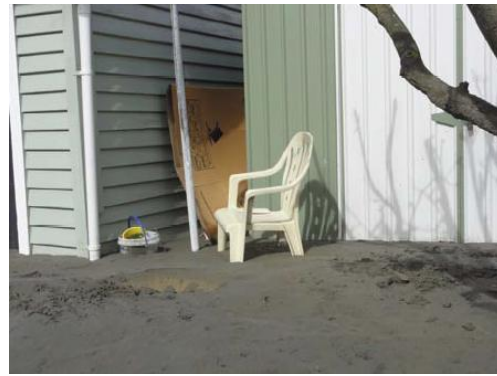
Typical manifestation of liquefaction in the backyard of a residential property is shown in Figure 4.4 (Bracken St, Avonside). Sand boil ejecta covered most of the lawn and was about 200 mm thick in places. There was evidence of massive liquefaction and large surface distortion on Bracken St. The potable water and sewer systems were out of service at the time of the inspections. Despite significant amounts of liquefaction ejecta and broken utilities throughout the neighbourhood, the house shown in the pictures suffered minor damage in terms of differential settlement and cracking.

(a) Large sand boils in residential area of Avonside (Bracken St).

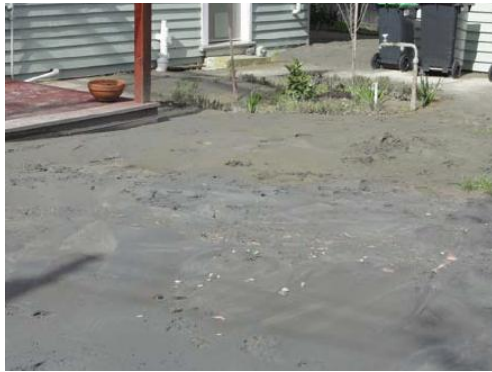
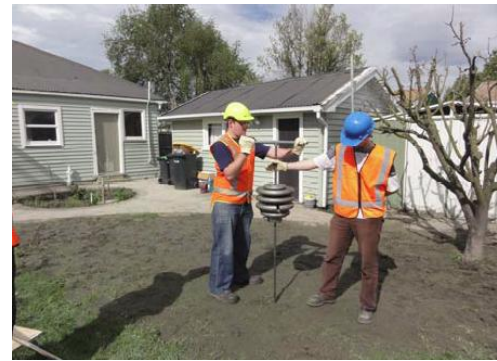
(b) The sand boil (grey non-plastic silty sand) in the bottom half of the photo to the left was typical of many locations across Christchurch and Kaiapoi where massive liquefaction was observed; at this location, a brown silty sand was also found on the ground surface (upper half of the sand boil); photo to the right: University of Canterbury postgraduate students perform Swedish Weight Sounding (SWS) test (Bracken St).

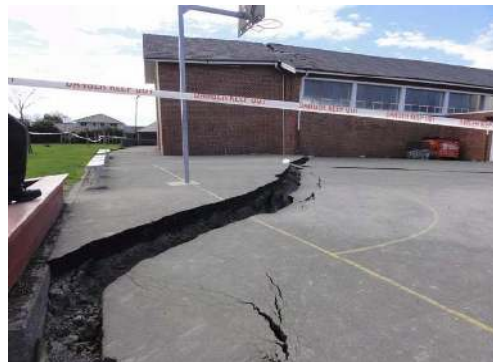
The geotechnical reconnaissance team performed a detailed survey at St Paul's Church (Gayhurst Rd, Dallington) which suffered damage due to liquefaction in the foundation soils (Chapter 5). Figure 4.5 shows a complex pattern of ground distortion including large cracks and vertical offsets around the building. Extensive sand boils covered the paved area around the building, backyard lawn, and around the perimeter of the building and its foundations. The building suffered large differential settlements and severe structural damage.

(a) Bearing failure in liquefied soils (St Paul's Church, Dallington); the crack is 500-900 mm wide with a vertical offset of 330 mm, at its maximum.

Specifically, the northwest side of the building was ripped in half due to a combination of differential settlement and lateral movement. This site is centrally located in a meandering loop of the Avon River and bounded by the river on all sides at distances of about 150-250 m, except to the north/northeast. There was apparent evidence of lateral spreading in this area, despite being located more than 150 m from the free-face of the river. (Note, however, that this distance is not necessarily anomalous. Evidence of lateral spreading has been found at distances of up to 2 km from a free-face in the New Madrid, Missouri, USA, area (Obermeier, S.F., per. comm.). These features manifested during the 1811-1812 earthquakes that occurred in that region.) The tension cracks and fissures around the building were much bigger than those near the river channel, and hence it is possible that they are not directly related only to the lateral spreading. Further investigations are required to clarify these details.

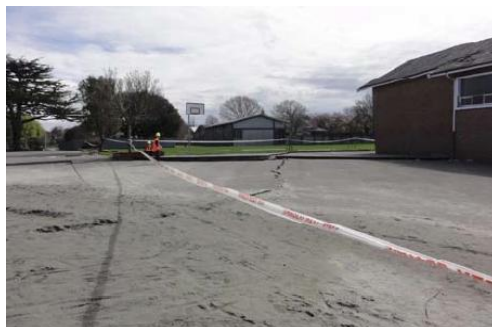
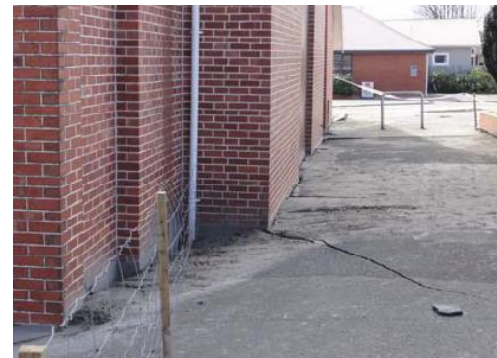
(b) Evidence of liquefaction in foundation soils resulting in large total and differential settlements.

Figure 4.5: Liquefaction-induced bearing failure in Dallington (St Paul's Church, Gayhurst Rd).

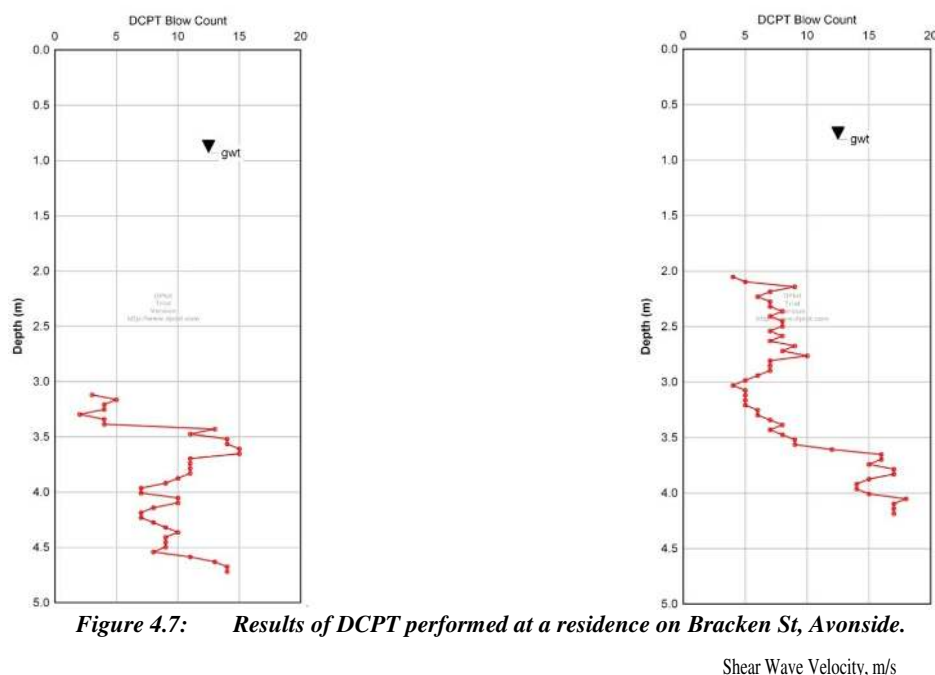
Figure 4.7: Results of DCPT performed at a residence on Bracken St, Avonside.

The ground water table at both sounding locations at the Bracken Dr residence was at ~0.8 m, and the top of the liquefiable layer was at a depth of ~2.1 to 2.4 m. The strata overlying the liquefiable layer were clayey. For one of the tests, the DCPT rods sank under their own weight 200+ mm, indicating very loose sand. Because no samples are recovered with the DCPT, the thickness of the liquefied sand layer cannot be determined for certain. However, from looking at the results shown in Figure 4.7, the penetration resistance sharply increases at a depth of ~3.5 m. Additionally, there is a very wet, very soft, thin (~100 to 150 mm) clay/plastic silt layer that overlies the liquefied layer. It is unknown whether this is a very sensitive material that softens as a result of earthquake shaking and/or sampling or whether it is a result of a water film that formed between the liquefied layer and clay layer.

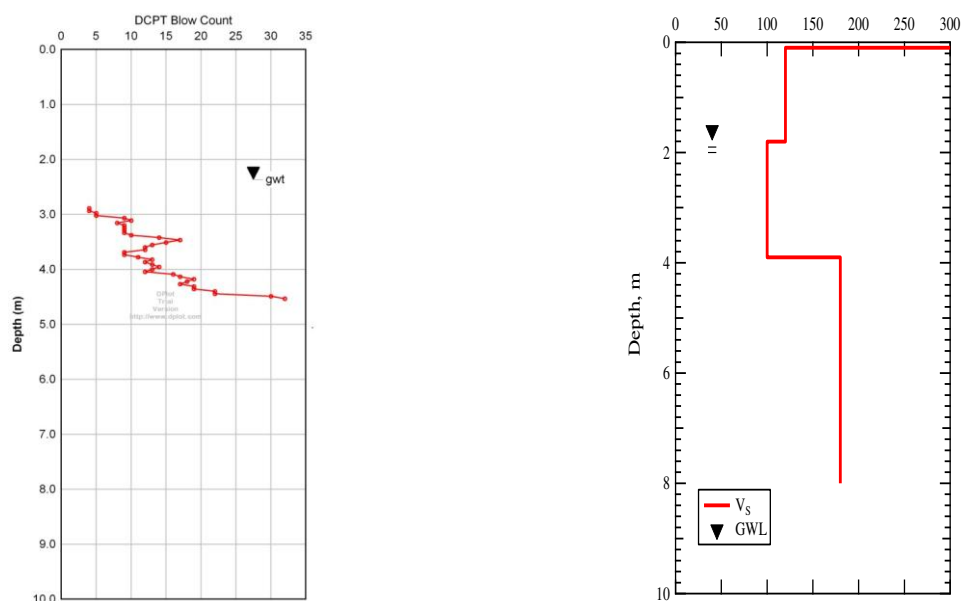
Figure 4.8: Results of DCPT and SASW tests performed at St Paul's Church in Dallington.

A DCPT and SASW test were also performed at St Paul's Church. The results of these tests are shown in Figure 4.8. Based on the bore hole augered for the DCPT test, the water table was at a depth of about 2.3 m and the top of the liquefied layer was at a depth of about 2.8 m. The SASW test was performed approximately 20 m away from the DCPT location.

The  $V_s$  profiles must be corrected for overburden pressure ( $V_{s1}$ ) prior to evaluating soil liquefaction triggering. Generally speaking, even without this correction any soil layers with  $V_s$  less than 150 m/s are quite soft and may be potentially liquefiable. However, it will be noted that  $V_s$  measurements alone cannot definitively determine liquefaction susceptibility, as the type of soil (i.e. clay or sand), not just its stiffness/velocity, is a key factor. The  $V_s$  profile shown in Figure 4.8 indicates soft soils down to 8 m depth, with the softest soils between approximately 2-4 m.

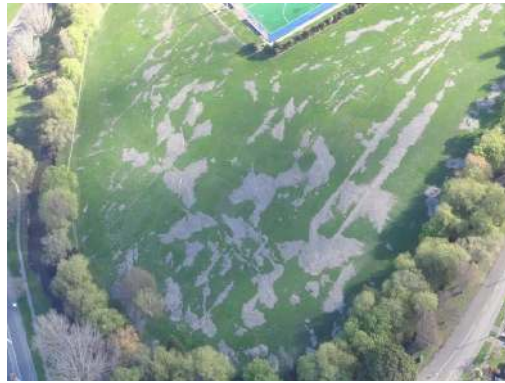
Further to the east of Dallington, extensive liquefaction, including substantial lateral spreading, was observed in Porritt Park (Wainoni), which is enclosed by the Avon River and a diverted stream around the park. Large sand boils covered substantial areas of the park (Figure 4.9). Parallel cracks spaced regularly along drainage lines were indicative of slumping and spreading towards the north and south branches of the stream. A couple of hockey fields located in the park were severely damaged by the liquefaction, resulting in a very uneven, bumpy surface of the fields.

(a) Aerial view: massive sand boils with large number of parallel cracks along drainage lines (from a helicopter flyover on the afternoon of Friday September 10).

Figure 4.9: Massive sand boils and lateral spreading cracks at Porritt Park (43.516278°S, 172.689917°E).

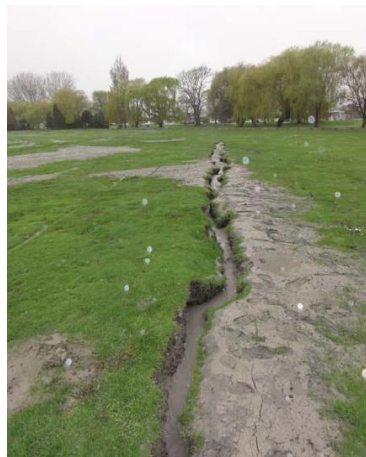
(b) ~10 cm wide lateral spread crack.

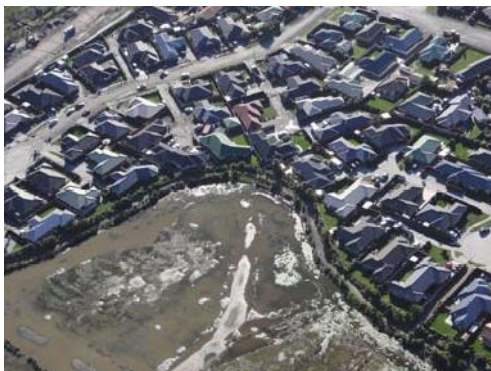
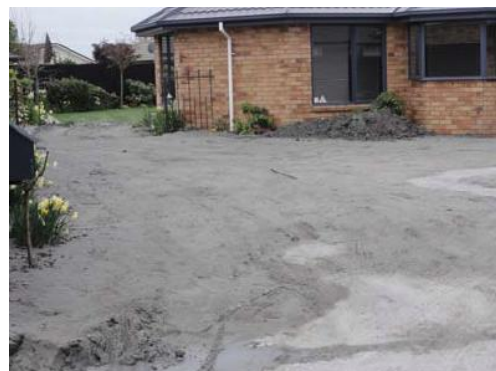
(a) Aerial view of the southern edge of Bexley which was severely affected by liquefaction and lateral spreading; (b) Evidence of liquefaction in residential area (Seabreeze CI).

Figure 4.10: Evidence of extensive liquefaction severely affecting residential houses in Bexley.

Widespread liquefaction occurred in Bexley, affecting a large number of residential houses (Figure 4.10). Ground distortion (i.e., differential settlement, large ground cracks, deformation of paved surfaces and substantial sand boils) was observed at Seabreeze Cl and Kokopu Ln. Residential properties along the southern edge of Bexley (along the wetland walkway) were severely affected by lateral spreading. Large movement of the walkway towards the water, slumping of the terrace fill and large ground cracks on residential properties were observed in this area. Similarly, severe manifestation of lateral spreading was observed at the east end of Bexley (Parenga Pl).

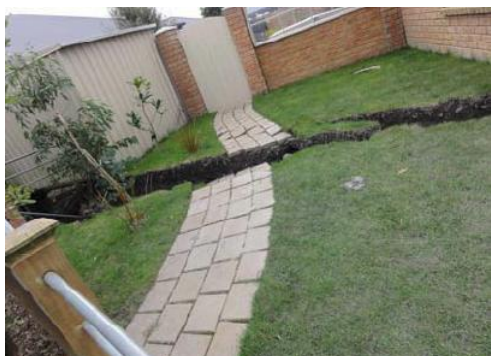
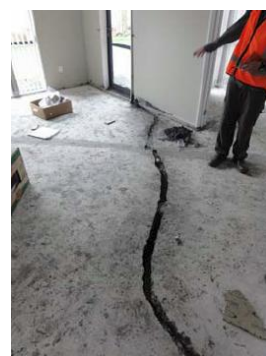
(a) Large ground cracks due to lateral spreading at Kokopu PI; (d) Cracks in unreinforced slab induced by lateral spreading.

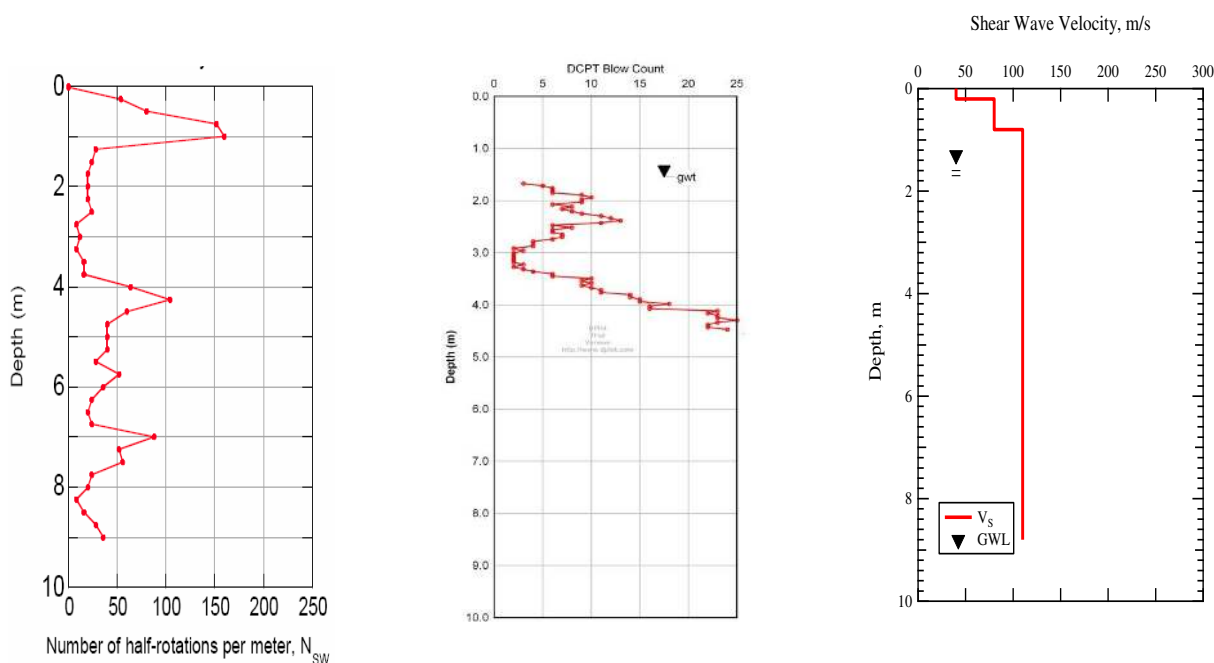
Figure 4.11: Results of SWS test, DCPT, and SASW test performed in the backyard of a house in Bexley.

An SWS test, DCPT, and SASW test were performed in the backyard of a house in Bexley; the results are shown in Figure 4.11. Based on the bore hole augered for the DCPT test, the ground water table was at a depth of ~1.5 m and the top of the liquefied layer was at a depth of ~1.6 m. The SASW test was performed ~10 m away from the DCPT sounding.

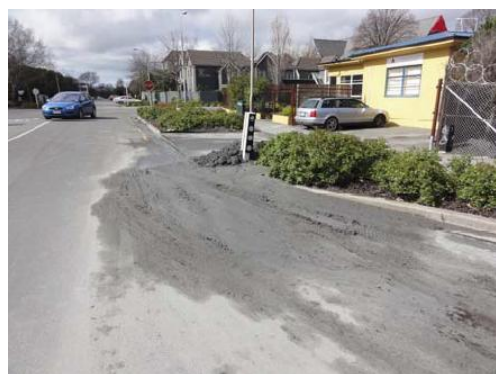
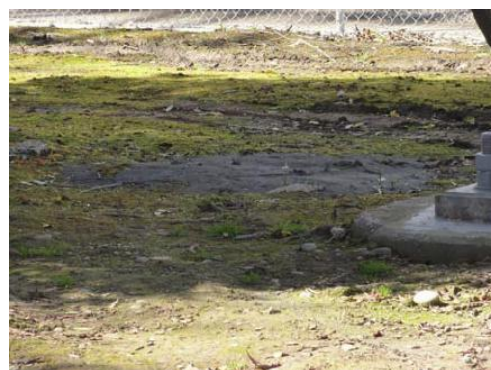
(a) Evidence of liquefaction at Peterborough St - Madras St (CBD); (b) Sand boil in the foundation soils of a transmission tower (sub-station northeast of Greers Rd - Ruddenklau Ln, Bishopdale).

Figure 4.12: Evidence of limited/partial liquefaction in areas of Christchurch.

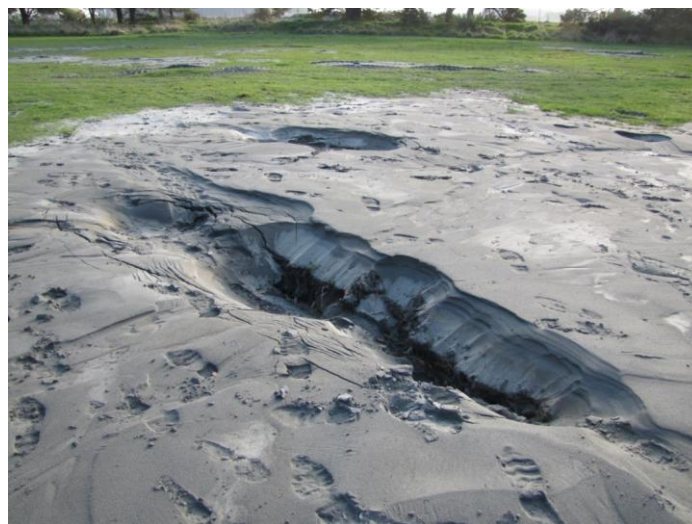
Figure 4.14: Sandboil in the Featherstone Reserve Pines Beach from which sand was taken for electron microscope pictures.

Figure 4.14 shows the large sandboil from which a bulk sample of the sand was recovered. Featherstone Reserve at Pines Beach was the location (approximate position 43° 22' 52" S 172° 42' 13" E).

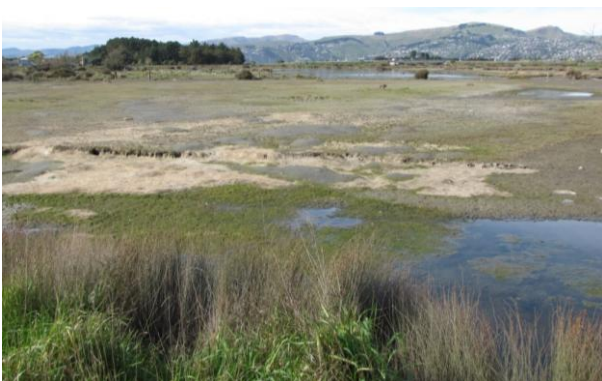
**Figure 4.19:** View of the Bexley Wetland at near high tide on Wednesday 29 September 2010. Prior to the earthquake this area was inundated at high tide.

Many sand boils are seen in the bed of the wetland area (at high tide on 29 September) which was inundated at high tide prior to the earthquake. Stream beds were also noticed to be heaved (Figure 4.20). A local resident confirmed that this was not how the stream bed appeared prior to the earthquake. In some places it was necessary to clear the stream bed soon after the earthquake.

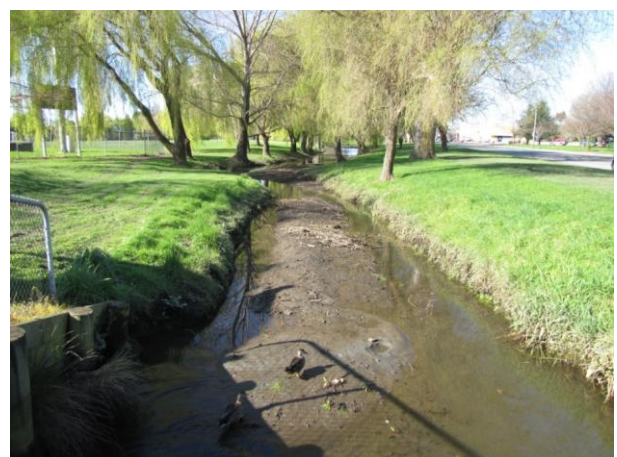
**Figure 4.20:** Photograph of the stream near Porritt Park on Wednesday, 15 September 2010. There is lateral spreading towards this stream from both sides. It is just possible to make out a sand boil in the midst of the stream bed debris to the right of the duck. Several other sand boils were visible along the stretch of heaved stream bed.

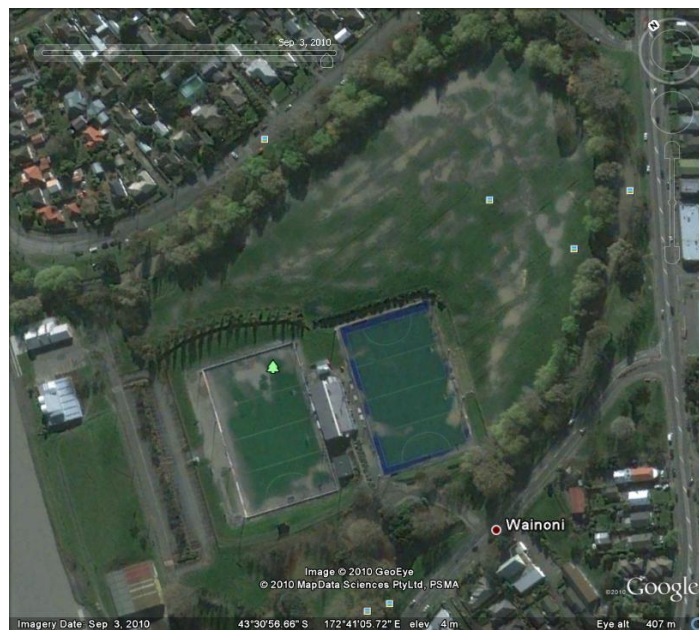
good evidence of liquefaction in some parts of the city. Figure 4.21 shows part of the GeoEye image covering Porritt Park (location about 43.515555°S, 172.685277°E; the image date is 3 September 2010 because GMT, rather than the local time and date in Christchurch, is used by Google). Figure 4.9a shows a picture of Porritt Park taken from a helicopter on the afternoon of Friday, 10 September 2010.

Comparison of these two images (Figs. 4.9a and 4.21), and also observations from on-ground reconnaissance, demonstrates that GeoEye is able to give good indication of liquefaction. Not surprisingly, it turns out that the key to this identification is contrast. The light colour of the ejected sand contrasts very well with the underlying green turf. In areas where the ejected sand covered the pavement, such as Bexley, the GeoEye image did not give such a clear indication of liquefaction.

Figure 4.21: Sandboil in the Featherstone Reserve Pines Beach from which sand was taken for electron microscope pictures.

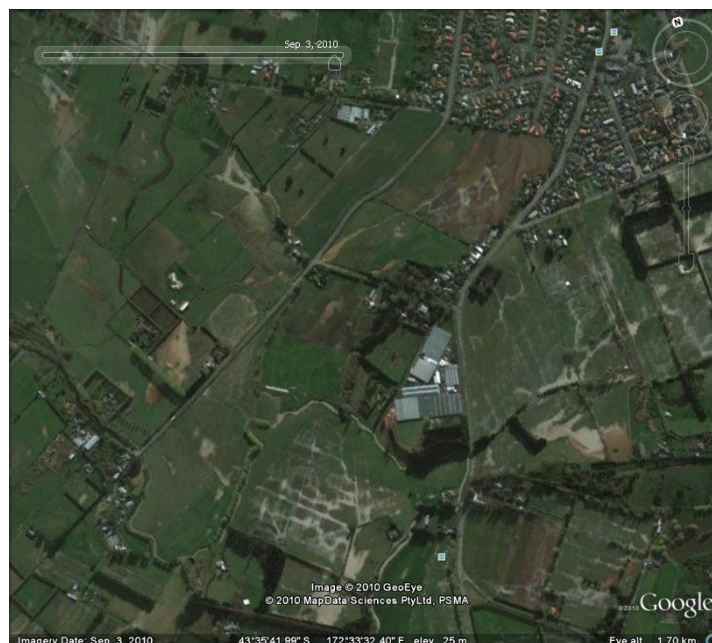
Figure 4.22: Part of Halswell as imaged by GeoEye after the earthquake. The ejected sand is accompanied by considerable volumes of water forming mini-lakes having a similar colour to the ejected sand (Google Inc., 2010).

appearance. This is because the ejected sand contained enough fine material (typically 10 % finer than about 50 microns) to stay in suspension for some time when mixed with water. A GeoEye image of part of the Halswell area is shown in Figure 4.22. Extrapolating from Figure 4.21, this figure suggests that there are some areas of Halswell where extensive liquefaction occurred. However, discussions with local residents revealed that a considerable volume of water came to the ground surface along with ejected sand, and this water took on a milky colour. So, the ejected sand could not be distinguished from the water in the satellite image. Some days after the earthquake this water had subsided.

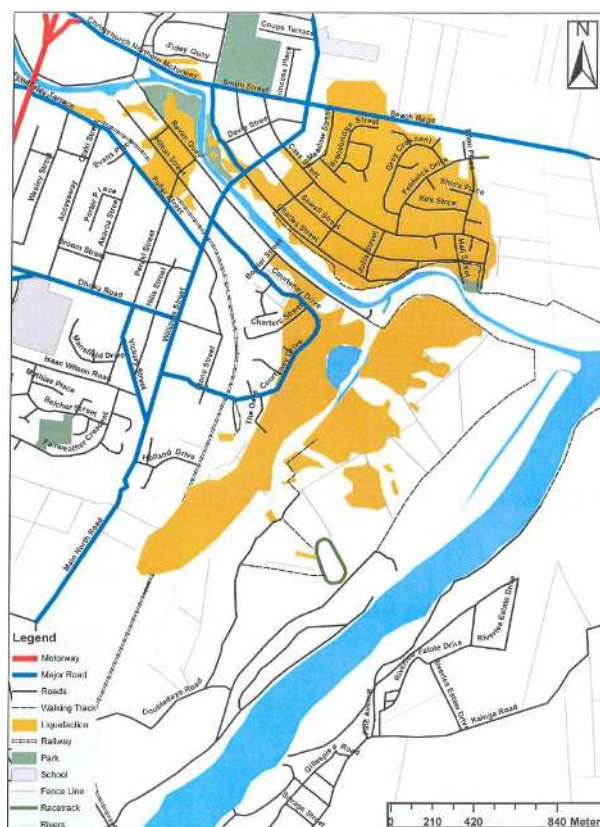
Figure 4.24: Areas of observed liquefaction in the town of Kaiapoi due to the 2010 Darfield earthquake (the liquefaction map is based on surface manifestation of liquefaction visible on aerial photographs and compiled evidence from ground surveying).

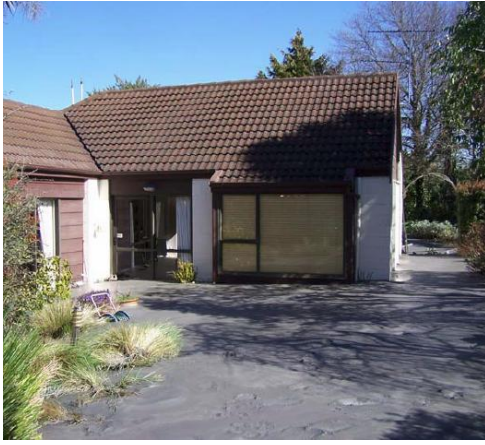
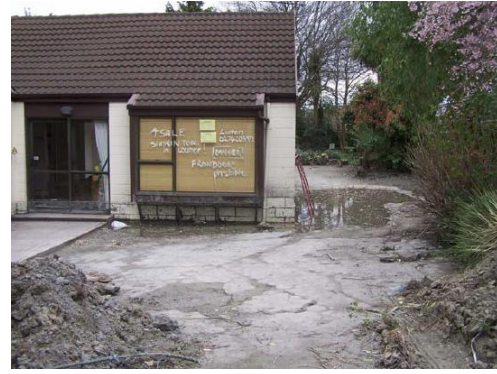
The liquefaction was particularly intense, producing massive sand boils of grey, silty sand, at Cassia Place and at the east end of Charles and Sewell streets. In the worst hit area, the silty sand ejecta was about 400 mm thick, as shown in Figure 4.25. Some residents reported geysers appearing in the backyard following the earthquake, often forming a small pond near the house that remained for several days after the event. An SWS test and DCPTs were performed by the team in this area, with the SWS test indicating loose/soft soils up to depths of 8-9 m (Figure 4.26).

(a) ~400 mm thick layer of silt-sand-water mixture covering a residential property affected by very severe liquefaction; (b) same-angle view, but after the clean up of sand boils.

Figure 4.25: Manifestation of very severe liquefaction in residential area at Cass Pl, North Kaiapoi.

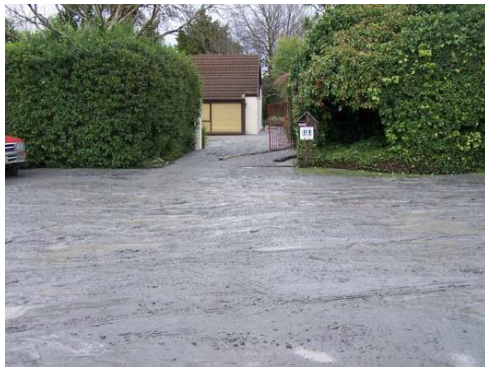
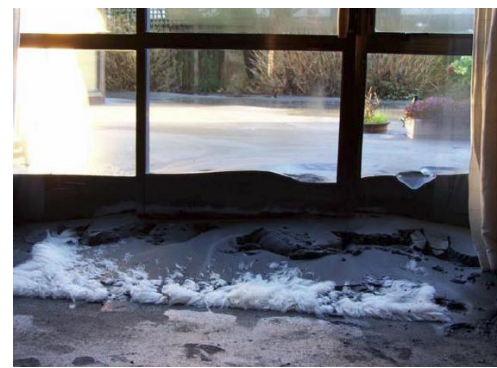
(c) View from the street (before clean up); (d) liquefied silt-sand-water mixture covering the ground outside the house and a rug inside the house (seen through a window from inside the house).

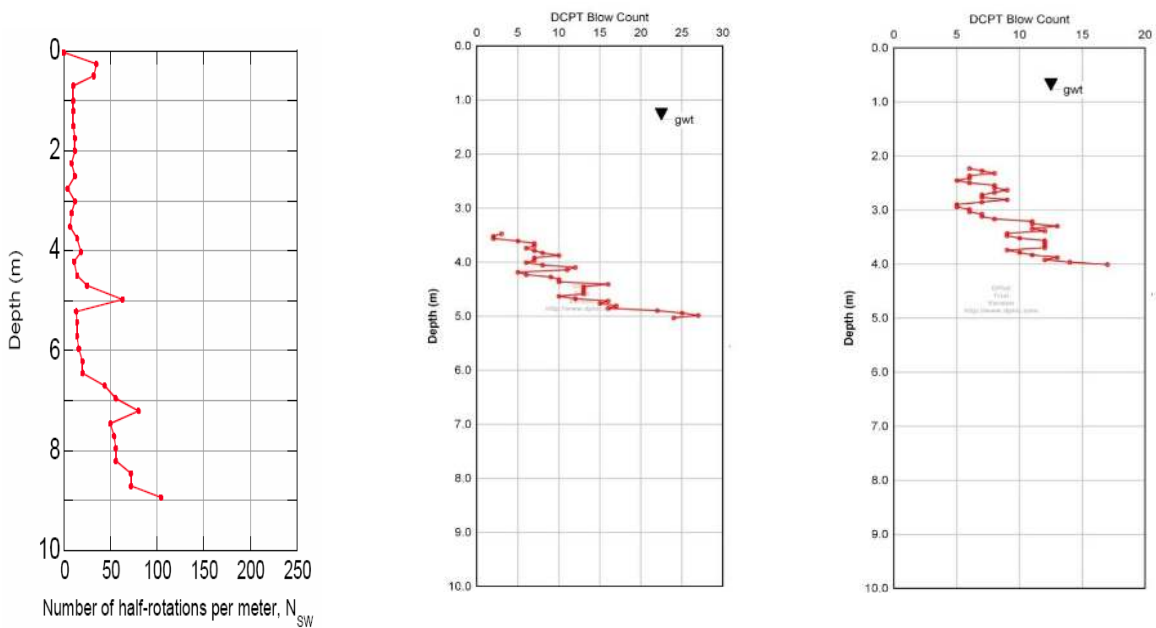
Figure 4.26: Results of SWS test and DCPTs performed in the backyard of a house at Cassia Pl.

As determined from the bore holes augered for the DCPTs the depth to the ground water table and to the top of the liquefied layer differed between the two test locations at Cassia Pl although the test locations were only ~25 m apart. However, the surface elevation of the two test locations differed by

about 0.5 m. As a result, the elevations of the ground water table are similar for the two test locations, with the depth to the top of the liquefied layer differing slightly. As with the site on Bracken St (Figure 4.4), a 100 to 150 mm thick, very wet, very soft clay/plastic silt layer overlies the liquefied layer.

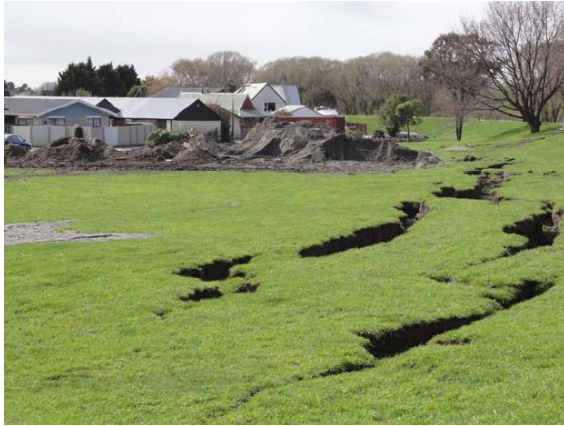
*(a) Lateral spread and slumping of the north stopbank of the Kaiapoi River near the east end of Charles St; note the huge piles of cleaned up sand obstructing the view of the houses.*

**Figure 4.27: Evidence of liquefaction and lateral spreading along Charles St and the north stopbank of the Kaiapoi River.**

The area along the Pegasus Bay Walkway (from the Kaiapoi Visitor Information Centre on the east to Askeaton Park on the west) was affected by significant lateral spreading with large cracks and fissures in the sloping ground towards Charles St (Figure 4.27). Residential houses in this area were affected both by liquefaction and lateral spreading (Figure 4.28). The reconnaissance team carried out detailed ground surveys of lateral spreading along several profiles at this location which will be presented in future more detailed publications. In addition two bore holes were made using a hand auger. However, the profile largely consisted of random fill (gravels/cobbles and wood), making it difficult to advance the auger. One of the bore holes went down to a depth of ~5.5 m, yet a thick liquefied layer could not be found. However, thin (< 100 mm) alternating layers of loose saturated sand and very wet, very soft clay/plastic silt were encountered, particularly near a large lateral spread crack (Figure 4.27b). This lateral spread crack had no traces of ejecta in and/or immediately near it. This crack was closer to the river than ones that were

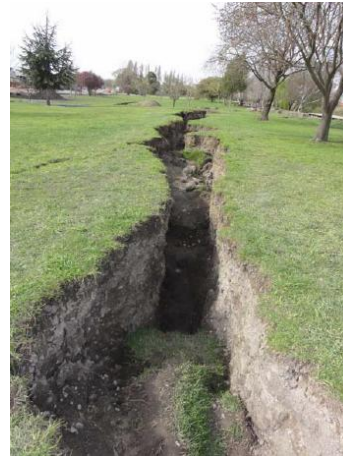
*(b) Lateral spreading of the north stopbank of Kaiapoi River (Charles St – Jones St).*

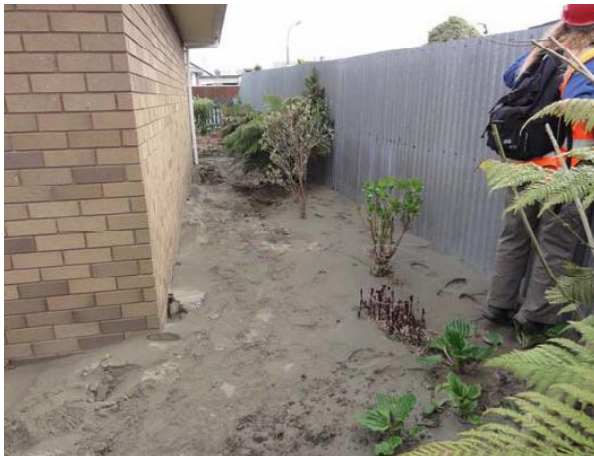
*(a) Evidence of extensive liquefaction at the east end of Charles St.*

**Figure 4.28: Liquefaction and lateral spreading in North Kaiapoi.**

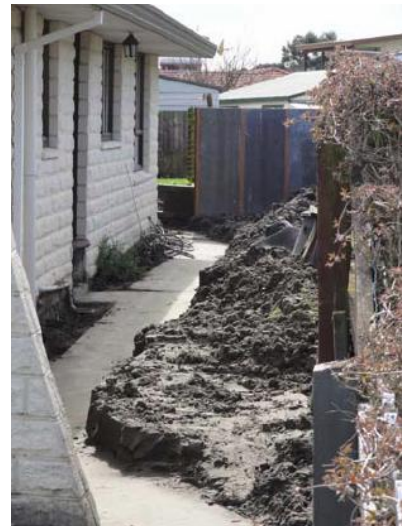
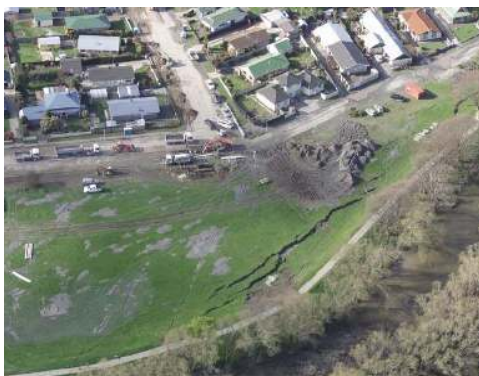
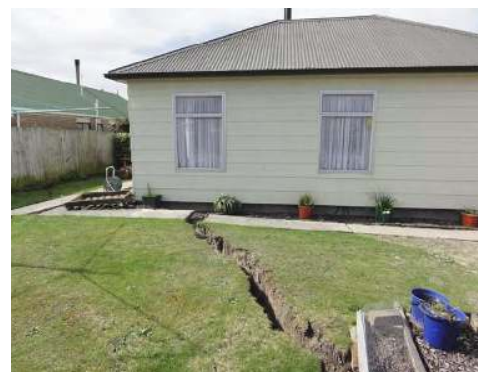
*(b) Lateral spreading resulting in a large ground distortion in foundation soils (Charles St).*

In this general area, including near the east end of Charles St and Sewell St, the liquefaction led to large settlement of many houses, including differential settlement that resulted in structural damage. The large ground distortion, cracks and fissures in the ground caused significant damage to buried

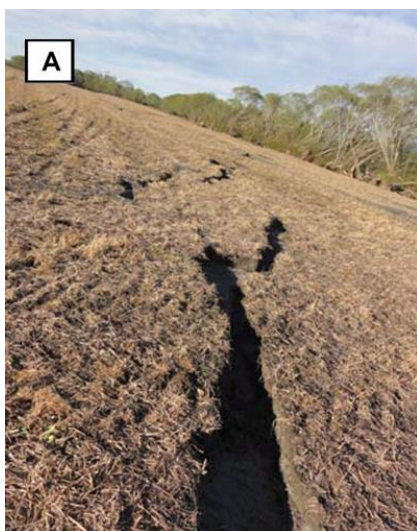
In South Kaiapoi, the most dominant ground failure feature was the liquefaction and massive lateral spreading that affected the eastern branch of Courtenay Drive. The area affected by lateral spreading, shown in Figure 4.29, was approximately 1 km long in the north-south direction and extended between 200 m and 300 m inland from the Courtenay Stream and Courtenay Lake. The lake was artificially created during the construction of the northern end of Courtenay Dr. Borrow material was removed from the area where the lake is presently located and used as hydraulic fill (about 1 m thick) for the northern branch of Courtenay Dr (WDC, 2010).

(b) Large lateral spread cracks in farm land (at B: 43.3941389°S, 172.659750°E).

Figure 4.29: Massive lateral spreading at South Kaiapoi.

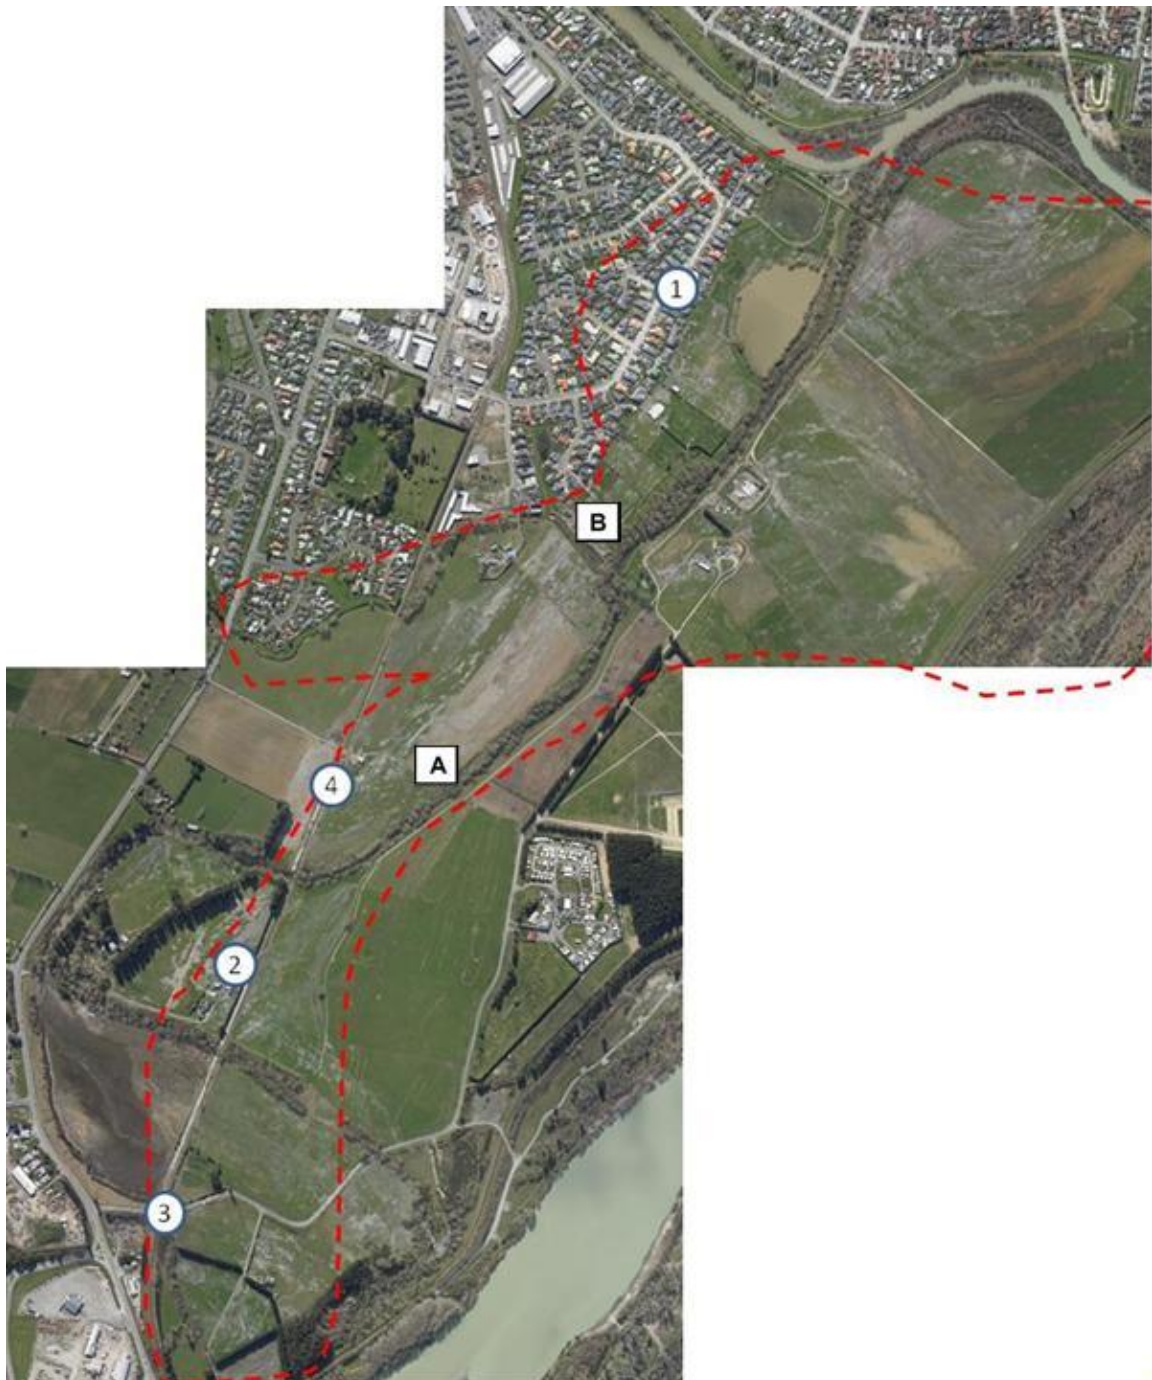
The eastern edge of Kaiapoi is shown in aerial photographs taken after the Darfield earthquake (Figure 4.30). The outline of the 1865 Waimakariri river channel (Figure 2.9) is shown by the dashed red line. On the eastern side of Kaiapoi, the old channel passes underneath the present day Courtenay Dr area shown as position 1, where severe damage to residential properties occurred due to lateral spreading (Figure 4.34). Further south at positions A and B (Figure 4.29), large cracks due to lateral spreading towards Courtenay Stream are evident. Along this stretch from position A to the north-east corner of Courtenay Dr (slightly north of position 1), detailed ground surveys were conducted along ten transects including measurement and mapping of width of cracks, vertical offsets, and geo-tagging of major cracks and other lateral spreading features. Figure 4.31 indicates geo-tagged major cracks and four transects of detailed measurements at position A.

**Figure 4.30:** Aerial view of the lateral spreading area at South Kaiapoi.

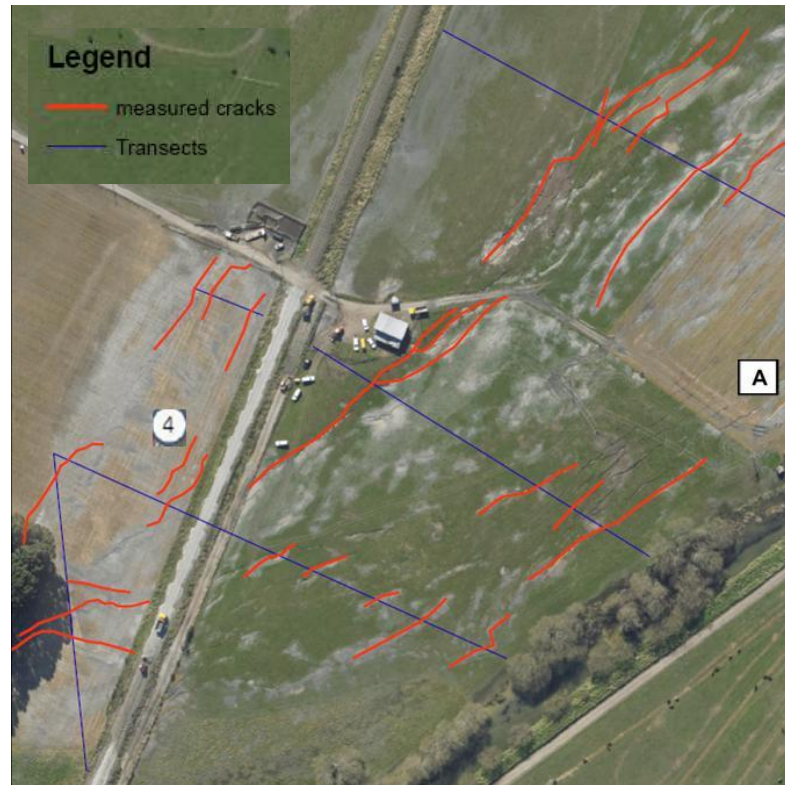
**Figure 4.31:** Aerial view of the lateral spreading area at position A at South Kaiapoi showing four transects of detailed ground surveys.

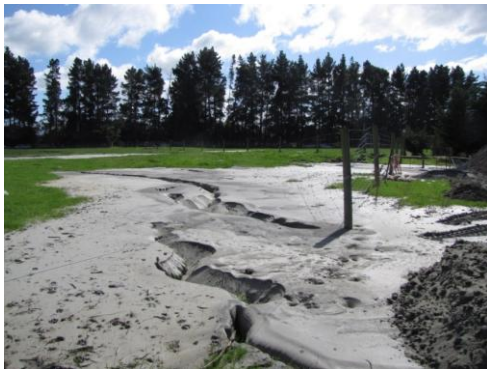
Further south near the train tracks at position 2 (Figure 4.30), large sand boils formed (Figure 4.32). At position 3 (Figure 4.33), liquefaction resulted in damage to the train tracks. The photo in Figure 4.33 was taken from a position on Doubleday's Rd in a NNE direction along the tracks, indicating ground deformation and track movement. Moving north along the train tracks to positions 4 and A (Figure 4.30), Figure 4.31 provides a more detailed aerial view of liquefaction and lateral spreading crossing the tracks just south of Kaiapoi. Using the vehicles in the photo for scale gives a good indication of the significant size of these cracks and the volume of ejecta.

**Figure 4.32:** Sand boils in fields (position 2; 43.4026°S, 172.6503°E).

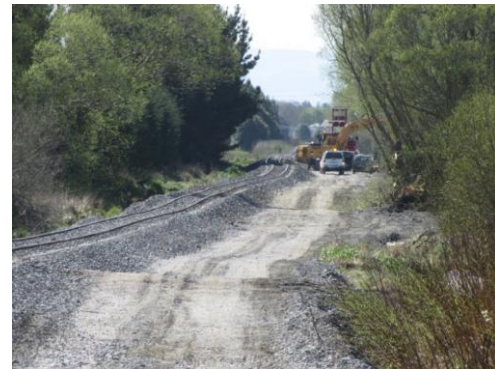
**Figure 4.33:** Damage to train tracks due to ground movement (position 3; 43.4068°S, 172.6489°E).

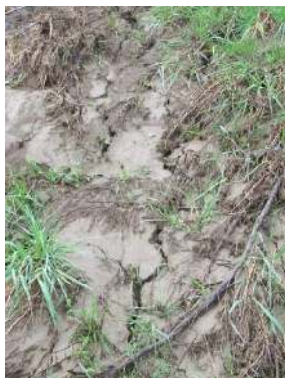
The NZ-GEER team visited the area on Monday, 13 September. On the evening of Sunday, 12 September, there had been heavy rain in the area, so on Monday the river channels were running high and the Hororata River was flowing in new areas because of a stopbank damage induced by the earthquake. The team first looked at end of Gillanders Rd. on the Darfield side, and found an area with ground damage off the end of the track, close to one of the river channels (Figure 4.37, Photo 1, BX22 257725 (43° 35' 48" S 172° 04' 48" E).

**Figure 4.37:** Ground damage adjacent to the bank of the Selwyn tributary near the end of Gillanders Rd (Darfield side). (Position marked as Photo 1 in Fig. 4.36).

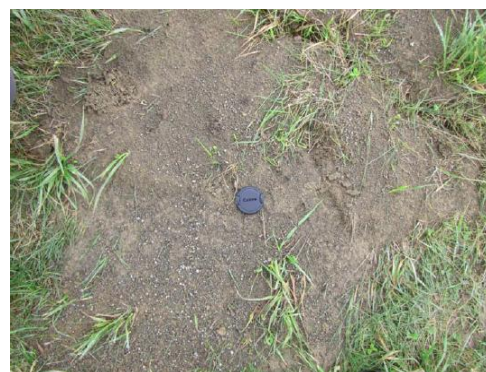
A short distance from here at the end of Gillanders Rd, the team found damage to the unsealed pavement and in the grass verge nearby. Evidence of liquefaction was seen (Figure 4.38, Photo 2, BX22 258726). Notable here was the fine gravel on the surface of the sand. Also note that rain had fallen the previous evening so the surface of the ejected material would have been altered somewhat.

**Figure 4.38:** Liquefaction on the grass verge adjacent to the end of Gillanders Rd (Darfield side). Note the fine gravel particles on the surface and the fissure towards the top right hand side - it was possible to push the sampling spoon to a depth of about 300 mm into the fissure. (Position marked as Photo 2 in Fig. 4.36).

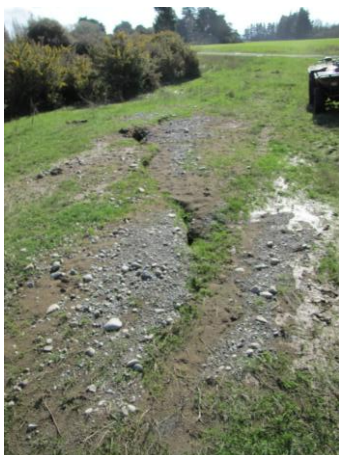
The liquefaction was located on the Selwyn Forks property (map reference BX22 250727). Access was a little difficult because a farm creek was being fed from an errant tributary of the Hororata River. The liquefaction was distributed across several fields. Material was ejected from fissures in the ground which are likely to be lateral spreads given the stream channels nearby. The ejected material was topped off with a layer of coarse gravel (Figure 4.39). Figure 4.40 shows not only sand and gravel but also clods of topsoil. It is not clear if the gravel was part of the liquefied layer or was carried to the surface with the ejected sand. When questioned, Mr Ridgen suggested that the ground profile consisted of topsoil, gravel and then sand. If this profile is confirmed then the gravel is probably carried to the surface by the liquefied sand coming from below.

**Figure 4.39:** Material ejected from a fissure on the Selwyn Forks farm (front paddock). Note the gravel overlying the brown coloured sand. This is what was visible after a night of rain. (Position marked as Photo 3 in Fig. 4.36).

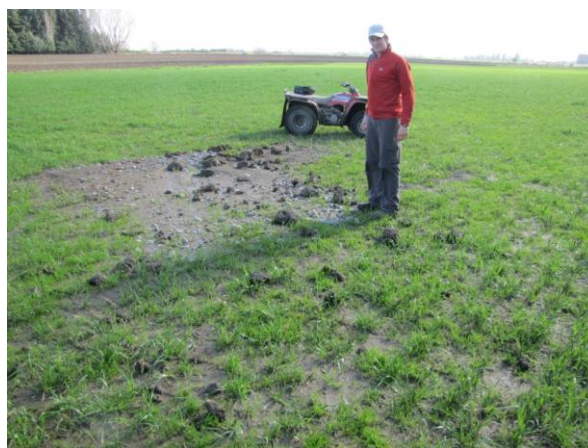
**Figure 4.40:** Ejected material on another paddock of the Selwyn Forks farm (Sheepyard paddock). As well as sand and gravel the ejecta contain clods of topsoil. (Position marked as Photo 4 in Fig. 4.36).

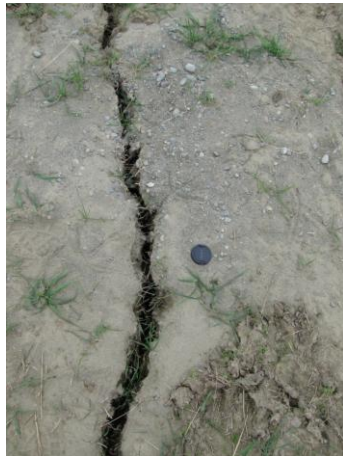
Figure 4.42 shows the material ejected at the position labeled Photo 5 (Figure 4.41, Lincoln BX23 479 626 (43° 41' 17" S 172° 21' 12" E) illustrating that the material ejected consisted of sand with some gravel. Comparison of photos in Figures 4.39, 4.40 and 4.42, shows that the materials ejected at Selwyn Forks and at Willow Lea were similar.

The farmer at Willow Lea, Mr Mark Fleming, reported that the fissures he observed were at least 2 m deep based on probing with a length of number 8 fencing wire. He also explained that the width of the fissures had increased gradually since the earthquake and that the prominence of the ejected sand had decreased with time (the photograph in Figure 4.42 was taken on September 29). More instances of liquefaction have been reported on other properties further down the Selwyn River, but the team has not confirmed this by site visits.

Figure 4.42: Ejected sand and gravel at the Willow Lea property (position marked as Photo 5 in Fig. 4.41).

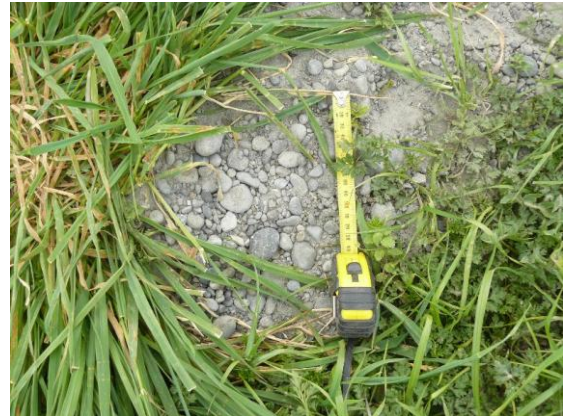
Liquefaction also occurred near the Clearwater development along Johns Road (43° 27' 15.96" S and 172° 35' 42.89" E). Figure 4.43 shows that gravel was ejected in addition to sand. There were a number of other instances of liquefaction in the open ground adjacent to the example illustrated in Figure 4.43.

Figure 4.43: Ejected sand and gravel in the Clearwater area (photo by Ian McCahon).

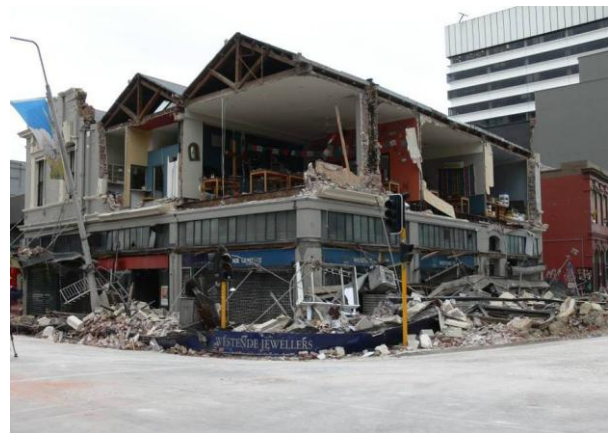
Figure 5.1: Structural collapse of a URM in the Christchurch Business District. (184 Manchester Street). Photograph courtesy of Assoc-Prof Jason Ingham.

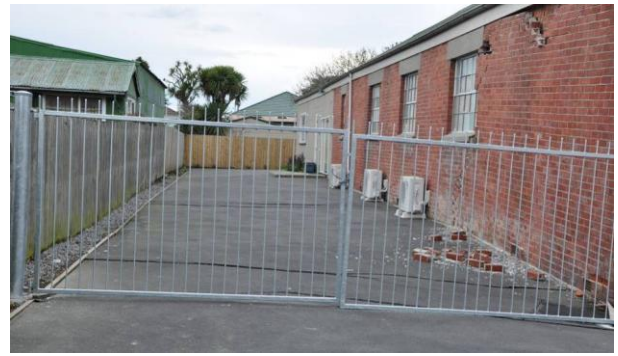
Figure 5.4: Lateral spread patterns extending east along the longitudinal axis of the Gospel Way church in Kaiapoi along Charles Street.

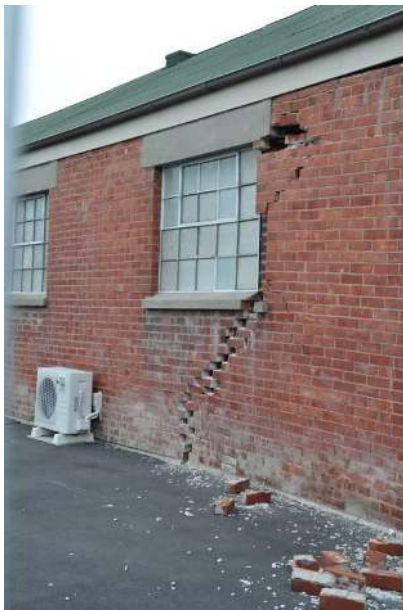
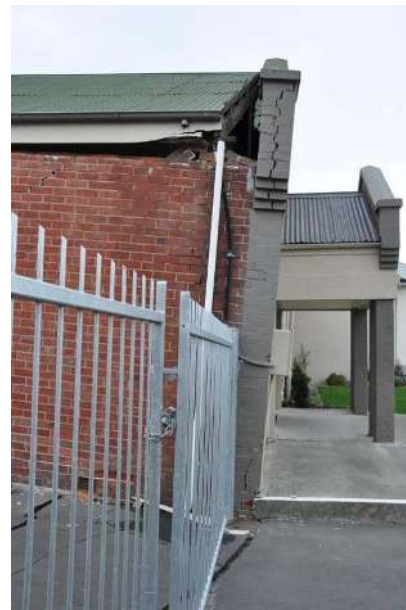
Small businesses line the fronts of Charles Street paralleling the Kaiapoi River from approximately Jones St to Davie St (Figure 5.2). The vintage of these structures vary, however, most are single or 2 stories and constructed of light wood framing with brick façade, or stucco, or solely of concrete masonry block. Extensive lateral spreading parallel to the Kaiapoi River extended into the small business and residential regions impacting numerous structures within this community. Liquefaction was evident beyond the lateral spread as discussed in Chapter 4. The most severe damage to structures within the small business community along Charles Street is shown in Figures 5.3-5.9. The Gospel Way church for example, a single storey structure of brick construction, suffered separation of its heavy front structure from its orthogonal support walls due to lateral movement of the ground towards Charles Street (Figures 5.3-5.5). The large lateral ground spreads extended northeast along the longitudinal axis of the building as evident in the adjacent parking area (Figure 5.4). This ground movement manifested into distinct shear cracks at the brick-mortar joints (Figure 5.5a). Structural separation such as that evident in Figure 5.5a was visible at several distinct locations extending along the longitudinal axis of the building. The most severe damage was evident at the front of this building, which settled approximately 150 mm, while the eastern length of the building remained approximately level (Figure 5.5b).

Figure 5.5: Gospel Way Church in Kaiapoi: (a) Shear crack pattern developed at brick-mortar joints along the northern side of the building and (b) separation (settlement and rotation) of the west face of the building.
