## GEOTECHNICAL RECONNAISSANCE OF THE 2010 DARFIELD (CANTERBURY) EARTHQUAKE

Editors: **Misko Cubrinovski<sup>1</sup>, Russell A. Green<sup>2</sup>**

This paper summarizes the observations and preliminary findings from this early reconnaissance work.

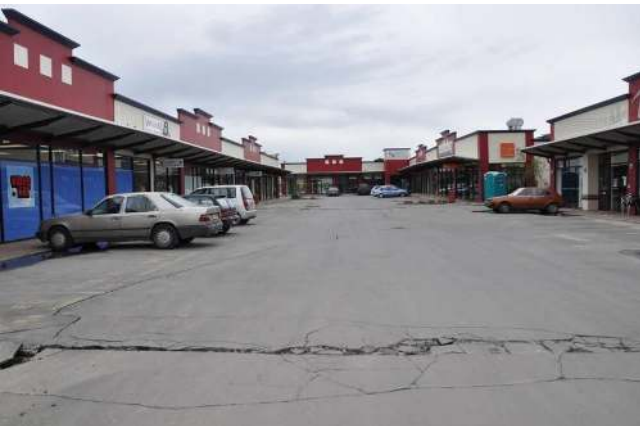
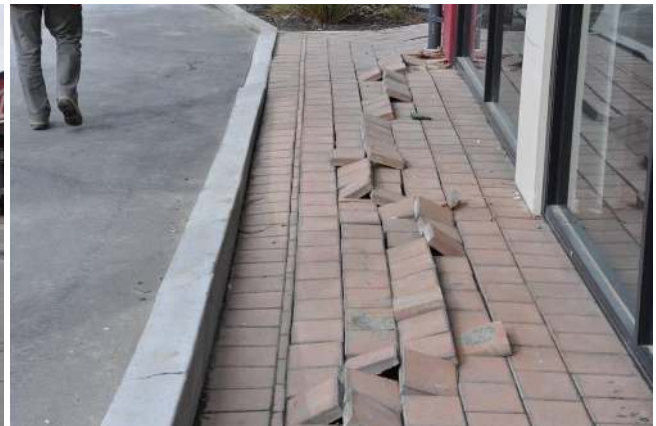
A small shopping area neighbouring the New World supermarket in Kaiapoi (between Williams and Jones streets north-south and Sewell and Charles streets east-west) showed patterns of extensive ground damage and resulted in many business closures (Figure 5.6a). Closures were primarily prompted by extensive hardscape and interior flooring damage (Figure 5.6b). These buildings attached units of one storey wood framed construction supported on slabs on grade and with glass front (open) facing as is common of walking business districts. The tallest structure to suffer damage in the direct adjacency to these business units was a red-tagged 3-storey property and family law office constructed of concrete masonry block units (CMU) (Figures 5.7-5.8). This structure is rectangular in footprint with little to no lateral resistance along the longitudinal axis of the building (as evident from the perimeter full facing glass openings – Figure 5.7a). The short axis of the building provides resistance to lateral movement and loads via stiff full length CMU walls at exterior ends of the structure (Figure 5.7b). The front of this building appeared to have settled and rotated towards the direction (southwest) (Figure 5.8). Lateral spread ground failure and liquefaction ejecta were evident directly adjacent to this building (Figure 5.9). A sample of material taken adjacent to this building was tested using laser diffraction scanning (Figure 5.10, denoted WP24).

Figure 5.6: Small business attached units neighbouring the New World supermarket in Kaiapoi (Charles St). (a) View looking east showing ground damage pattern and (b) resulting hardscape damage at the front of one business unit.

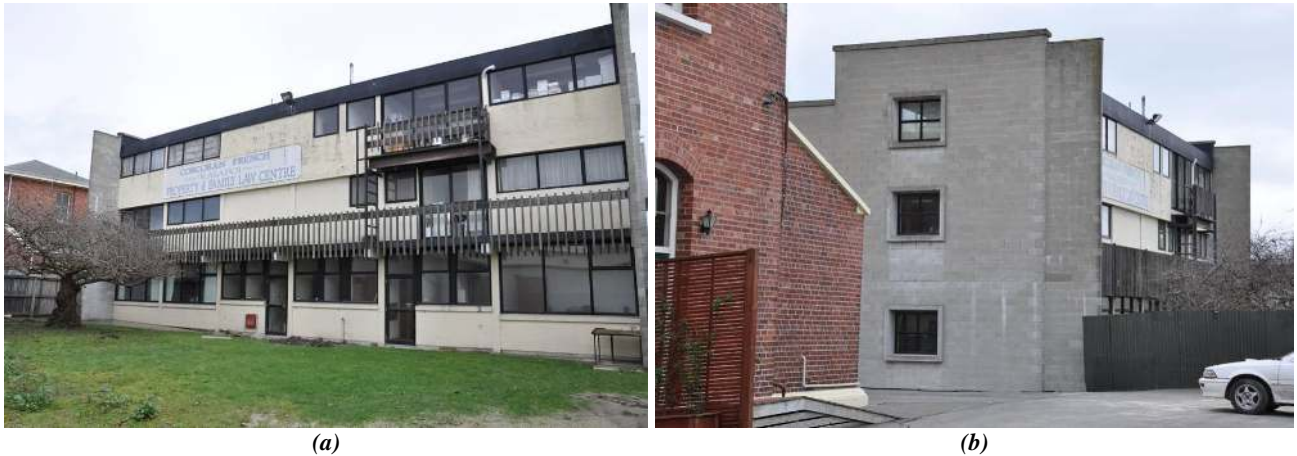
**Figure 5.7:** *Property and Family Law Offices in Kaiapoi business district. (Williams St.) (a) View looking northwest (at long axis end) of building and (b) view looking northeast showing shear wall ends of short axis of building.*

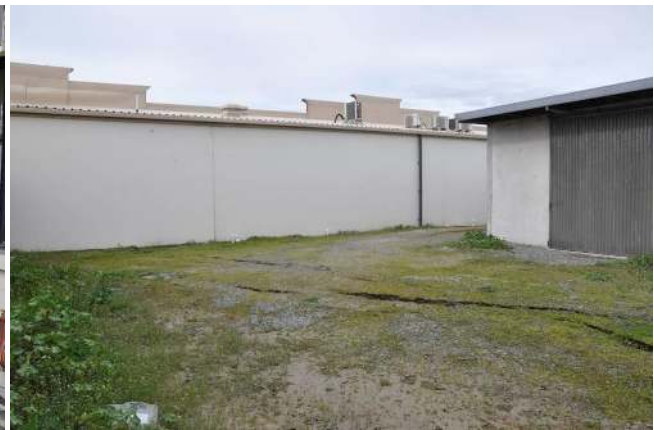
**Figure 5.9:** *Surrounding ground failure patterns directly adjacent to the Property and Family Law Offices in Kaiapoi business district. View looking southeast.*

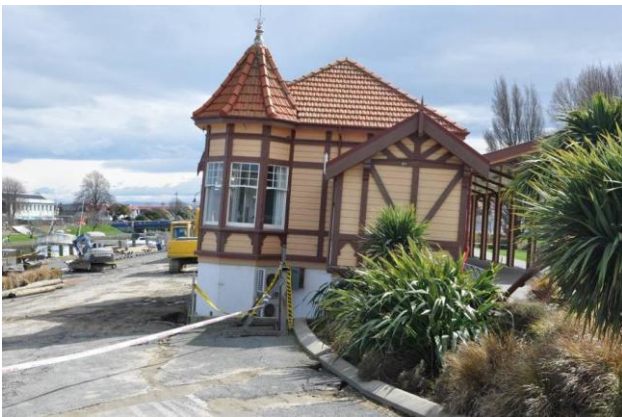
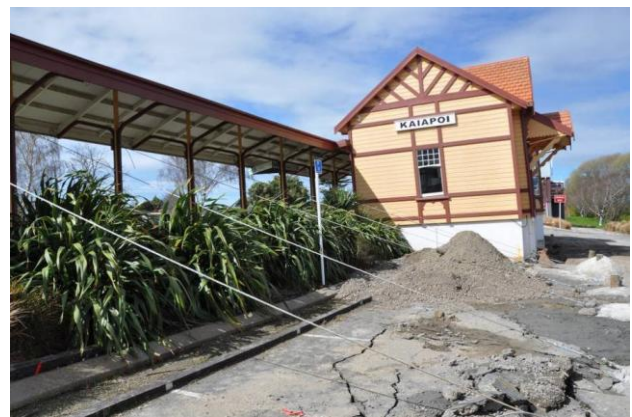
Movement of the Kaiapoi wharf resulted in damage to the historic Kaiapoi Railway Station, which is now renovated and used as the Kaiapoi Information Centre (43.3838°S, 172.6596°E) and its neighbouring Harbour Building (43.3834°S, 172.6591°E). The Kaiapoi Information Centre building is a renovated wood framed building on an elevated foundation (Figure 5.11). As a result of loss of ground support, this building tilted approximately 5 degrees northeast (away from the river). Rapid stabilization of the building had been complete by the time of the NZ-GEER team visit on 11 September 2010 in the form of concrete footings poured on the exposed (near river) foundation side of the building (Figure 5.11b). In addition, tension tie-backs anchored from newly poured concrete footings to a patio area were used to stabilize the upper pavement during the continuing ground movement. The Harbour building is a one-storey masonry block building that suffered tilting towards the river and separation from the wharf of approximately 150-250 mm on its west face (Figure 5.12).

**Figure 5.11:** Renovated Kaiapoi Railway building now used the Kaiapoi Information Centre, adjacent to the Kaiapoi Wharf. (a) View looking northwest and (b) view looking southeast (note the temporary elevated patio support tie-backs and newly poured footings at the front (river side) of the building).

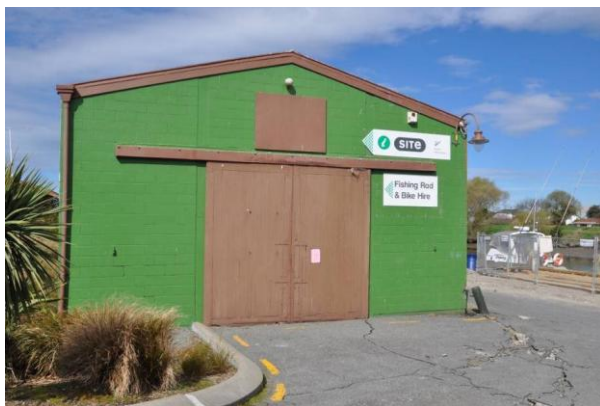
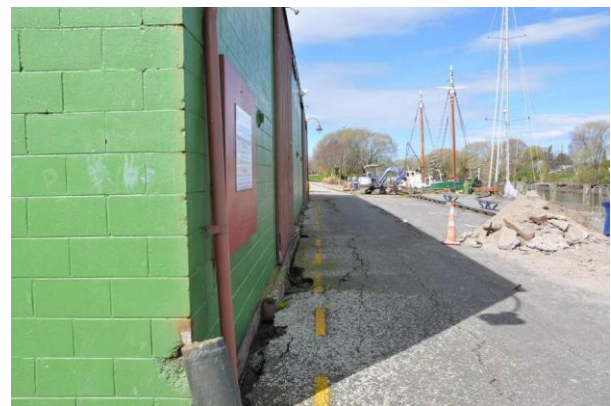
**Figure 5.12:** Harbour building adjacent to the Kaiapoi River and wharf structures. (a) View looking southeast and (b) view of the northwest corner of the building. Note the approximate 150-250 mm gap between the pavement and building.

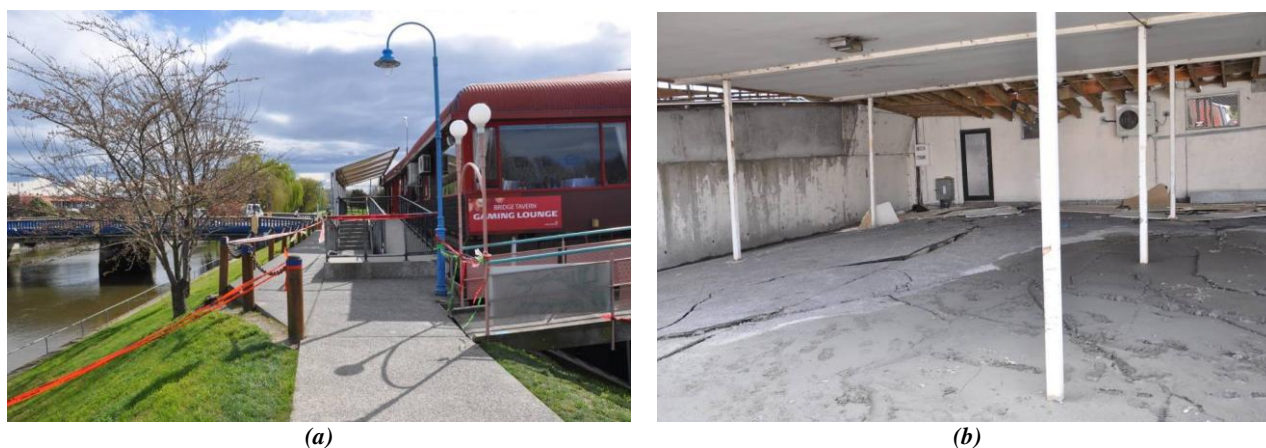
North of the Kaiapoi Information Centre and Harbour Buildings, a two storey wood frame building with subterranean parking (nearest to river) and a full floor level (nearest to Charles Street) currently housing the Bridge Tavern building was extensively damaged due to ground movement (Figure 5.13). Although movement of the retaining wall adjacent to the Kaiapoi River was not evident, the east embankment side, which supported the first storey subterranean parking area showed evidence of ground settlement and cracking. This damage precipitated movement of columns supporting the upper storey of the building (Figure 5.13b).

**Figure 5.13:** *Bridge Tavern adjacent to the Kaiapoi River. (a) view looking northwest at Williams Street bridge and (b) view looking northwest at subterranean parking.*

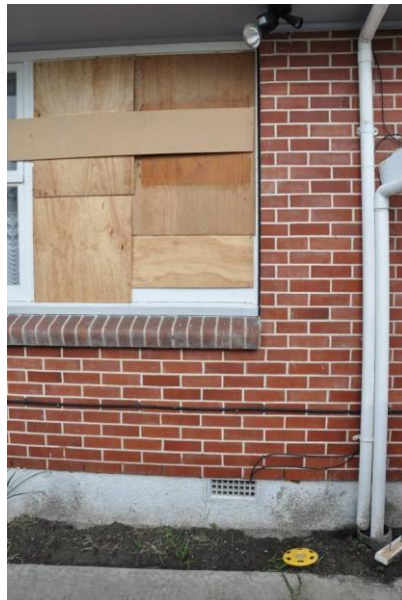
Brick homes consistently observed shear cracking, discontinuities between window and door openings and brick, popped out and/or damaged glass windows, and damage to floor slabs and hardscape (Figure 5.16). Homes along Charles Street at the time of the NZ-GEER team visit (11 September 2010) were either red or yellow tagged. Very few homes were occupied, with most suffering extensive sand ejecta surrounding the home as well as settlement. In a number of cases, residents of severely damaged homes had moved out completely (e.g. Figures 5.17-5.18). This house at Charles Street experienced approximately 0.4 m of settlement along its North face (Figure 5.17b). Sand ejecta were present surrounding most homes along Charles Street and extending east into the North Kaiapoi residential area approximately 0.5 km.

**Figure 5.16:** Residence along Charles Street (same structure as Figure 5.16). Damage to glass windows and between window and wall.

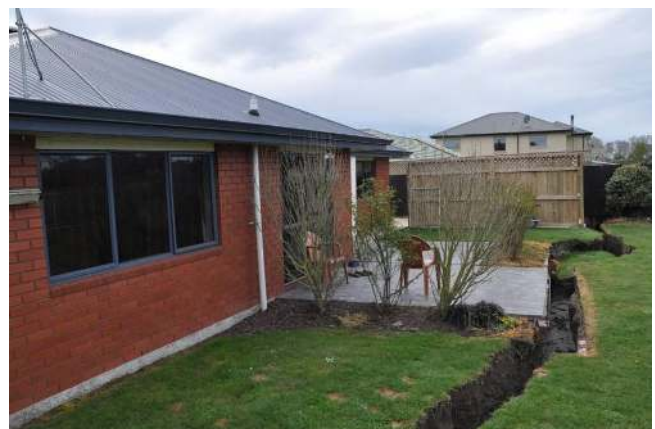
*Kaiapoi South* – In general damage to building structures in the Kaiapoi South community was limited to Courtenay Drive between Kaikanui Street and ending at Parish Lane. This is a residential neighbourhood with relatively new homes, all constructed within the last ten years. Most homes are one-storey light wood framing or brick supported on unreinforced slabs with perimeter stemwall foundations and light metal roofing. An example of the typical construction style in this area is shown in Figure 5.19. Liquefaction was reported to inundate the neighbourhood north of Courtenay Drive towards Charters Street, however much of this had been cleaned up by the time of the NZ-GEER team visit and appeared to have minimal impact on the homes. The impact to homes along Courtenay Drive however, and particularly those on the east side of the drive, with direct facing to a paddocks' field as well as a branch of the Courtenay Stream, was extensive. Ground failure in this region manifested in large lateral spread zones coupled with liquefaction (Figure 5.20).

**Figure 5.20:** Ground failure feature extending through the backyard of a home on the south side of Courtenay Drive in the South Kaiapoi residential community.

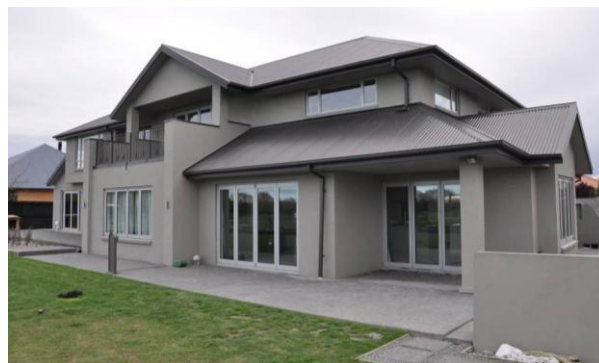
**Figure 5.23:** *Damage to a residence along Courtenay Drive in the South Kaiapoi residential community. Rear of home facing Paddocks field articulates relatively no damage.*

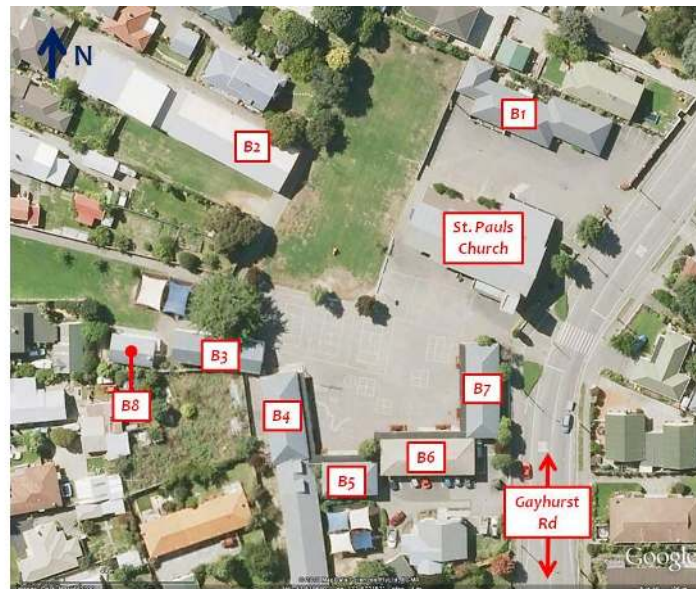
A historically significant feature in the neighbourhood of Dallington is the St. Paul's church and surrounding school (Figure 5.28; 43.5196°S, 172.6725°E). St. Paul's church was severely damaged due to surrounding ground movement, which was precipitated by extensive liquefaction within the general area shown in Figure 5.28. Most significantly the structure suffered through building separation due to ground extension and vertical offset subtending north-south approximately one-third of the length along the west end (orange separation location denoted in Figure 5.29).

Surrounding St. Paul’s church is an Integrated State school affiliated with the church (buildings denoted B1-B8 in Figure 5.28). Building B1 (Figure 5.34) and B6 (Figure 5.36) are constructed of running bond brick perimeter walls with light metal roofs, whereas buildings B4, B5, and B7 incorporate light wood framing along their longitudinal axes and brick along their transverse axes (e.g. Figure 5.37). Building B2 is constructed of concrete masonry block units (Figure 5.35).

Figure 5.28: St. Paul’s church and school in Dallington area (43.5196°S, 172.6725°E). Notation “B#” is used for reference only to identify adjacent buildings (see discussion). Annotated GoogleEarth image.

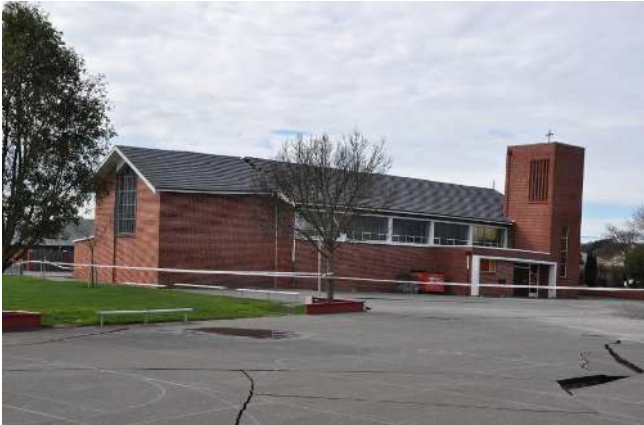
This resulted in structural separation of the building into two distinct structures. The West end of the building rotated 2 degrees south and 4 degrees west (Figures 5.30-5.33), resulting in 460 mm of settlement of the south-west corner (estimated with reference to prior ground elevation). No significant lateral translation of the building was measured at its perimeter rather structural movement was confined to rotation and settlement as described in Figure 5.29. This relatively heavy single storey structure was constructed of running bond brick perimeter walls, with a timber (truss) roof. Wall heights were approximately 8 m at the perimeter of the sloping roof and 5.5 m at flat portions. An approximately 12 m tall tower is articulated at the southeast corner of the structure (Figure 5.33b). The ridgeline extends across the longitudinal axis (running approximately east-west) along the building.

Figure 5.30: St. Paul's church in Dallington area - overall view of building looking north-east.

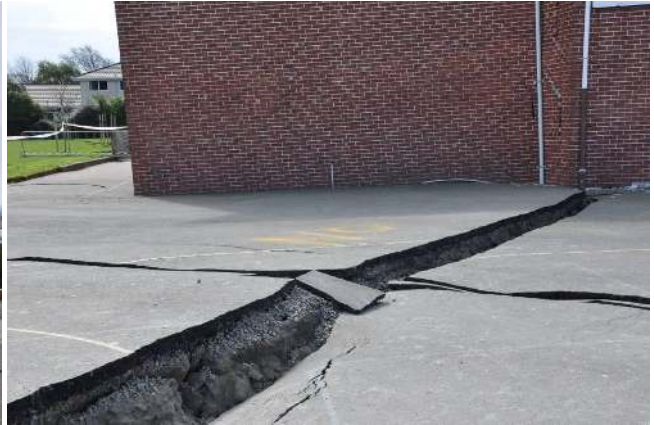
Figure 5.31: St. Paul's church in Dallington area - view looking north at ground failure, which continued through the building.

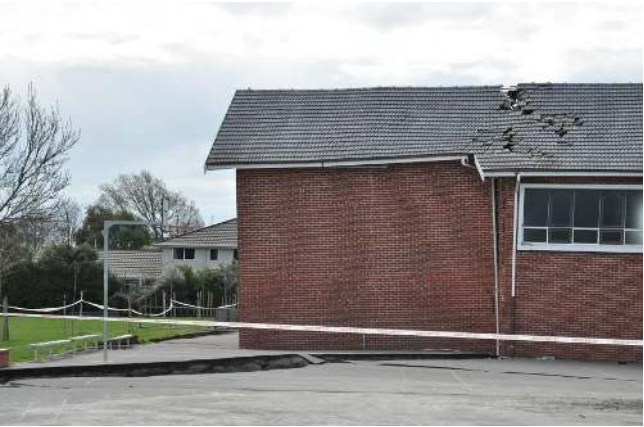
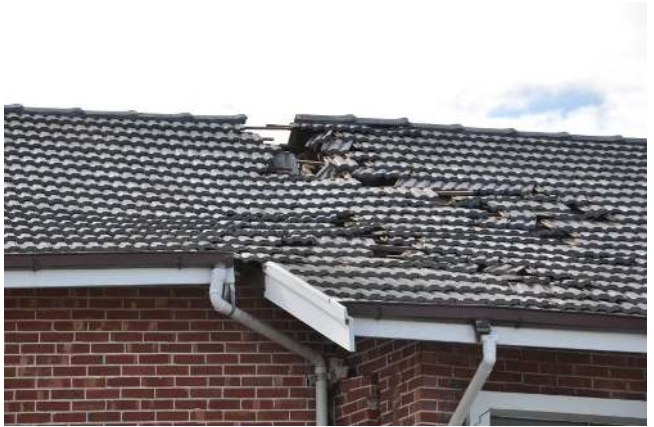
Figure 5.32: St. Paul's church in Dallington area - view looking north (a) far view of separated west end of building and (b) close-up view of structural separation.

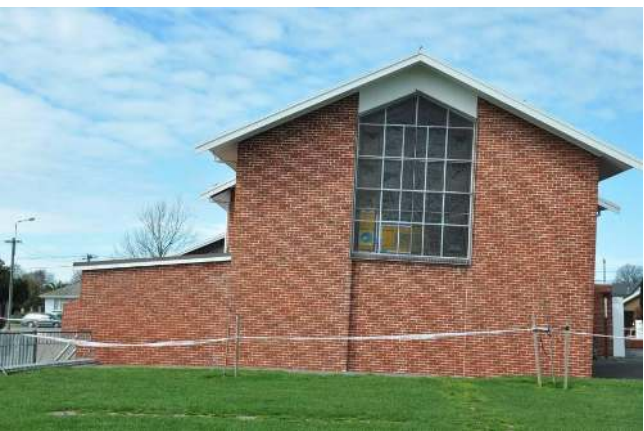
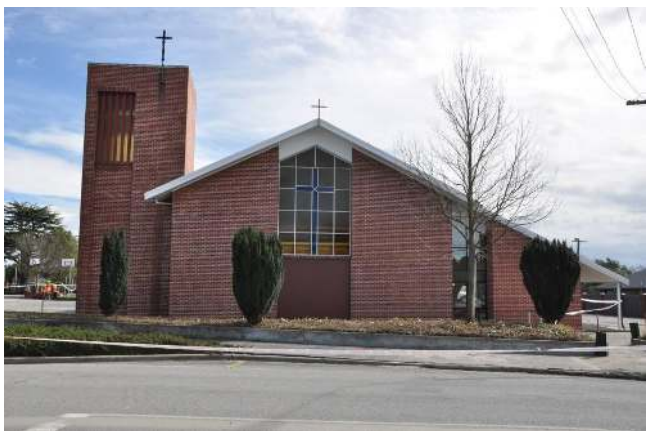
The north and south (long axis ends) of the building articulate approximately 25% glass windows. Similarly the East entry facing Gayhurst Road presents stained glass features surrounded by brick walls (Figure 5.33b). The foundation was not accessible at the time of the NZ-GEER team’s visit.

Figure 5.33: St. Paul's church in Dallington area: (a) view looking east at the west end and (b) view looking west at the east end.

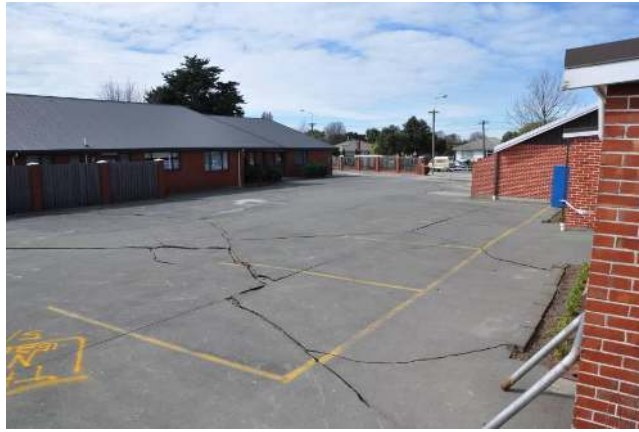
**Figure 5.34:** *St. Paul's church and surrounding school - Building B1 (on left) and St. Paul's church (on right).*

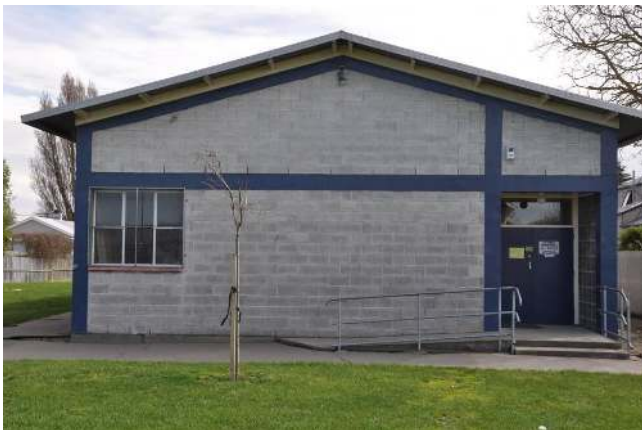
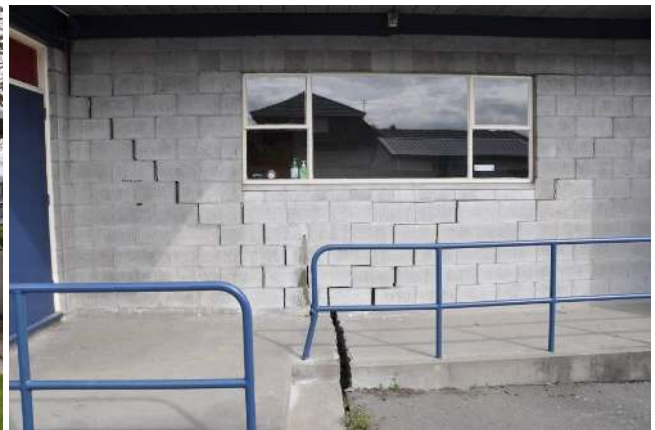
**Figure 5.35:** *St. Paul's church and surrounding school - Building B2: (a) view looking west and (b) view from north side of building, looking south.*

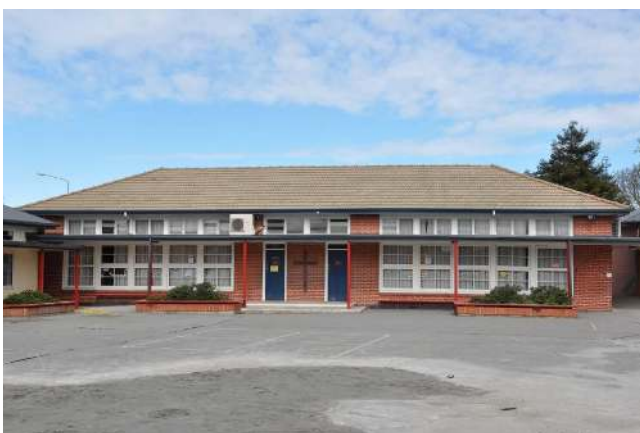
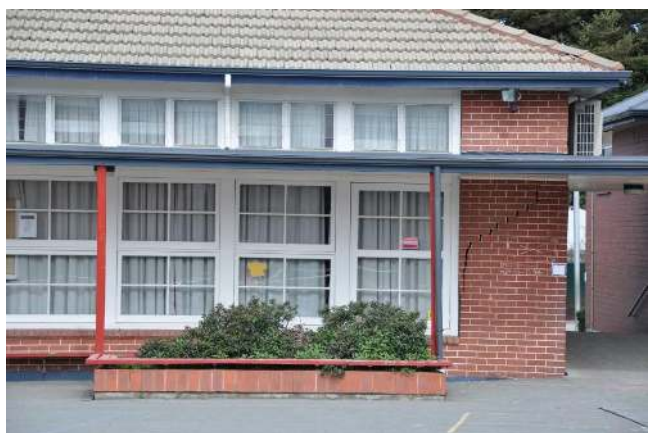
**Figure 5.36:** *St. Paul's church and surrounding school - Building B6 view looking south: (a) overall view of building and (b) west end of building.*

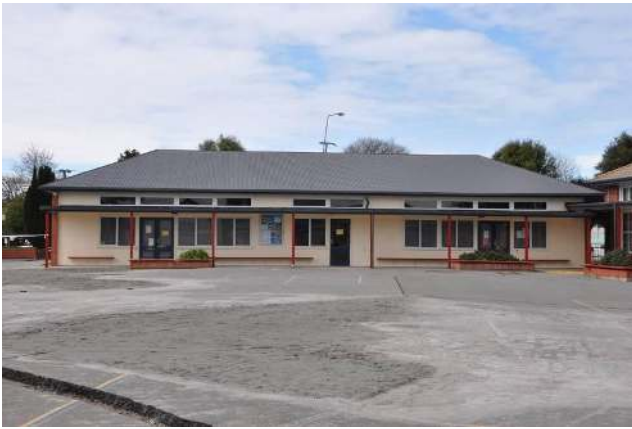
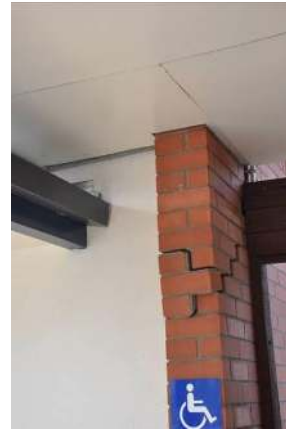
Figure 5.37: St. Paul's church and surrounding school - Building B7: (a) view looking east and (b) view of south-west corner of building articulating column damage at wood-brick interface.

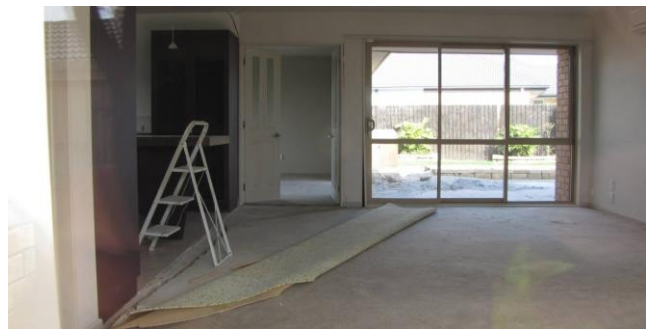
In the residential area of Bexley, homes were significantly affected by lateral spreading (e.g. Figures 5.38-5.39). The lateral spreading was apparent from walking around the path along the southern boundary of the subdivision next to the wetland. Fissures of 300 mm or greater in width traversed the ground of several properties. A floor slab fissure (estimated width 50 to 75 mm, visible because the carpet had been lifted) extended across the full width of one house. Settlement had occurred but with relatively little tilting. Given that the fissure went through the concrete floor slab, there appeared to be relatively little damage to the walls.

Figure 5.39: Fissure in concrete floor slab (to the left hand side passing beneath the ladder). (Same house as in Figure 5.38.) (Kokopu Street).

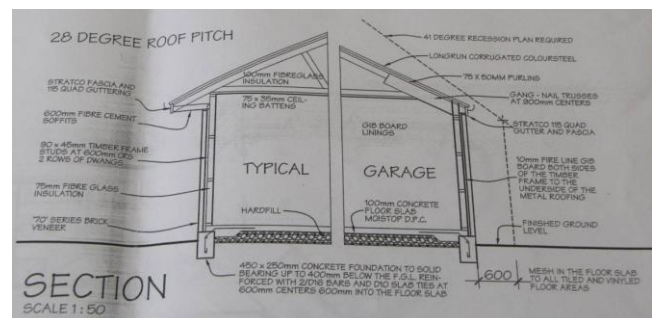
Foundation details taken during a visit to one home in Bexley are shown in Figure 5.40. The system set-out in Figure 5.40 is a perimeter beam with two D16 bars, D10 starter bars 600 mm long at 600 mm centres around the edges. The cavity inside the perimeter beam is filled with coarse gravel, covered with dampcourse, and then topped with a 100 mm thick concrete slab, which, apart from the starter bars, is mostly unreinforced. The drawing in Figure 5.40 specifies mesh reinforcing in areas that are to be tiled or covered in vinyl. Nonetheless, reinforcing was not observed to cross any fissure as noted in the drawing.

Figure 5.40: Concrete slab-on-ground details for the Bexley houses.

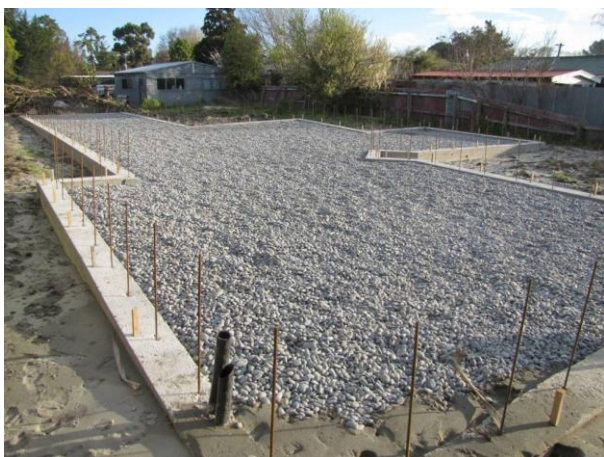
Assuming the top of the perimeter footing was close to level before the event, it was apparent that the footing was not capable of withstanding the ground deformation during the earthquake as the footing was no longer level (Figure 5.41). Two D16 reinforcing bars were observed in this footing where cracking had occurred.

Figure 5.41: Site at Pines Beach which appears to be using the same slab-on-grade system as at Bexley (Chichester Street)

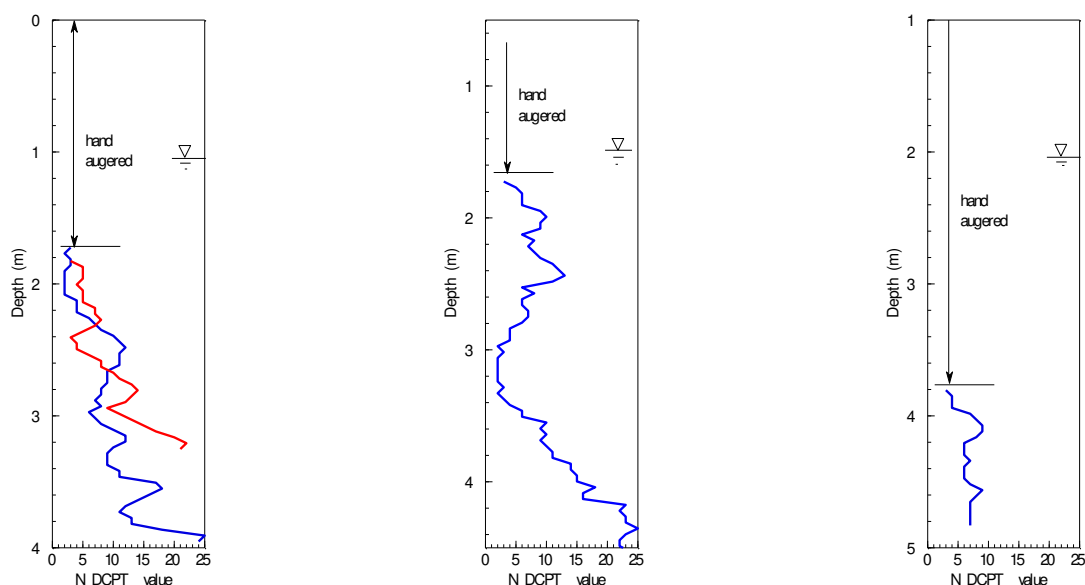
Liquefiable soil is not mentioned. Preliminary site investigations, conducted following this earthquake, indicate that the liquefiable layer is often deeper than 1 m and not infrequently deeper than 2 m (Figure 5.42). This means that the possibility of liquefaction is not as easily identifiable as the above three “good ground” exclusions.

Figure 5.42: Results of the DCPT for the liquefiable layer for Spencerville (left: 43.43075°S, 172.693000°E; 43.431583°S, 172.693233°E), Bexley (middle: 43.518370°S, 172.722050°E) and Courtenay Drive (right: 43.390010°S, 172.662640°E).

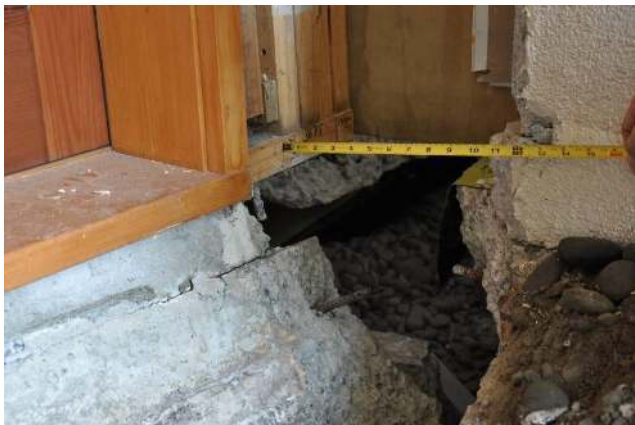
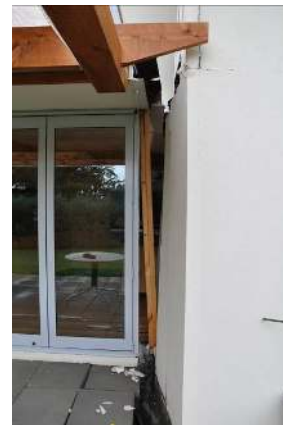
**Figure 5.44:** Ruptured floor slab near the front entrance of Riverside Lane. Clearly visible is the gravel infill shown in Figure 5.41 (note that there appears to be no ejected sand present). (a) ground fissure separating front entry of home and (b) same ground feature propagated through home and departing on opposing side.

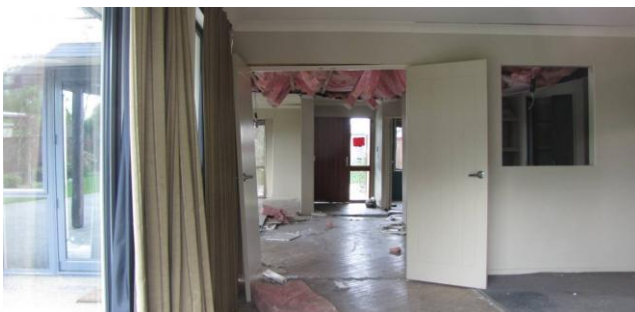
**Figure 5.45:** Interior view of residence at Riverside Lane. Note the two floor breaks visible in the picture

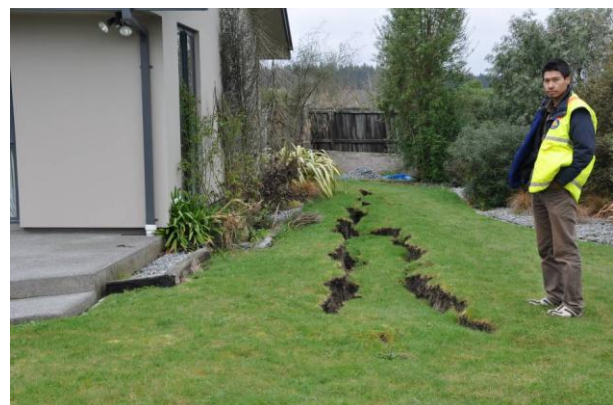
**Figure 5.46:** Lateral spread adjacent to residence at Riverside Lane. The location of this fissure is about 26 metres from the nearby Styx River.

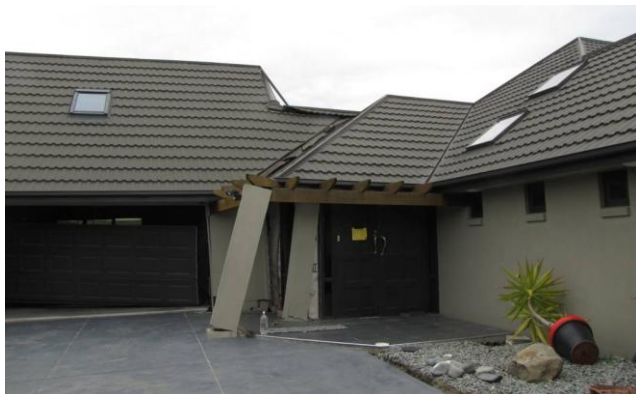
**Figure 5.47:** House with fissured floor slab with damage carried through to the roof line which is no longer weather proof. (Riverside Lane, Spencerville).

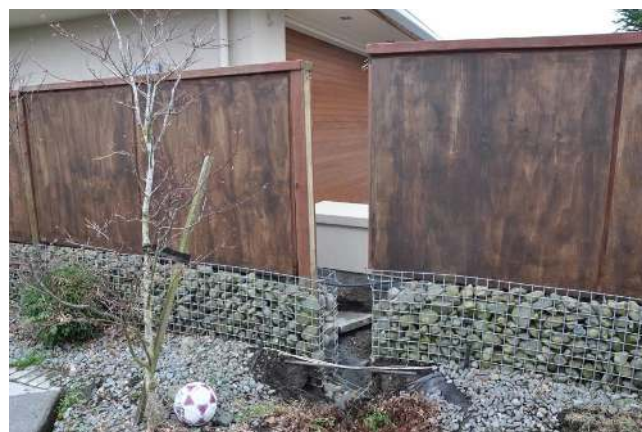
**Figure 5.48:** Separated fence line due to propagating ground fissure meandering between homes along Riverside Lane.

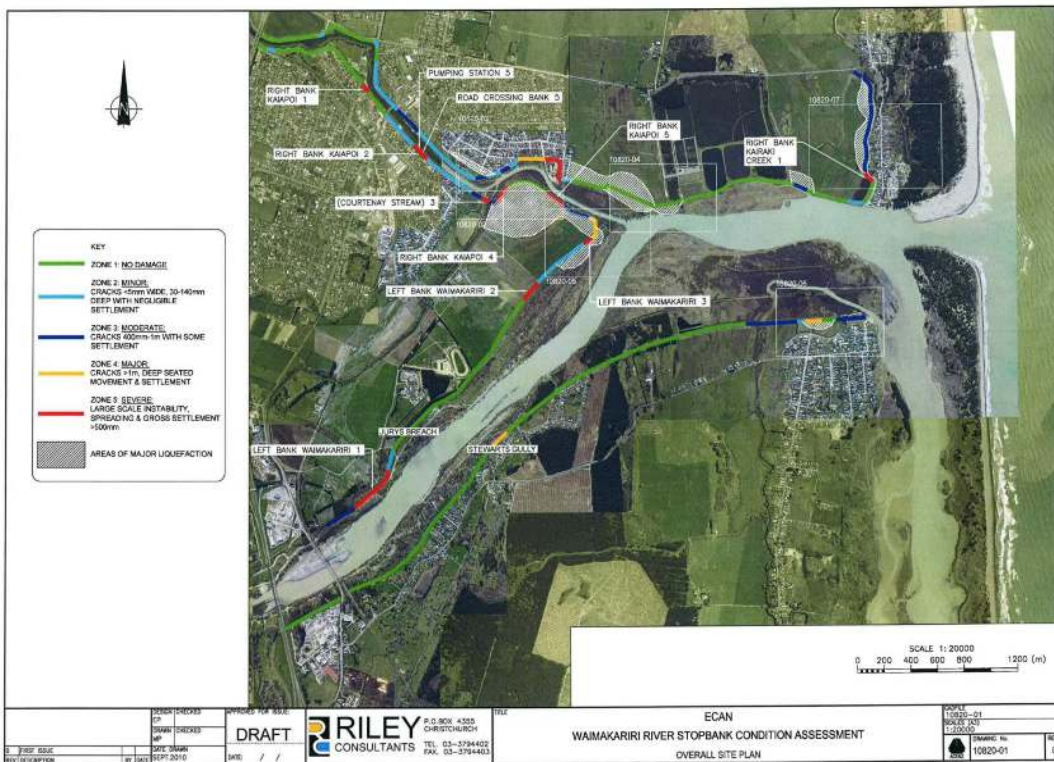
Figure 6.3: Post-earthquake damage survey of stopbanks performed by Riley Consultants for Environment Canterbury along the Waimakariri River, downstream of SH1, and Kaiapoi River. (Riley Consultants, 2010; courtesy of Ian Heslop and Tony Boyle, ECan).

stopbanks requiring repair (Boyle, 2010). The majority of the damage along the Waimakariri River was downstream of SH1 (Figure 6.3). Repairs to the high priority sites were expected to be completed within a few weeks after the earthquake, with medium priority sites expected to be completed in a couple of months. The cost of the repairs to the high and medium priority sites is estimated to be ~\$NZ 3m (Boyle, 2010).

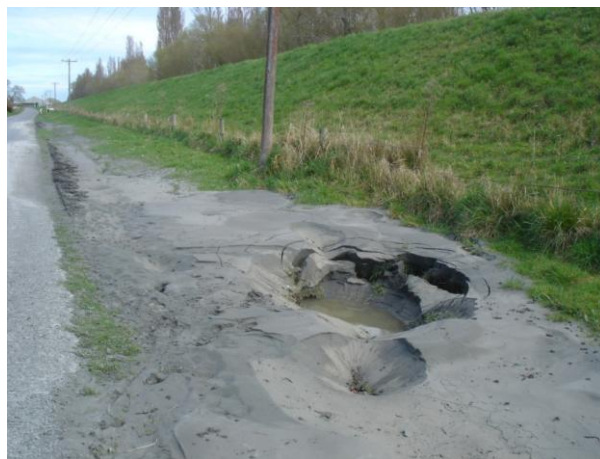
Figures 6.4-6.9 are photographs of the stopbanks for the Waimakariri River along Coutts Island Rd. Numerous sand boils were found along the base of the stopbank for an ~0.5 km stretch (Figures 6.4-6.6), on both the river and land sides. By the time of the team's damage survey on 11 September

**Figure 6.4:** *Photo 1: Large sand boil at the base of the landside of the stopbank on Coutts Island Rd. (43.425018°S, 172.628442°E).*

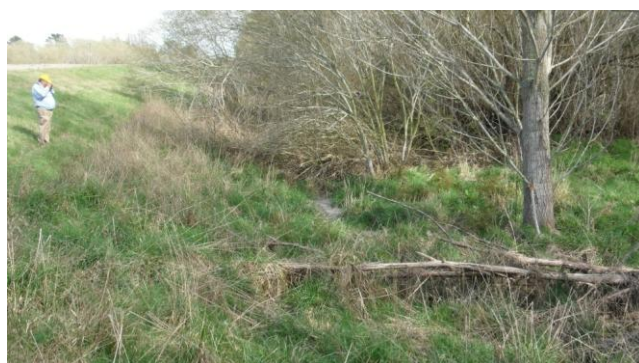
**Figure 6.6:** *Photo 3: Liquefaction ejecta (centre of photo) along the base of the stopbank on Coutts Island Rd (riverside). (43.424093°S, 172.630468°E).*

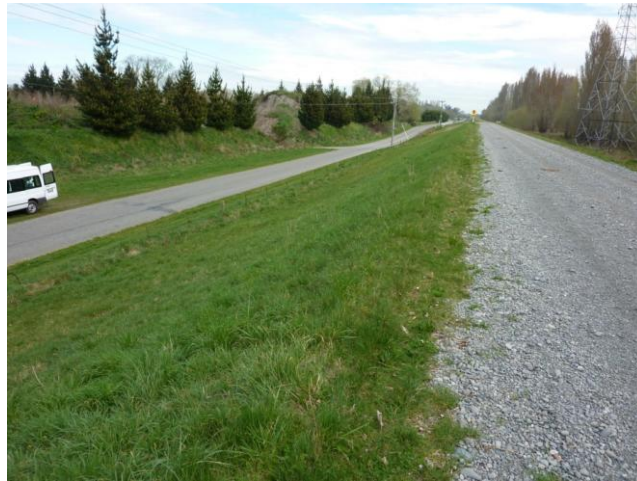
**Figure 6.9:** Photo 6: Stretch of stopbank without evidence of liquefaction. In the distance, a small rise can be seen in the road. This rise is the start of the ~0.5 km stretch where liquefaction was observed along the base of the stopbank. (43.4225°S, 172.6350°E).

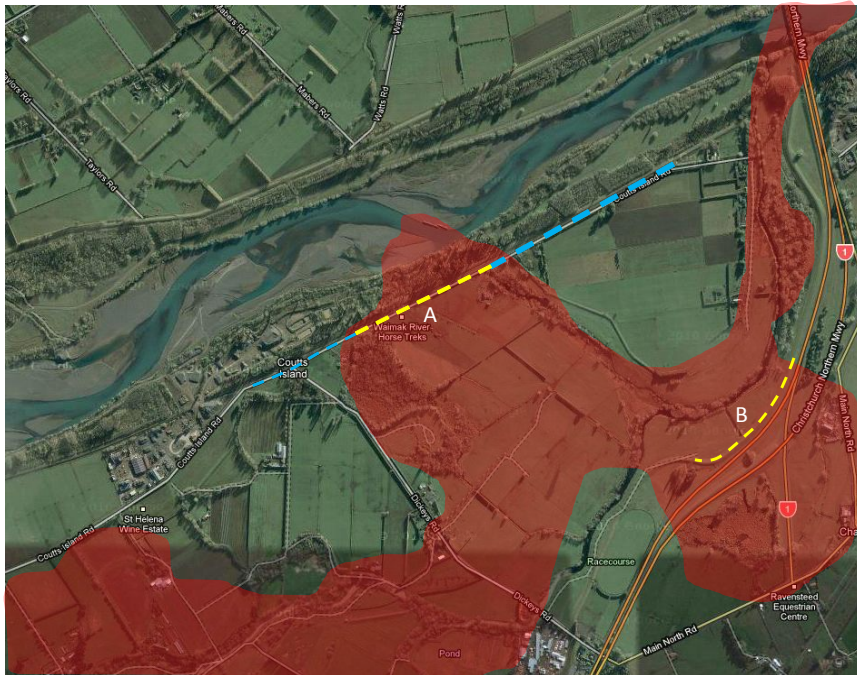
From interviews with local land owners, this section of the land that experienced widespread liquefaction was part of an old river channel. This was confirmed by review of old maps of the area. Figure 6.10 is an aerial image of the Coutts Island Rd area with the 1865 south branch of the Waimakariri River channel highlighted in red. The ~0.5 km stretch of the stopbank where liquefaction was observed is denoted by the dashed yellow line (A) in this figure. As may be seen in this figure, the area that liquefied coincides with the location of the old river channel, while the stretches of stopbank with no observed liquefaction (dashed blue line) lie outside of the old river channel.

**Figure 6.10:** Overlay of 1865 stream channel on present day Coutts Island Rd. This image is ~3.5 km across (centre 43.4266°S, 172.6302°E) (Google Inc. 2010).

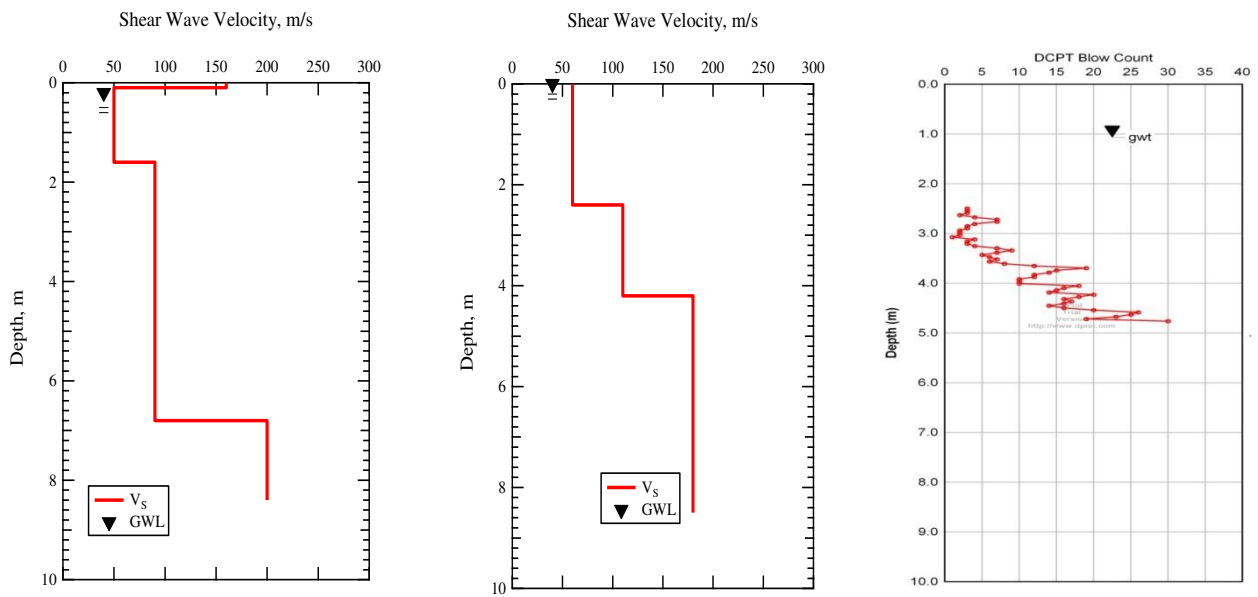
Figure 6.12: Results from SASW tests (left: SASW1 43.425029°S, 172.628676°E; middle: SASW3 43.424351°S, 172.630475°E) and DCPT (right: DCPT1 43.425139°S, 172.628618°E) performed along the base of the stopbank on Couatts Island Rd in an area that liquefied.

Other than SASW3 and DCPT1, performed about 175 m from each other in an area that liquefied, the agreement between the SASW and DCPT results is not very good in terms of depth to a stiff, presumably nonliquefiable layer. Further analyses are required to fully understand why. However, the sites that did not liquefy were along the banks of the old river channel. A liquefiable layer could not be found in these areas using the hand auger, and the soil profiles (DCPT2 and DCPT3) consisted of clayey sand and peat. Given the depositional environment of these profiles, it is likely that the strata varied significantly laterally, which could be the explanation for the poor agreement between the DCPT and SASW test results.

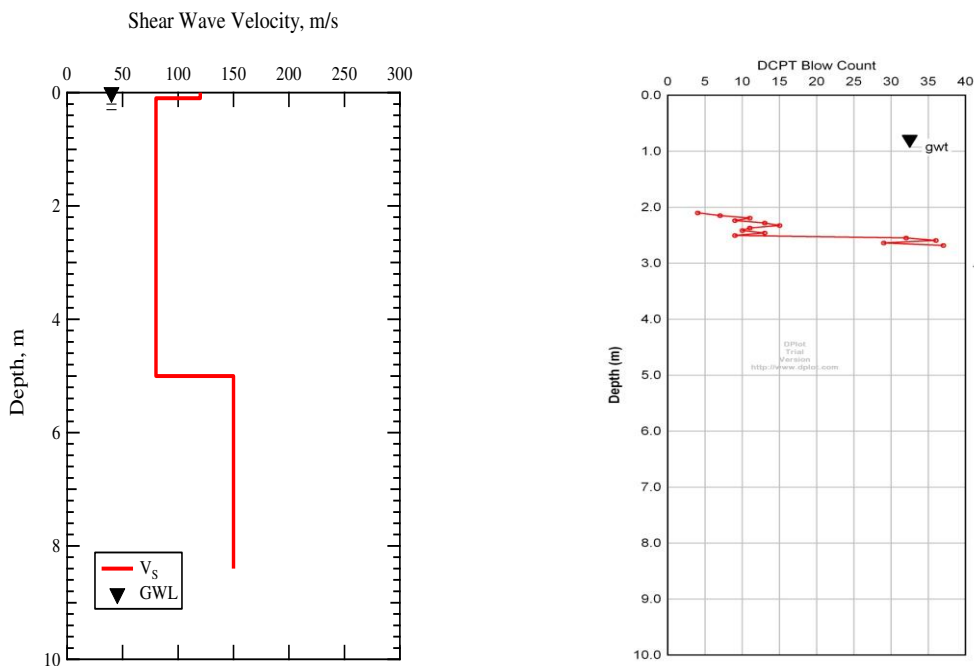
Figure 6.13: Results from SASW test (left: SASW2 43.426294°S, 172.625439°E) and DCPT (right: DCPT1 43.426186°S, 172.625673°E) performed along the base of the stopbank on Couatts Island Rd in an area that did not liquefy.

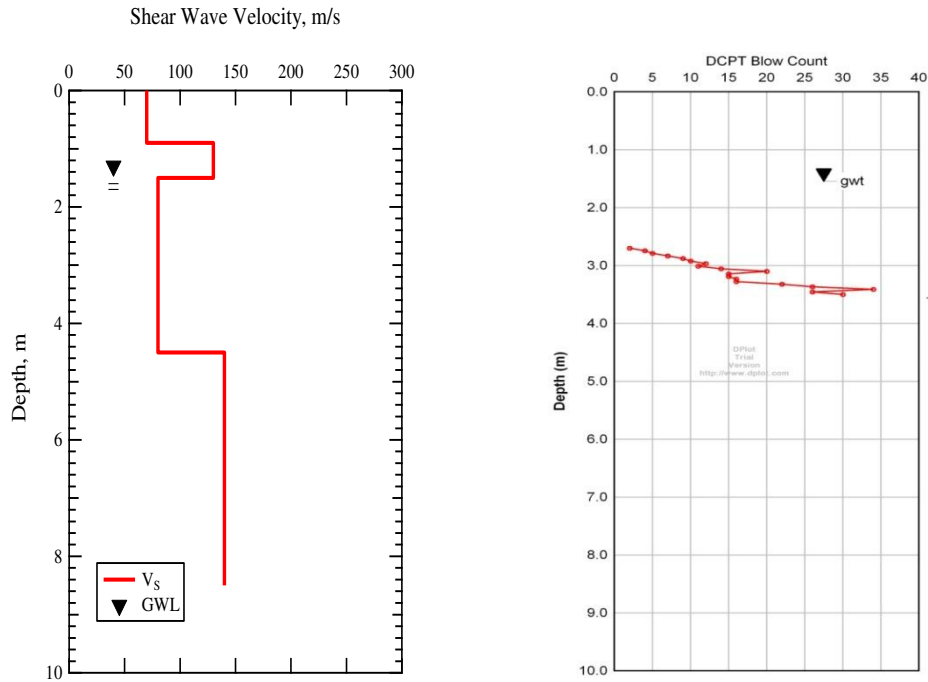
Figure 6.14: Results from SASW test (left: SASW4 43.422635°S, 172.635038°E) and DCPT (right: DCPT3 43.422685°S, 172.635081°E) performed along the base of the stopbank on Coutts Island Rd in an area that did not liquefy.

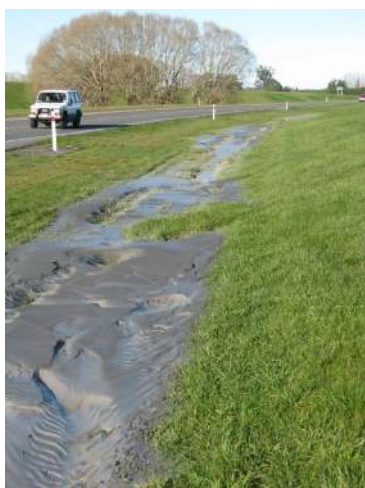
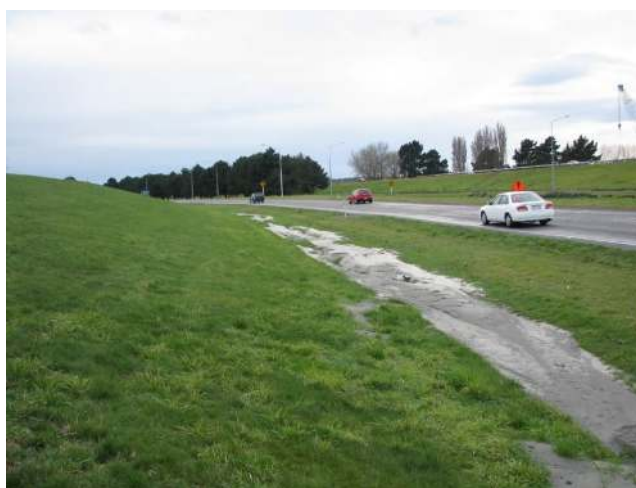
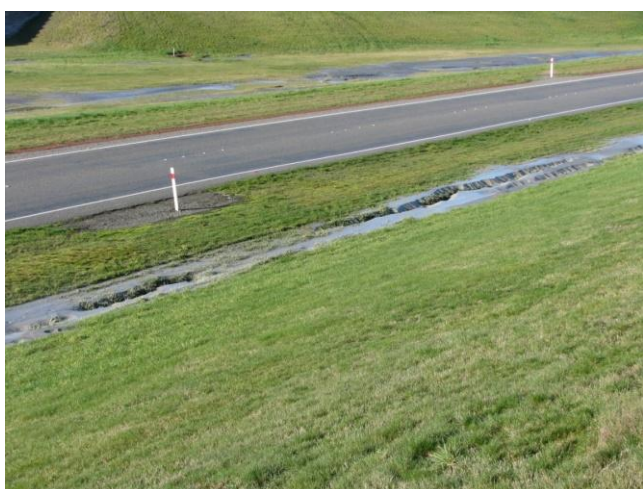
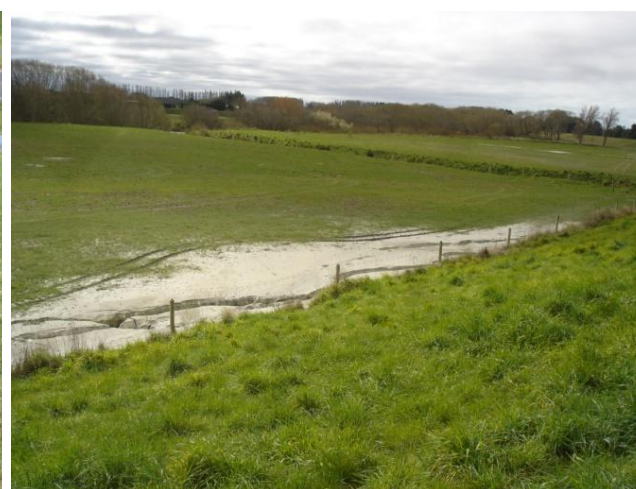
the stopbank and longitudinal cracks were observed running along the crest and sides of the stopbank (Figures 6.15 and 6.16). As may be seen from Figure 6.10, this stretch of the stopbank lies within the abandoned river channel of the old south branch of the Waimakariri River.

**Figure 6.16:** Photos 11 to 14: Liquefaction ejecta on both the river and landsides of the stopbank. (43.428968°S, 172.645435°E).

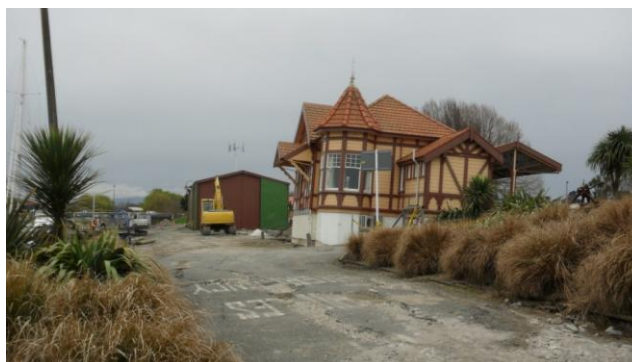
**Figure 6.17:** Photo 15: Visitors Information Centre on the stopbank on the north side of the Kaiapoi River. The location of this photograph is denoted in Figure 6.2. (43.387384°S, 172.659743°E).

In downtown Kaiapoi adjacent to the river, the Visitors' Information Centre on the north side of the river sank and tilted as a result of liquefaction and lateral spreading (Figure 6.17). Ground cracks, as wide as 300 mm and as deep as 1 m,

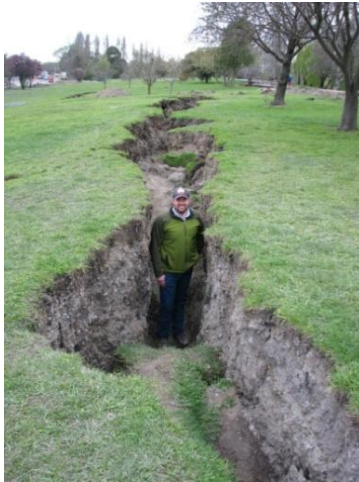
**Figure 6.18:** Photos 16-18: Lateral spread cracks along landside of the stopbank on the north side of the Kaiapoi River. The locations of these photographs are denoted in Figure 6.2. (43.384484°S, 172.660653°E).

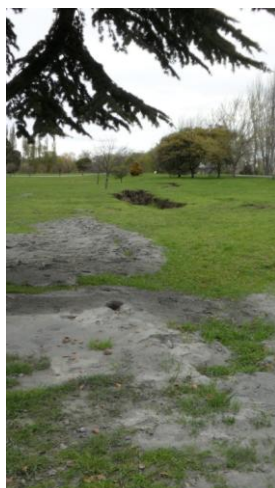
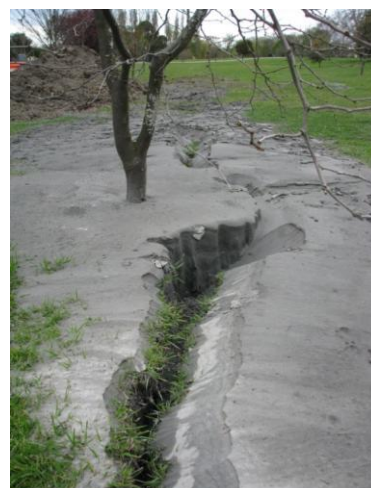
**Figure 6.19:** Photos 19-20: Lateral spreading cracks along the landside of the stopbank on the north side of the Kaiapoi River. The locations of these photographs are denoted in Figure 6.2. (43.384633°S, 172.661231°E).

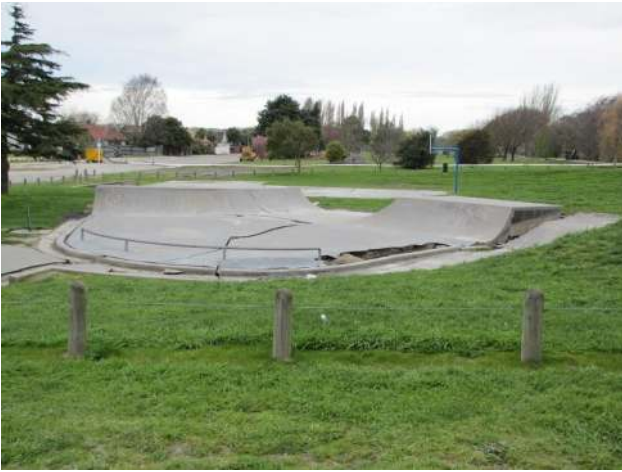
**Figure 6.20:** *Photo 21: Skate park on the stopbank on the north side of the Kaiapoi River. The location of this photograph is denoted in Figure 6.2. (43.384094°S, 172.660370°E).*

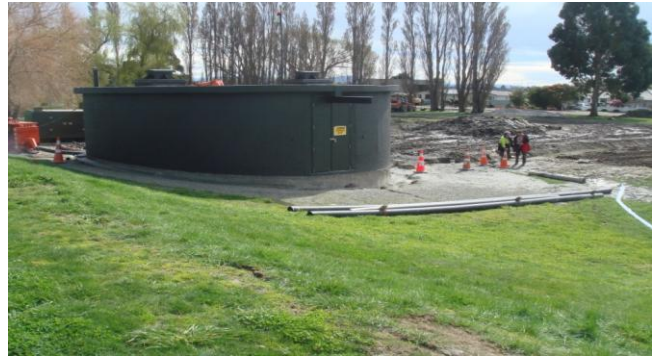
Further east along the Kaiapoi River (~400 m), the ground adjacent to a 6 m diameter structure (containing an underground tank and control equipment) settled by about 300 mm, resulting in damage to pipes attached to the tank (Figure 6.21). Additionally, aerial photographs of lateral spreading along the north bank of the Kaiapoi River going east from the town centre are shown in Figure 6.22.

**Figure 6.21:** *Photo 22: Settlement of tank structure. The locations of these photographs are denoted in Figure 6.2. (43.386918°S, 172.664412°E).*
