## GEOTECHNICAL RECONNAISSANCE OF THE 2010 DARFIELD (CANTERBURY) EARTHQUAKE

Editors: **Misko Cubrinovski<sup>1</sup>, Russell A. Green<sup>2</sup>**

This paper summarizes the observations and preliminary findings from this early reconnaissance work.

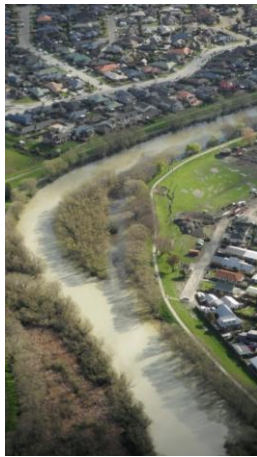
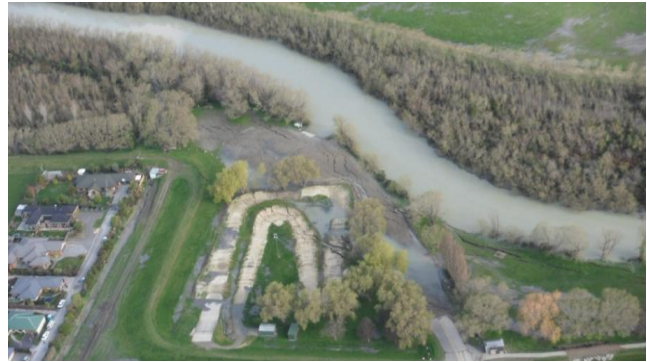
**Figure 6.22:** *Photos 23 & 24: Aerial photographs of lateral spreading of stopbanks on the north bank of the Kaiapoi River. The locations of these photographs are denoted in Figure 6.2. (left: 43.387389°S, 172.666173°E; right: 43.386875°S, 172.672297°E).*

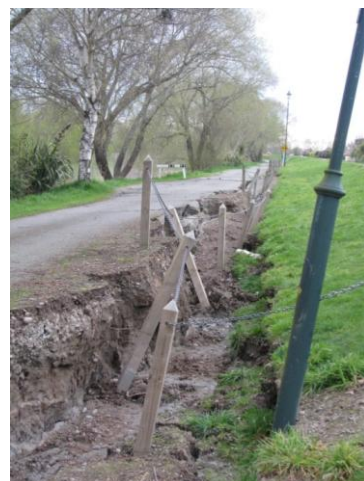
**Figure 6.24:** *Photo 26: Lateral spread cracks along the riverside stopbank on the south side of the Kaiapoi River. The location of this photograph is denoted in Figure 6.2. (43.385839°S, 172.660941°E).*

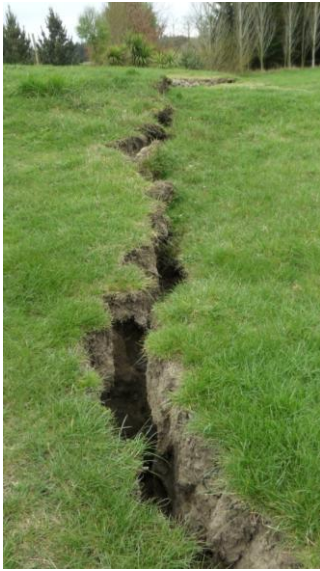
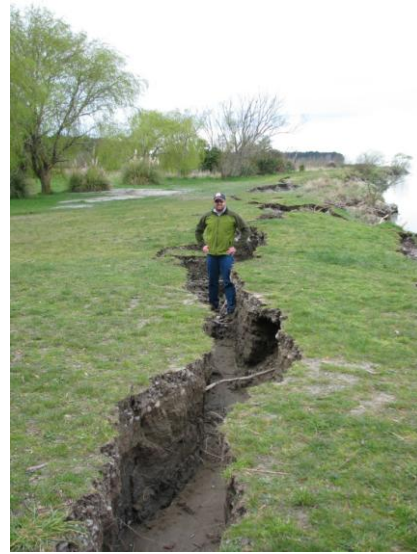
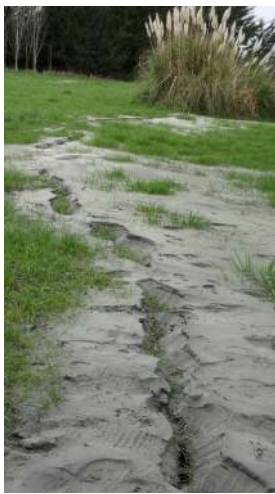
**Figure 6.28:** *Liquefaction and lateral spread features on or near stopbanks located about 100 to 200 m west of the Kaiapoi Sewage Treatment Plant. (upper left: 43.389175°S, 172.683235°E; upper right: 43.389701°S, 172.683390°E; bottom left: 43.389519°S, 172.682203°E; bottom right: 43.389432°S, 172.6682060°E).*

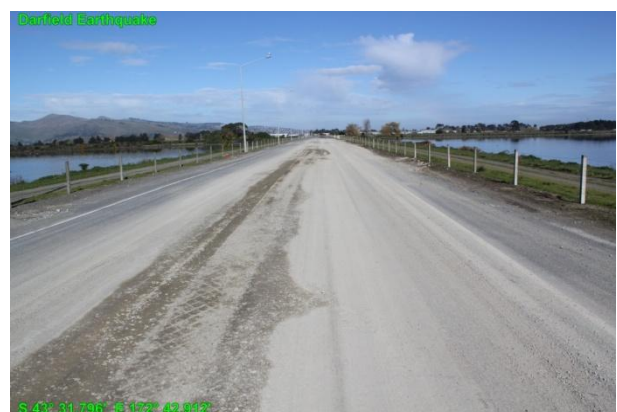
the centreline of the road, although it was already filled with compacted dense graded aggregate during the site visit (Figure 6.30). Nevertheless, longitudinal cracks were still evident on the side of the road (Figure 6.31).

**Figure 6.30:** Repaired Dyers road that runs between Ponds 2A and 3. ( $-43.529933^\circ$ ,  $172.715200^\circ$ ).

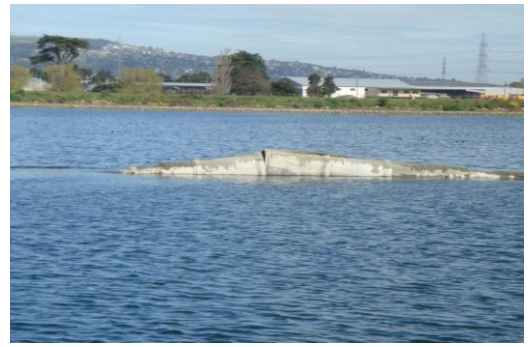
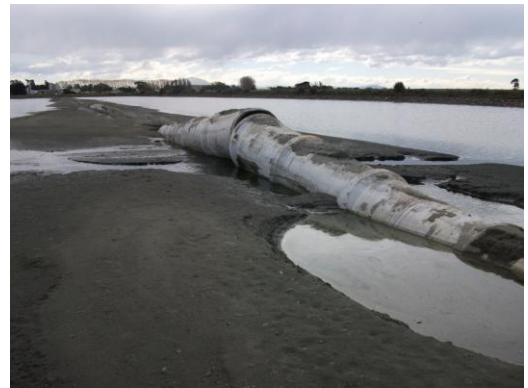
**Figure 6.32:** Buckled pipe protruding from Pond 1 during pond dewatering, and after pond level was lowered. Pipeline crown was at the pond invert prior to the earthquake. (-43.530867°, 172.705190°).

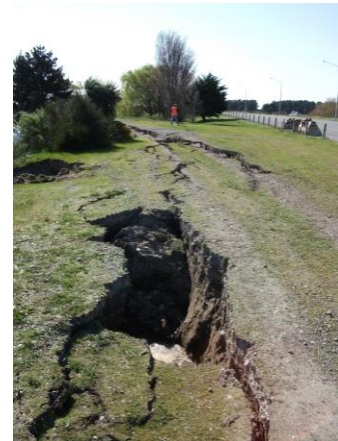
**Figure 6.33:** Lateral spread cracks at the eastern end of Pond 2B. The sink hole in the foreground of the photo on the right formed over the top of two outlet pipelines. (-43.52895°, 172.717300°).

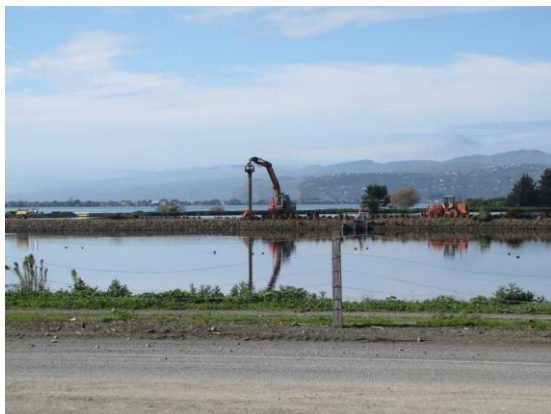
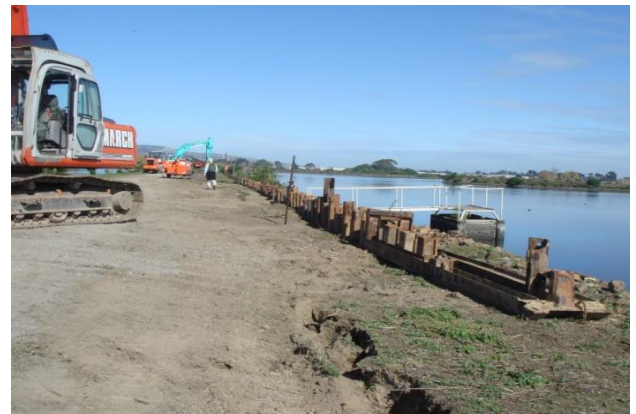
The distortion of the embankments noted above is indicative of bearing failure of the embankment as it has settled and spread into the liquefied sub-soils, with large tension cracks forming through the fill used to form the embankments and pulling apart of concrete pipelines as the fill has spread. Site investigations undertaken indicate that the soils beneath the pond embankments are potentially liquefiable to depths of 10 m to 15 m.

Because of the slumping of the pond banks, engineers decided to drop the pond water levels and reduce the hydraulic pressures on the embankments. At the time of the reconnaissance team visit, sheet piles were being driven into the Pond 3/6 embankment to stabilize it and arrest further movement (Figure 6.34). Furthermore, the pipelines beneath Dyers Road were being replaced.

**Figure 6.34:** Sheetpiles being driven to stabilize the pond embankment to arrest further movement. (-43.530563°, 172.718349°).

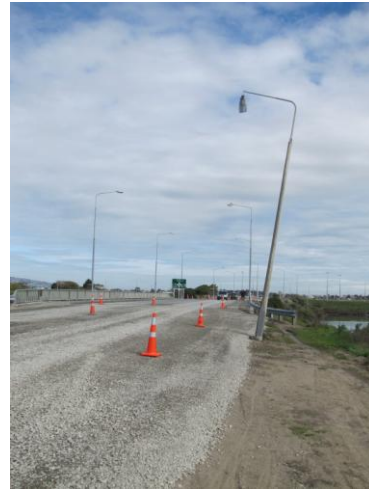
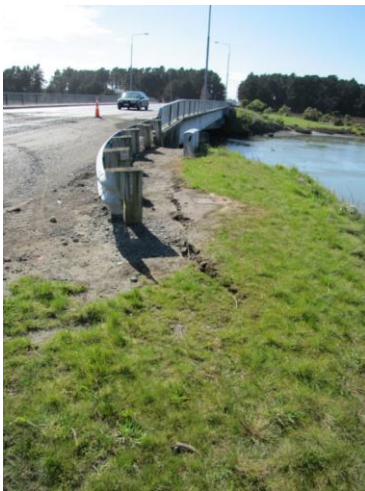
**Figure 7.2:** *Cracking on margins of west approach embankment, Bridge Street Bridge.*

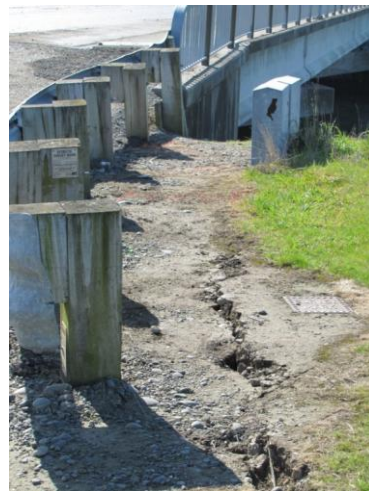
**Figure 7.3:** *Lateral spreading of east banks adjacent to the Bridge Street Bridge.*

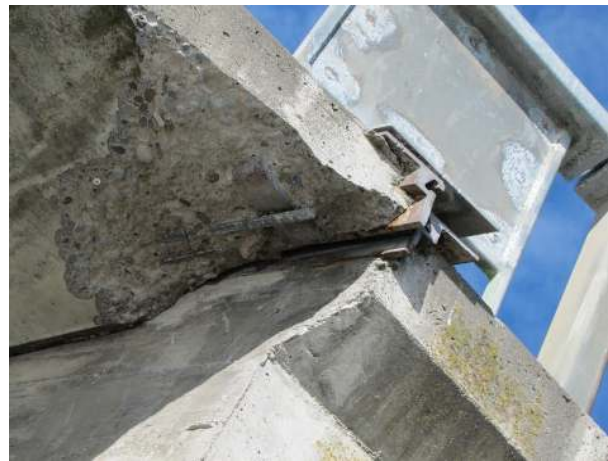
(a) West abutment gap closure and spalling.

Figure 7.4: Bridge Street Bridge expansion gap closure.

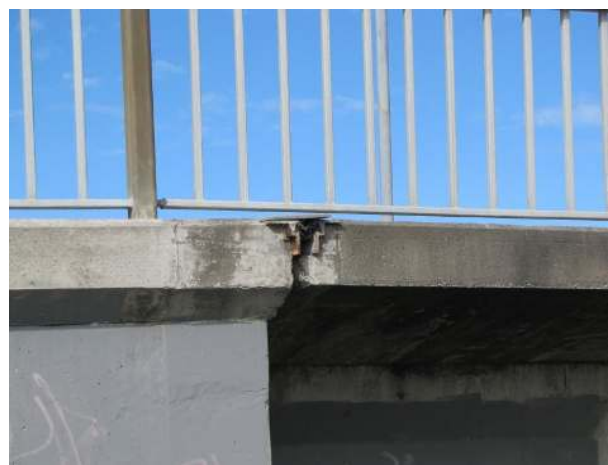
(b) East abutment gap closure.

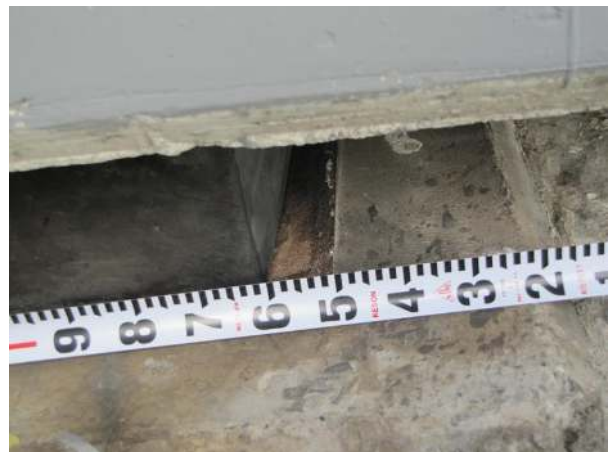
Figure 7.5: West abutment bearing pad displacement, Bridge Street Bridge (scale in Inches).

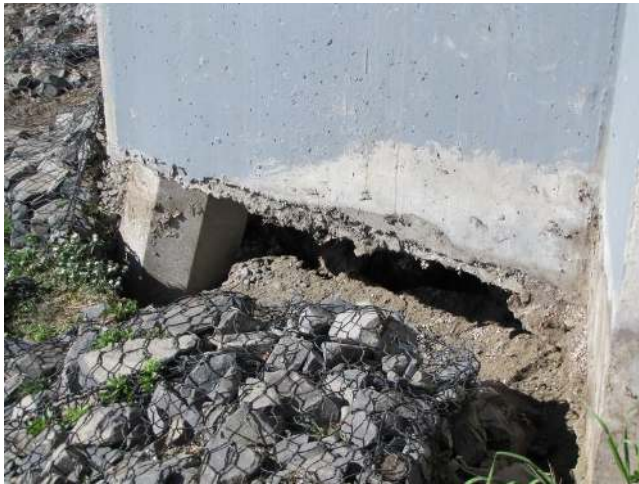
**Figure 7.6:** West abutment batter (angled) pile, Bridge Street Bridge.

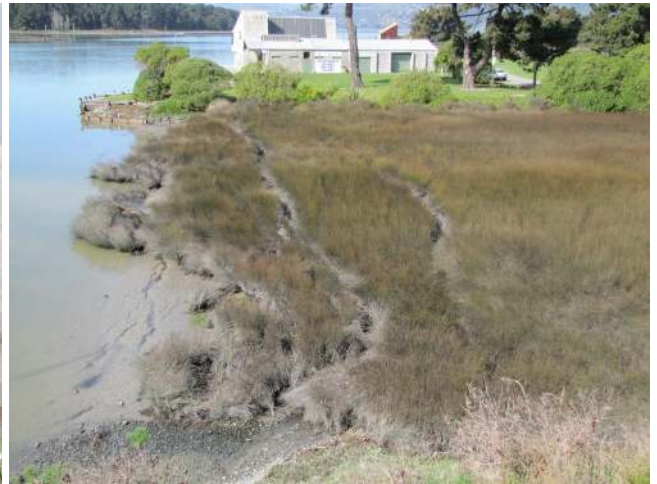
**Figure 7.7:** Lateral spreading on west bank, Bridge Street Bridge.

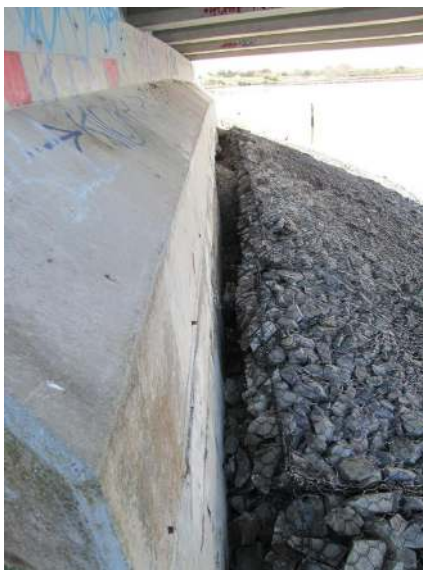
**Figure 7.8:** Gap between west abutment backwall and end embankment, Bridge Street Bridge.

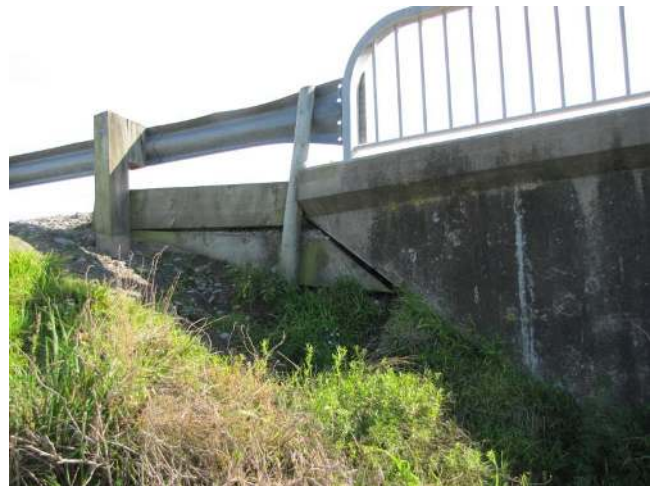
**Figure 7.9:** Back rotation of west abutment, Bridge Street Bridge.

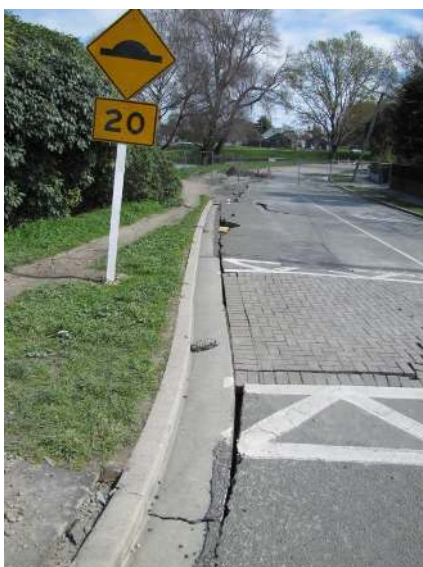
**Figure 7.10:** Cracking of roadway on west approach fill, Swanns Road Bridge.

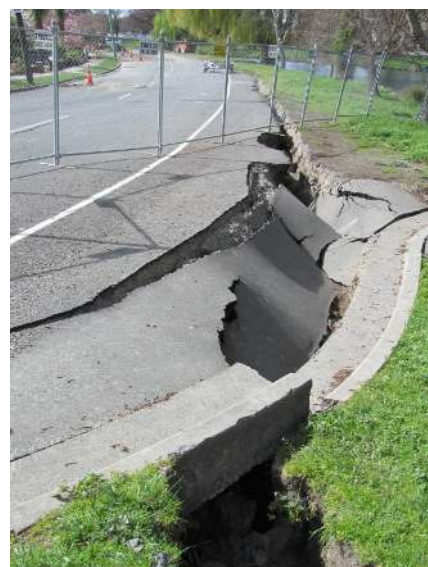
**Figure 7.11:** Lateral spreading on west approach fill, Swanns Road Bridge.

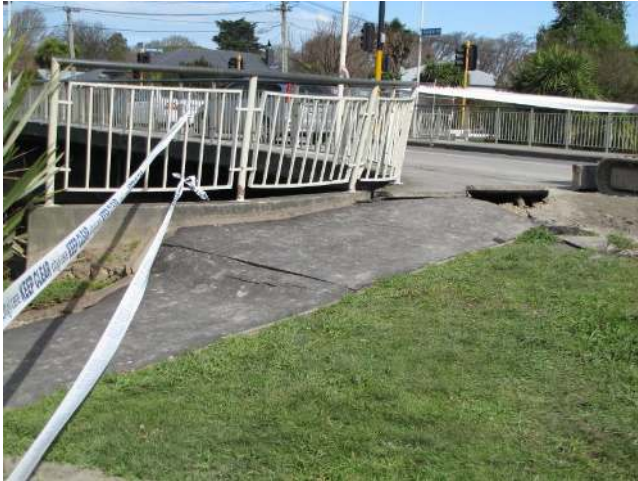
**Figure 7.12:** *Incipient lateral spreading at west abutment, Swanns Road Bridge.*

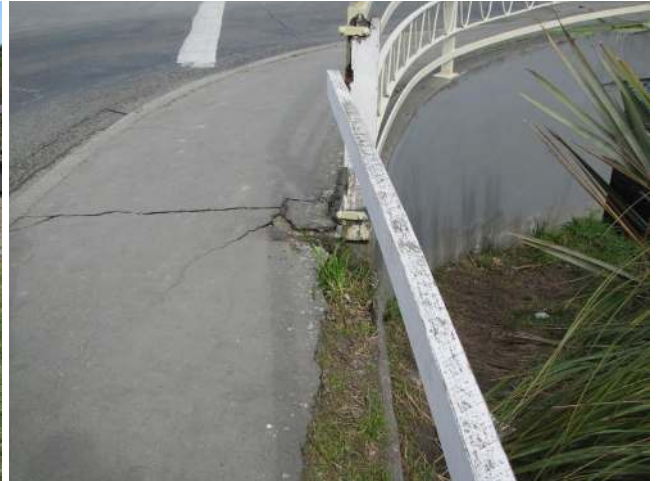
**Figure 7.13:** *Incipient lateral spreading at north abutment, Gayhurst Road Bridge.*

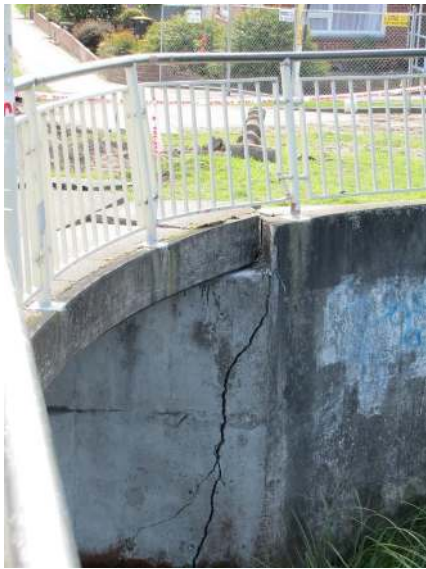
**Figure 7.14:** *Cracking of north abutment, Swanns Road Bridge.*

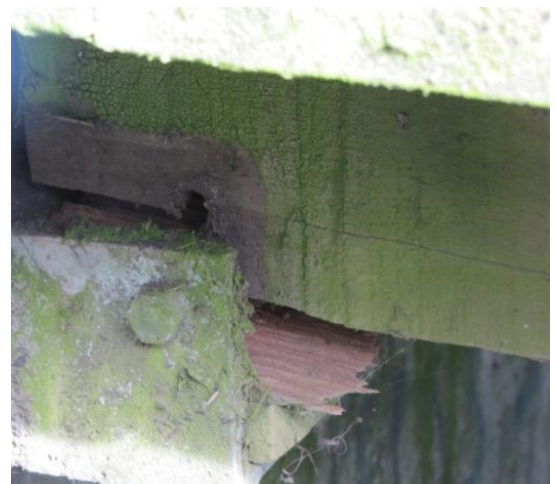
joins River Road on the west bank of the Avon River (43.531°S, 172.6656°E), the rather light deck of the bridge buckled to accommodate the lateral spreading at the abutments (Figure 7.16).

**(b)** *Sheared bearing on east bank.*

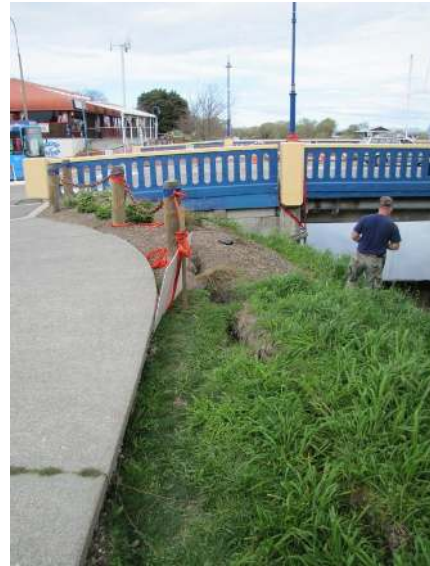
and cracking in the abutment walls was observed at the Williams Street Bridge (43.3825°S, 172.6575°E) (Figures 7.17, 7.18) and buckling of the lightweight deck of a pedestrian bridge due to convergence of abutments as a result of lateral spreading was observed just north of Williams Street, in the vicinity of Trousselot Park (43.3811°S, 172.6558°E) (Figure 7.19). Evidence of liquefaction and incipient lateral spreading was also observed along the walking path from the Williams Street Bridge to Trousselot Park and in the park itself (Figure 7.20).

**Figure 7.18:** *Incipient lateral spreading of east abutment, Williams Road Bridge.*

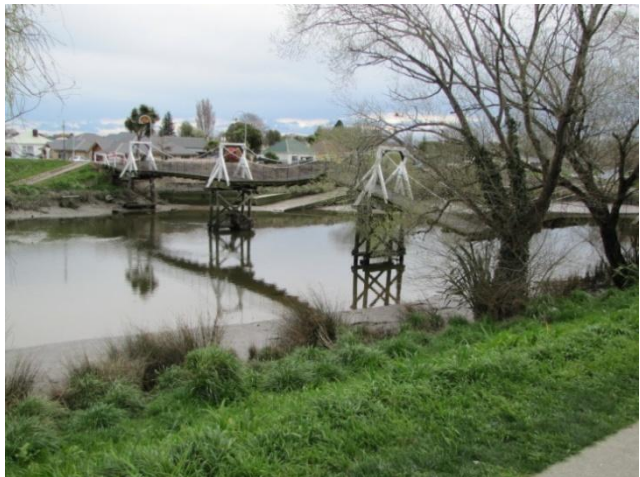
**Figure 7.19:** *Buckling of footbridge near Trousselot Park.*

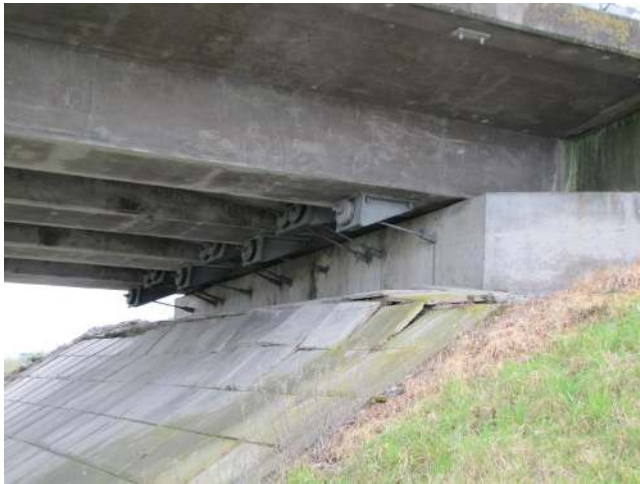
**Figure 7.22:** Cable Restrainers at north abutment, Chaney's Overpass.

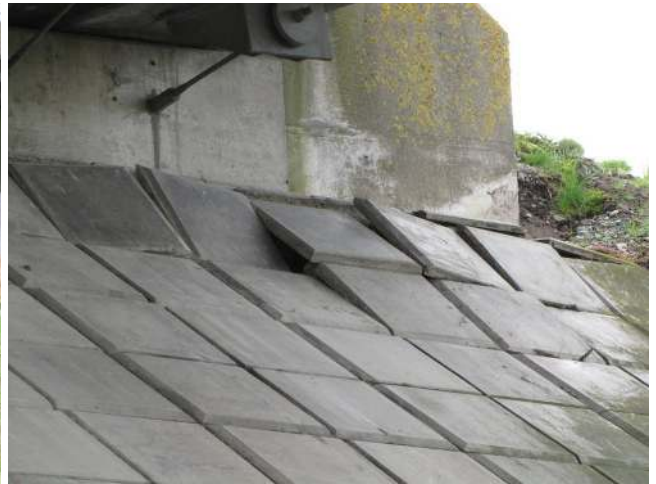
**Figure 7.23:** Displaced concrete tiles on end embankment for north abutment, Chaney's Overpass.

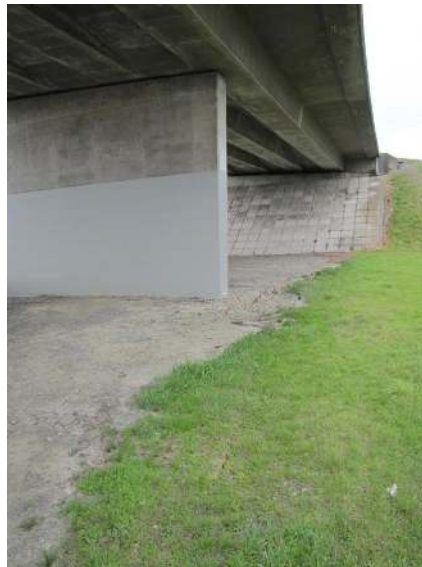
**Figure 7.24:** Evidence of liquefaction beneath Chaney's Overpass.

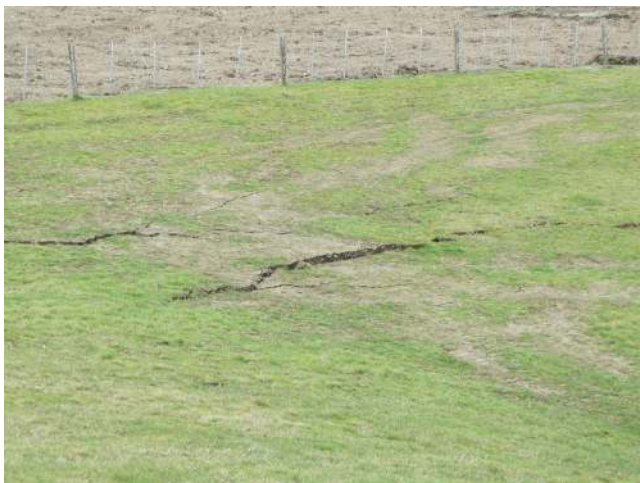
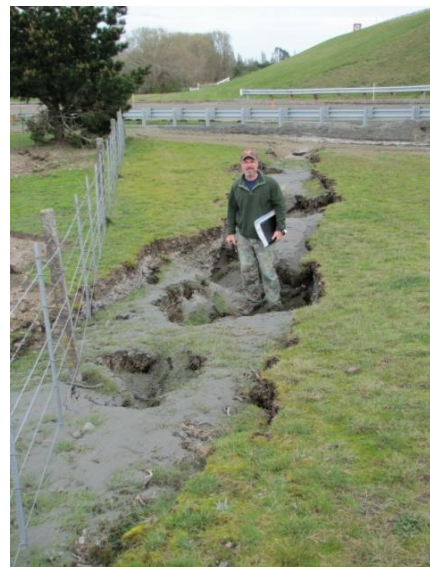
**Figure 7.25:** Evidence of liquefaction adjacent to Chaney's Overpass.

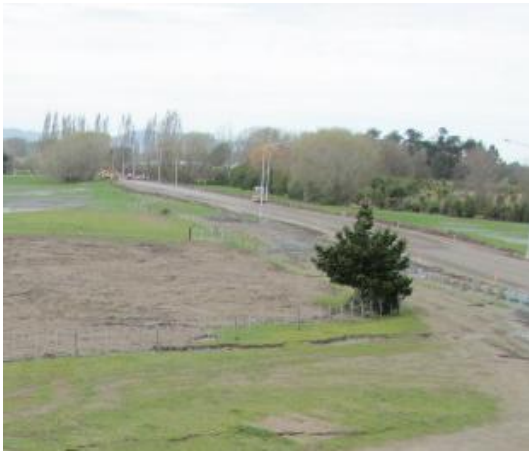
*Figure 7.26: Cracking in and along roadway adjacent to Chaney's Overpass.*

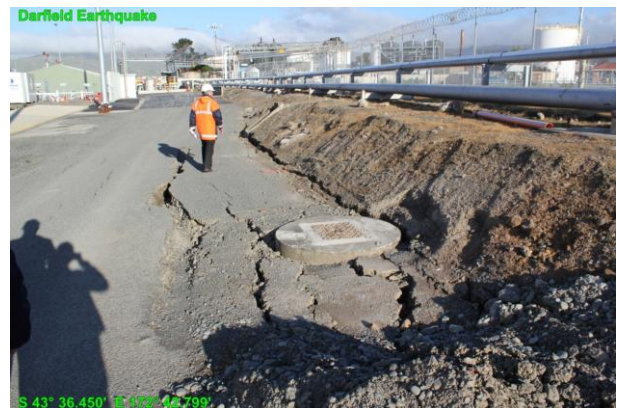
The soil profile at the Port typically consists of 10 m or more soft clay and silty sand layers underlain by rock, along with some un-engineered fill and boulder rip-rap. Liquefiable soils are limited to a few seams within the natural sediments and are believed to have had no impact on the performance of the port. All wharves are on vertical pile foundations, including hardwood timber piles, 600 mm diameter reinforced concrete piles, 600 mm square reinforced concrete piles, and steel pipe piles. Many are skin-friction piles that develop their vertical capacity within the underlying clay and sandy soil layers. No damage to any piles was observed, though some were noted to have apparently settled up to 0.3 m, becoming disengaged from the wharf deck. All the wharves underwent limited settlement and lateral deformation, though limited to 0.2 to 0.3 m. Typical damage from settlement and lateral deformation are shown in Figures 7.37-7.39.

Figure 7.37: Settlement and lateral deformation at fuel transfer facility (43.60750°S, 172.71332°E).

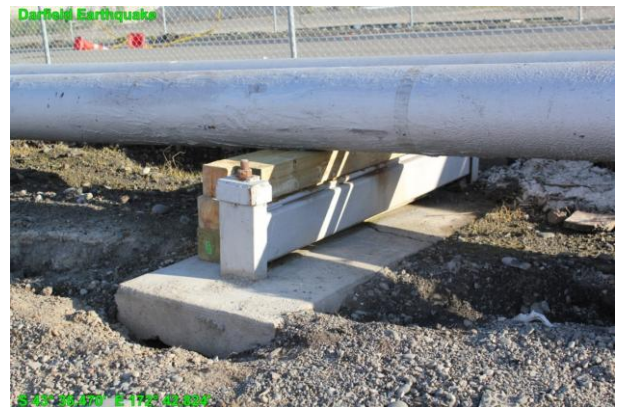
Figure 7.38: Temporary wooden support to accommodate settlement under fuel line.

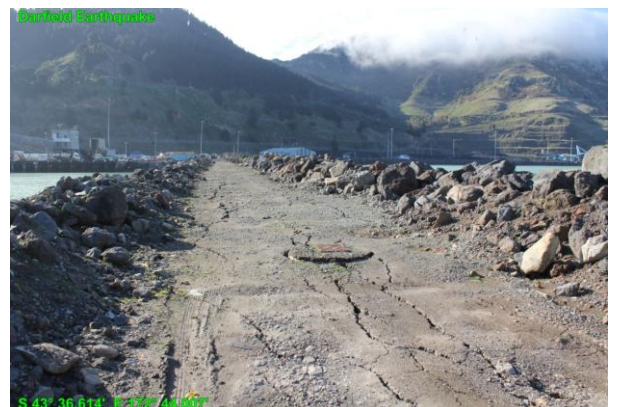
Figure 7.39: Cracking along jetty at eastern end of port.

The limited wharf movements did open up cracks in the asphalt pavement sections of the wharf deck. In order to keep the port operational, Port officials were considering different temporary repair alternatives, including grouting, sand infill, or crushed rock. Port engineers also expressed concern that the concrete pavement in the backlands areas was bridging over voids that developed due to lateral displacement of retaining walls at the back of the wharves that accompanied lateral displacement of the deck.

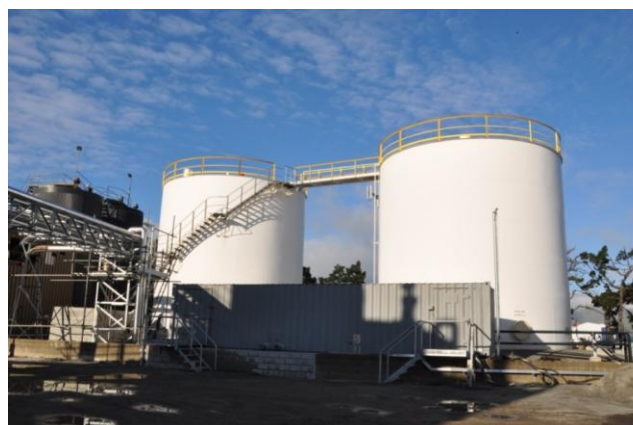
within the bitumen plant, four tanks and some supporting piping suffered movement and damage. The most severe lateral movement was that of Tank 1 (located at 43.6085°S, 172.7149°E), which moved laterally 50 mm towards the water. Tank 2 (43.608768°S, 172.714651°E) settled uniformly about 30 mm causing separation of the connecting bridge between it and a neighbouring tank of like geometry (Figure 7.42). This tank, with dimensions of 12.8 m high by 13 m diameter, housed used oil and was nearly filled to capacity at the time of the main shock, weighing an estimated 550 tons. Tanks 3 and 4 (43.6085°S, 172.7149°E) were side-by-side and each experienced movement that resulted in pullout of nearly all perimeter anchor bolts at their base. These tanks were 12.5 m tall by 6 m diameter with an estimated 150 ton weight at the time of the main shock. Crews were repairing the support anchorage for Tanks 3 and 4 with the retrofit shown in Figure 7.43. No structural damage to the tanks was observed and flexible connections survived the strong shaking with only minor leakage. Asphalt repair using cement injection to fill the lateral spread cracks was on-going during the teams visit (Figure 7.44). Sand boils were also observed at several locations within the plants boundaries. Soil samples of the ejecta indicated the material was clean sand with little to no fines (Figure 7.45).

Figure 7.42 Tank 2 (right, large white tank) with Tanks 3 and 4 shown to the left (smaller grey tanks) at the Fulton Hogan Bitumen Plant. (43.6088°S, 172.7147°E).

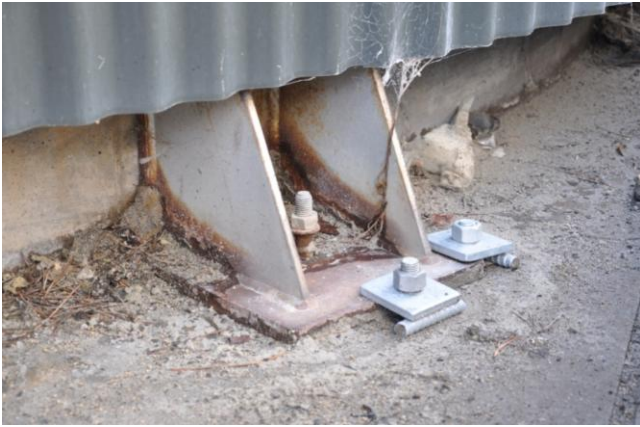
Figure 7.43: Typical repair to Tank 3 and 4 (addition of clamp plates). Note the pullout of the original anchorage. Fulton Hogan Bitumen Plant. (43.6085°S, 172.7149°E).

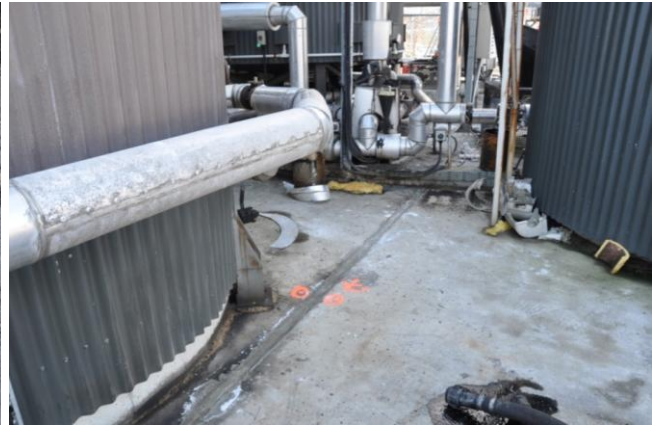
Figure 7.44: Repair of lateral spread cracks within the Fulton Hogan Bitumen Plant, nearby Tank 3. (43.6085°S, 172.7150°E).

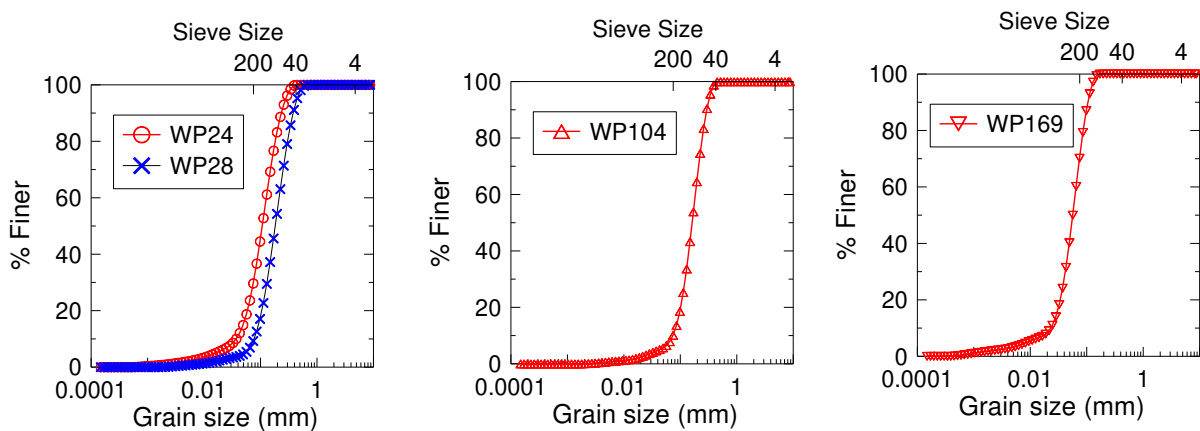
Figure 7.45: Laser diffraction tests of samples taken from ejecta observed at the Fulton Hogan Bitumen Plant. Sample WP169 taken at 43.6087°S, 172.7142°E.

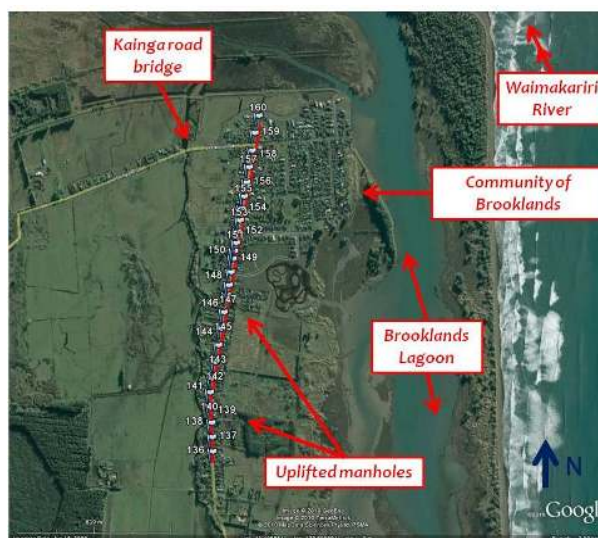
Figure 7.46: Approximately 2 km stretch along Lower Styx Road with observed uplifted manholes. (GoogleEarth image; 43.4059°S, 172.6999°E). Waypoints 136-160 represent locations of elevated manholes.

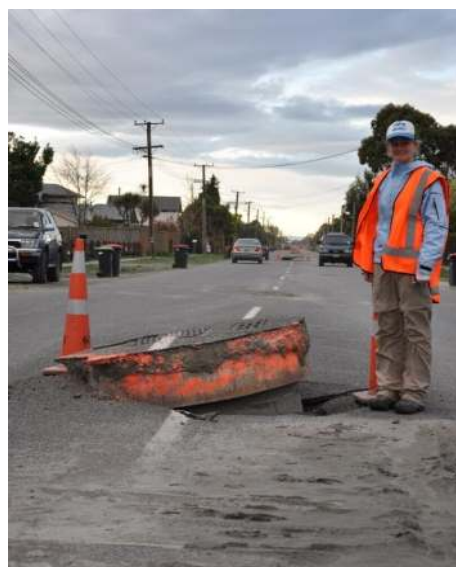
In a number of residential communities, sewage and potable water were problematic immediately following the main shock. Perhaps hardest hit were the communities of Spencerville and Brooklands. At the time of the Teams visit on 13 September 2010, neither community had a functioning wastewater collection system, and Brooklands did not have potable water. Liquefaction along Lower Styx Rd, the primary connection between these two communities, caused ground subsidence, a rise in the water table, and uplifting of 25 manholes (Figure 7.46). Construction workers were dewatering the region during the Team's visit and informed us that the manholes were 4 m deep. The manholes were approximately 280-460 mm above the existing road surface (Figure 7.47).

Figure 7.47: Uplifted manholes along Lower Styx Road, note the continuation of pattern in the foreground (43.4113°S, 172.6930°E).
