Identification and improvement of critical joints in CLT construction without weather protection

Kristo Kalbe^{1*}, Villu Kukk¹, Targo Kalamees^{2,1}

¹ nZEB Research Group, Tallinn University of Technology, Tallinn, Estonia

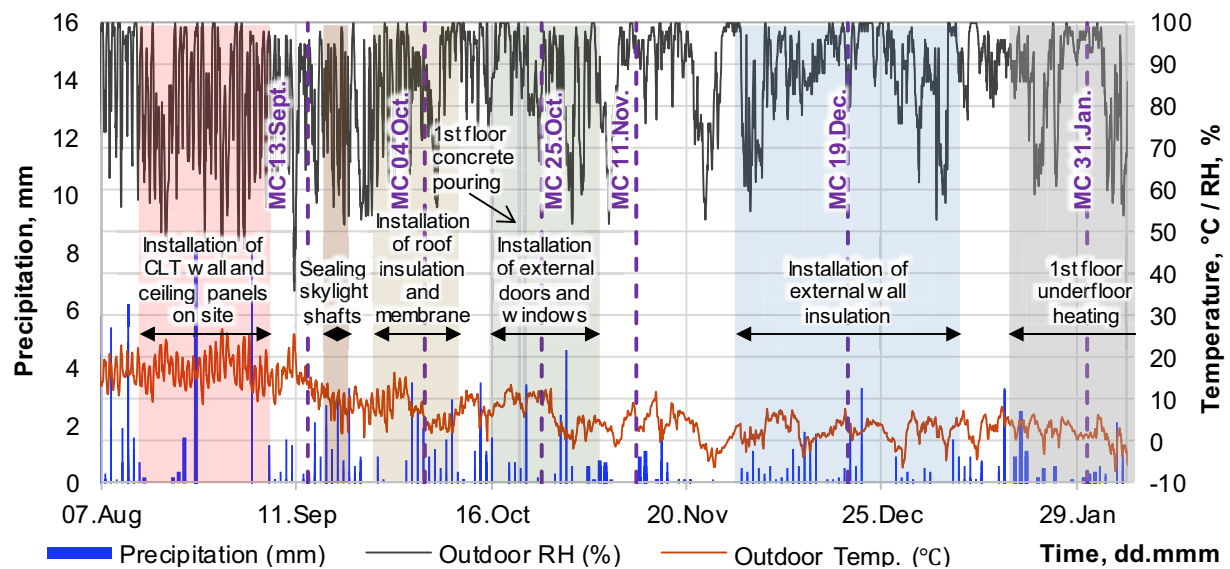
In Figure 3 there is a summarising graph of weather data presented in the time axis, including different construction phases that occurred over the course of the observation period. Precipitation occurred throughout the construction time and there were only a few completely dry periods, which is common during autumn in a cold and humid climate.

The installation of CLT panels (from 14.08.2019 to 06.09.2019) took place during the period of highest precipitation amounts. The average precipitation amount was 1.4 mm/h and the maximum reached 8.5 mm/h. We made the first round of MC measurements on the 13th September, after the CLT panels were installed. The ceilings were covered with water and water was flowing down the walls. It was clear that the CLT structures had been exposed to a sizeable amount of water. MC exceeded 17% in most measurement points around the perimeter, over 20% in more than half and over 26% in three points. The average outdoor temperature during the period was 17°C and the average relative humidity was 80%. Figure 4 shows all the measured values and calculated average values for each visit. Smoothed lines are presented between the average values of each visit to show the trend of MC over the visits.

Fig. 3. Weather data during the construction period and MC measurements (MC 13 Sept.- MC 19 Dec.).
