**Brief note**

## **IDENTIFICATION OF THE CAUSE OF THE STEM NECK FRACTURE IN THE HIP JOINT ENDOPROSTHESIS**

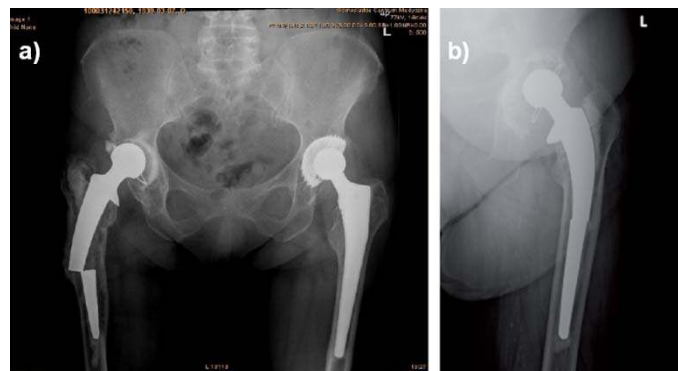
Fig.1. Endoprosthesis stem fractures: a) with the shaft of the femoral bone (the material of the Faculty and Clinic of Orthopaedics and Musculoskeletal System Traumatology at the Silesian Medical University in Katowice), b) isolated distal part of the Weller endoprosthesis stem [11].

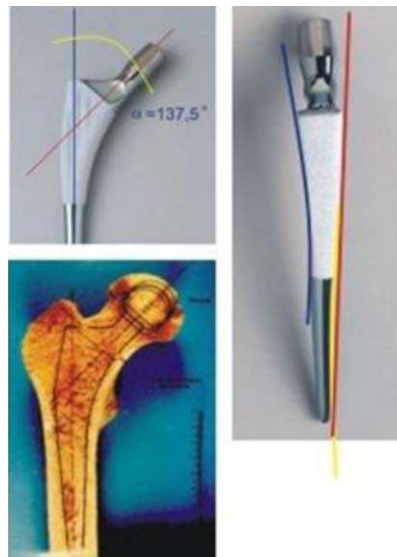
Fig.5. Aura II stem construction [22].

It is a combination of a self-locking, universal Müller-type stem with a standard geometry of an anatomical endoprosthesis. The difference in the curvature of the lateral surfaces of the stem enables it to adjust to the anatomy of the proximal epiphysis. In this way, the contact surface of the bone with the implant is greater. The stem neck has a narrowing, which limits the possibility of a conflict between the neck and the implant of the acetabulum and, at the same time, increases the movement range. The bend in the distal part reduces complications, such as femur pain at the end of the endoprosthesis stem. At the same time, Aura II preserves the properties of a self-centring and self-locking stem in the bone marrow canal. The Aura II stem is produced in a cement version and two non-cement versions. In each version, there are 18 types of stems available, 9 left and 9 right ones with an anteversion of 6 degrees. In the cement version, the stem is smooth, polished with vertical grooves in the proximal part in order to ensure better fixation in the bone cement. The stem under examination is made of the M30NW austenitic steel which complies with the following standards: ISO 5832/9, BS 7252 part 9 and ASTM F 1586. According to the information provided by the producer, steel is obtained by melting, followed by the AOD (Argon Oxygen Decarburisation) process and meets the high standards required for orthopaedic implants. It has high resistance to corrosion and better mechanical properties than the 316L steel and it is non-magnetic (Tabs 1 and 2) [23]. After casting, the stem is formed in the plastic working process by drop forging. The process of forging and heat processing aims to reduce casting defects, recrystallisation and fragmentation, achieve uniform composition and eliminate porosity.
