In situ testing and modeling of cultural heritage buildings in Peru

P.B. Lourenço, G. Karanikoloudis & F. Greco

ABSTRACT: This paper provides the results of *in situ* testing and modelling of four case studies in Peru and is part of the ongoing Seismic Retrofitting Project, under the auspices of the Getty Conservation Institute (GCI): Casa Arones (Cusco), Hotel Comércio (Lima), Ica Cathedral (Ica) and Kuño Tambo (Acomayo). These are mostly earthen buildings made with adobe, with the presence of large amounts of timber and, in some cases, brick masonry and rubble stone masonry (mostly for the base course in contact with the ground). *In situ* testing consist of an extensive sonic testing campaign and dynamic identification. Advanced modeling of two case studies allowed demonstrating that these structures have a high vulnerability and require strengthening measures.

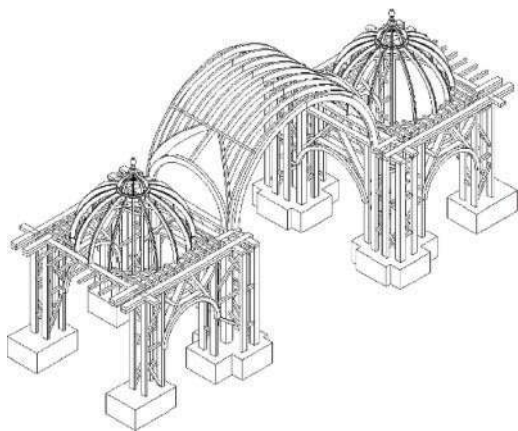
Figure 10. 3D architectural AutoCAD model.

The 3D finite element model of the representative bay is constructed in SAP 2000 structural and earthquake engineering software, CSI (2014), after the Autocad drawing show in Figure 10. The deformed mesh under self-weight is shown in Figure 11.

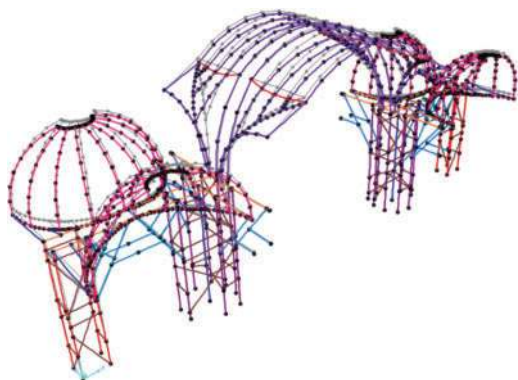
Figure 11. Deformed shape of the structure under self-weight.

According to the obtained results from the local verification for ULS under earthquake load combination, the stresses that occur in correspondence to the mortise and tenon connections of the beams at the top of the lunettes are large enough to provoke the failure of the structure, as verified during the earthquakes.
