An Investigation of Diesel-Generator Shaft and Bearing Failures.

Abstract: A shaft failure in a 634 kW diesel generator after 4000 hours of operation required investigation, especially when similar sets began to show signs of excessive bearing housing wear. The failure was found to be due to torsional fatigue caused by operation at an unforeseen resonant condition. The damage to the bearing housing of this type of set was also attributed to this behaviour.

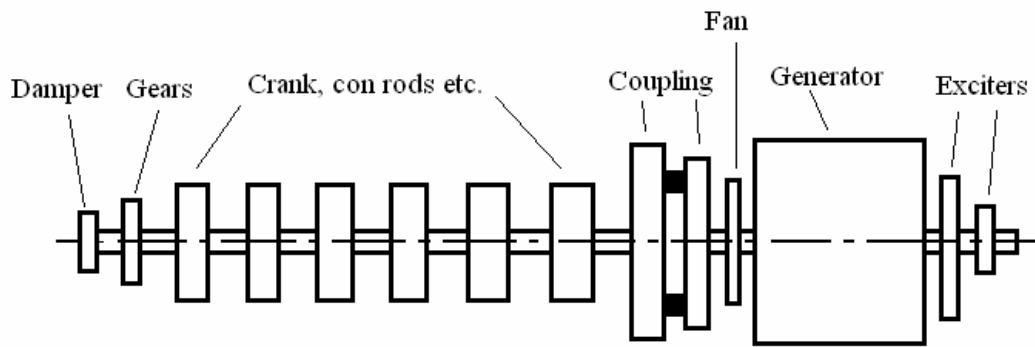
The system comprised a V12 diesel engine driving the generator through a flexible coupling. A schematic drawing of the system is shown in Figure 4. At the design stage, the system had been checked for torsional natural frequencies and its response to dynamic forcing from the engine under normal running and misfire conditions. The checks were carried out for full load and 25% load conditions. Table 1 shows a Holzer(4) analysis for the set at full load showing the first torsional natural frequency to be 40.8 Hz. At lower levels of power generation, due to the non-linear nature of the elastomeric components in the coupling, the stiffness of the coupling reduces and at 25% load the 1st torsional natural frequency reduces to 19 Hz.

Figure 4 Schematic diagram of diesel-generator system.
