# LIFELINES PERFORMANCE AND MANAGEMENT FOLLOWING THE 22 FEBRUARY 2011 CHRISTCHURCH EARTHQUAKE, NEW ZEALAND: HIGHLIGHTS OF RESILIENCE

## SUMMARY

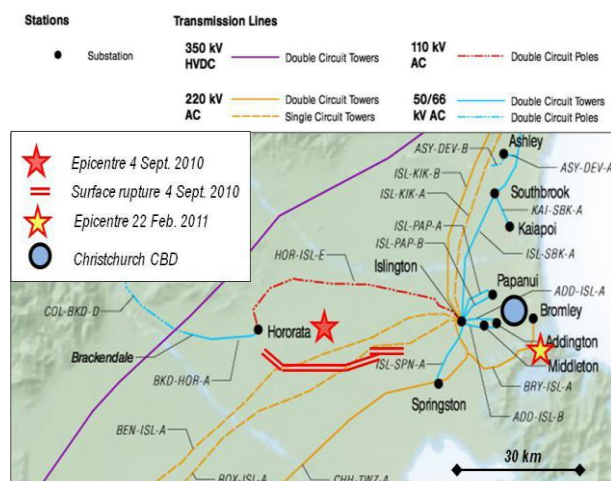
**Figure 4:** Transpower assets (substations and transmission lines) affected by the 4 September 2010 and 22 February 2011 earthquakes (Photo credit: Transpower).

Only minor structural damage of transmission assets was experienced (McGhie and Tудо-Bornarel, 2011). Most of the damage caused by the 22 February 2011 earthquake to Transpower assets occurred at Bromley, which experienced very high ground accelerations (Figure 5) and Papanui substations. Some minor damage occurred at Transpower's Addington warehouse, which consisted of local buckling of the pallet racking structures and collapse of one shelf.

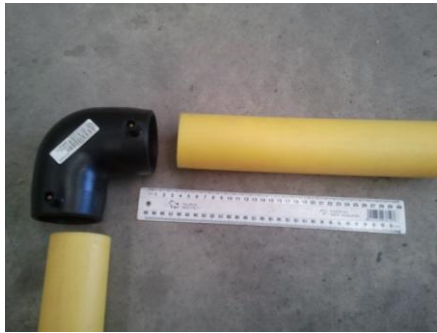
**Figure 14:** Example of MDPE electrofusion joint for the Contact Energy pipes

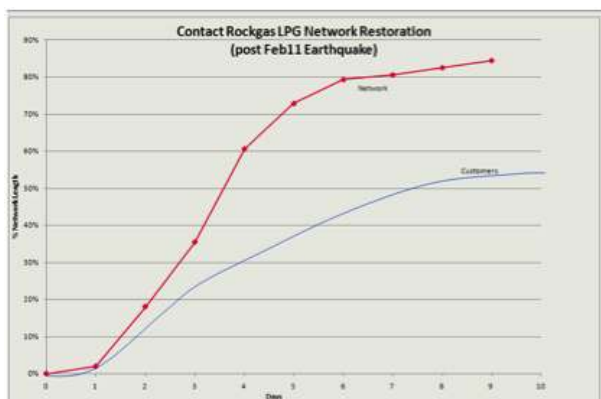
Despite the excellent performance in multiple earthquakes, as indicated in Figure 15, from a broader community perspective the gas system could not return to its pre-earthquake service levels due to the reduced number of customers as a result of the earthquake and related impacts.

**Figure 15:** Rockgas serviceability following the 22nd February 2011 earthquake.

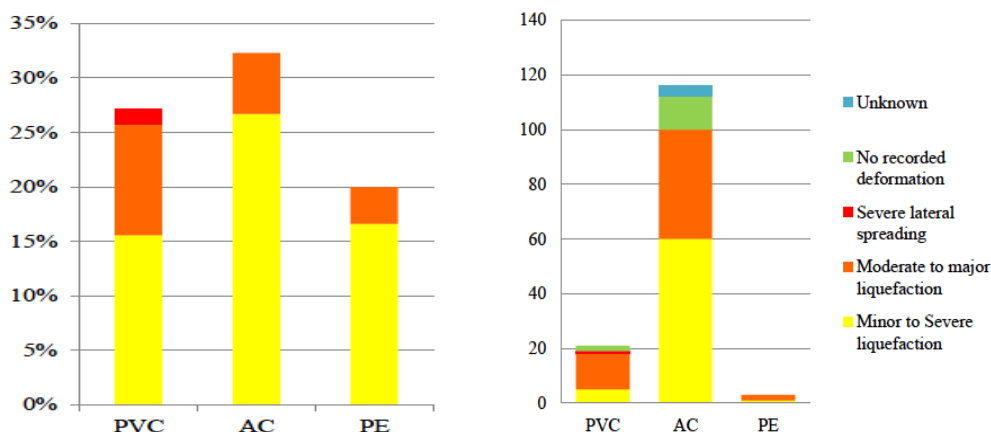
HDPE pipe is being extensively used for all new pressure mains as it was found to perform well in the 4<sup>th</sup> September and 22<sup>nd</sup> February earthquakes and 13<sup>th</sup> June aftershock. Figure 17 show preliminary results on the performance of different pipe material for the Kaiapoi water network following the 4<sup>th</sup> September earthquake.

**Figure 17:** Kaiapoi water network following the 4<sup>th</sup> Sept, Darfield Earthquake: a) (Left) Percent of total length of different pipe materials within different ground deformation areas; b) (Right) Number of repairs made on mains and rider mains in different levels of ground deformation areas. (Knight, 2011).

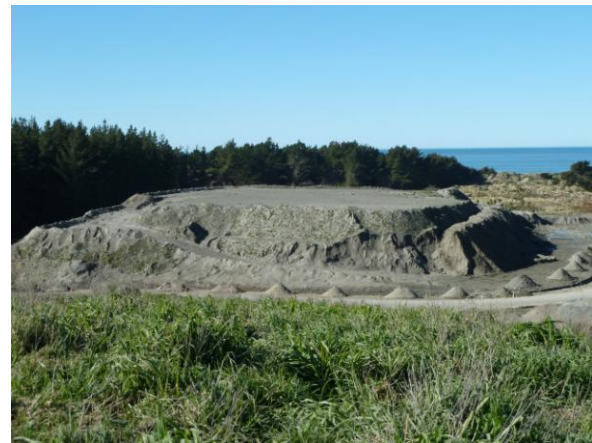
**Figure 19:** Estimated > 400,000 tonnes of liquefaction silt removed from the Christchurch urban area after the February 22 earthquake at the Burwood landfill disposal site.
