**Loading, Degradation and Repair of
F-111 Bonded Honeycomb Sandwich
Panels - Preliminary Study**

DSTO-TR-1041

**Airframes and Engines Division
Aeronautical and Maritime Research Laboratory**

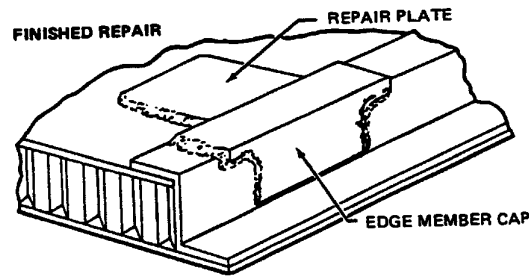
Figure 20. Finished repair for a hole or void in the face adjacent to an edge member.

This repair is for damage in the face or core adjacent to an edge member. The panel is cleaned and a moisture removal procedure carried out to dry the honeycomb core. The damaged area and edge member flange are routed to remove the damage. A core plug is manufactured and both the core plug and routed hole are prepared for bonding by performing a standard surface preparation for adhesive bonding. The plug and repair plate is then bonded to the damaged panel. An edge member angle cap is installed to cover the repair plate and edge member and finally, a honeycomb leak test carried out. A diagram of a finished repair is shown in Figure 20.

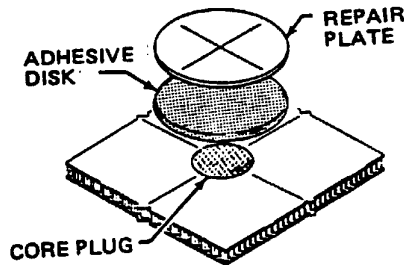
Figure 21. Hole repair using an overlap patch.

This repair is similar to D12 but without the complication of being adjacent to an edge member. The panel is cleaned, the damage removed and the panel is dried. The repair plates and core plug are then fabricated to suit. The surfaces to be bonded are prepared and the core plug installed, followed by the installation of the repair plate (note that the repair plate is non-flush) by bonding. Finally, the repair is surface finished and a honeycomb leak test performed.

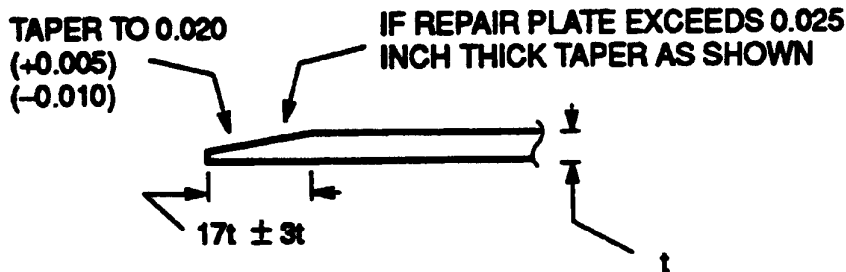
Figure 22. Taper dimensions for non-flush repair plates exceeding 0.025 inches thick.

The design requirements of repair plates and edge members specify the necessary overlap lengths, dependent on the face thickness, and these are shown in Table 6. In addition, repair plate edge tapers are specified as shown in Figure 22.

The SRM and C5033 use different specifications for repair plate thickness, however, if one considers a metallic repair plate design, generally the result for both design specifications would be the same or similar repair plate thickness. Comparing Figure 22 and Figure 25 the main difference in the design of the taper for metallic patches or repair plates is the undercut that is specified in C5033 but not in the SRM. It has been shown that the undercut produces a lower peel and shear stress concentration at the edges of the patch [17].

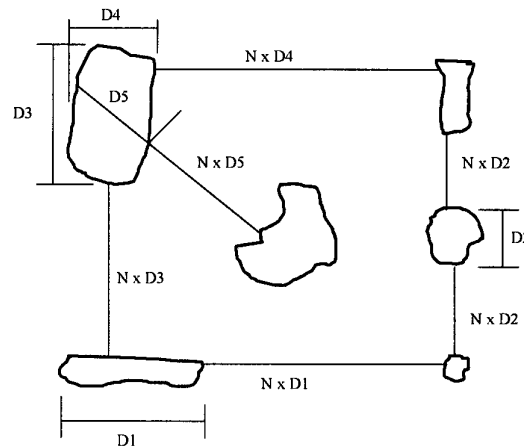
Figure 24. Minimum separation distances for multiple disbonds. For critical structures $N=4$ and for other structures $N=3$.

Figure 24 explains the minimum permissible spacings between voids as stated in C5033.

Further, no void is permitted within 0.125 inches of any edge of a metal to metal bond. Face to core disbonds must not exceed 0.5 inches diameter for critical structure and 0.75 inches diameter for other structure. In addition, there are restrictions on the dimensions of core splices and core-to-core bonds.

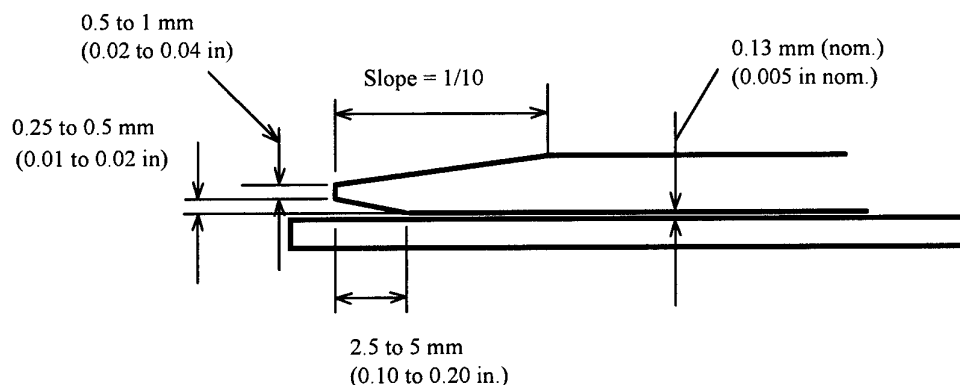
Figure 25. Tapering of metallic patches to reduce peel and shear stress at the edges of the repair.

The requirement on tapering at the edges of a metallic patch is shown in Figure 25. There is also a requirement that the patch must be shaped to the contour of the panel. The patch needs to follow the surface profile to ensure the resulting adhesive film thickness will have a tolerance of ± 0.002 inches.
