LONG RANGE INSPECTION OF RAIL USING GUIDED WAVES - FIELD EXPERIENCE

P. Cawley¹, P. Wilcox², D.N. Alleyne², B. Pavlakovic², M. Evans², K. Vine² and M.J.S. Lowe¹
¹ RCNDE, Dept Mech Eng, Imperial College, London, UK ² Guided Ultrasonics (Rail) Ltd, 17 Doverbeck Close, Nottingham, NG15 9ER, UK

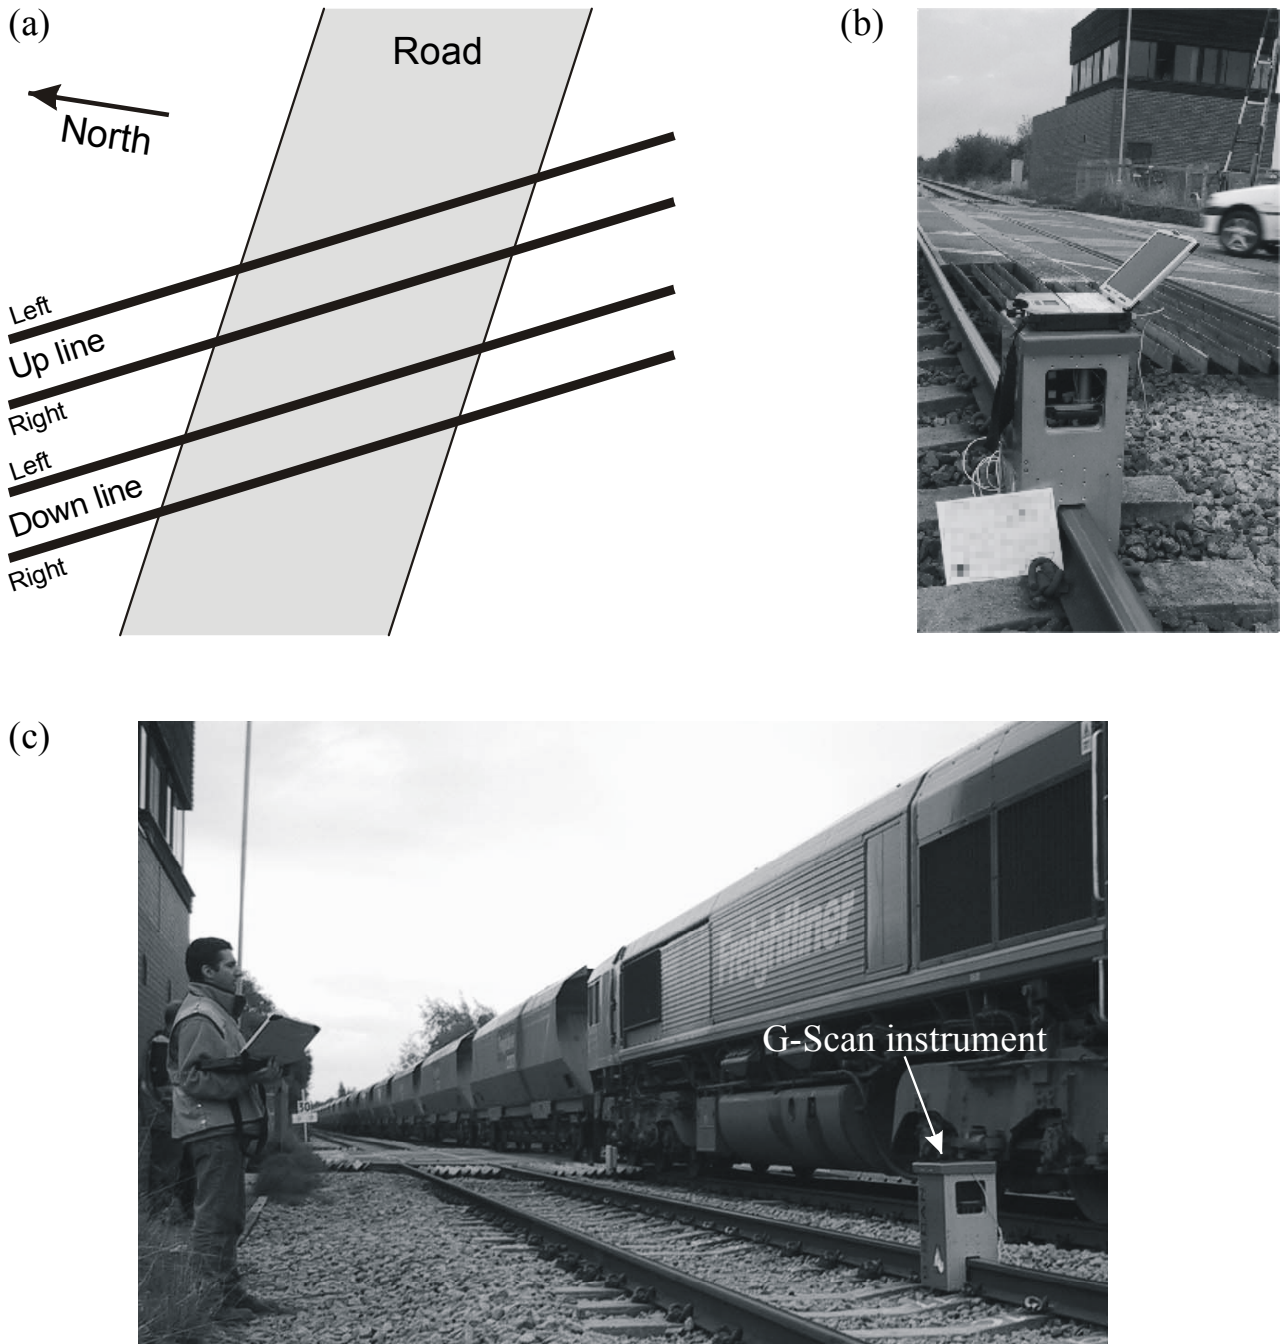
Results of Level Crossing Inspection: Level crossings present a challenge for rail inspection as access is only available to the running surface of the rail. Furthermore, the enclosed environment within the level crossing may lead to more rapid corrosion of the rail foot than that which normally occurs in free rail.

The pre-production G-Scan system has been used to inspect rail on the 'up' and 'down' lines at a Network Rail level crossing. This is part of an ongoing programme of testing to collect a large body of data on different rail conditions and to optimise the interpretation of features and presentation of results. The layout of the level crossing and the test locations are shown in Figure 3(a). Figures 3(b) and (c) show pictures of the G-Scan equipment in use at the level crossing. The tests were performed with both road and rail traffic in close proximity.

Figure 3. (a) Schematic diagram of the layout of the level crossing inspected, (b) and (c) G-Scan system in use at the level crossing.
