# MQXFA11 shipping incident report

US-HiLumi-doc-4341

Date: 08-08-2022

## US HL-LHC Accelerator Upgrade Project MQXFA11 shipping incident report

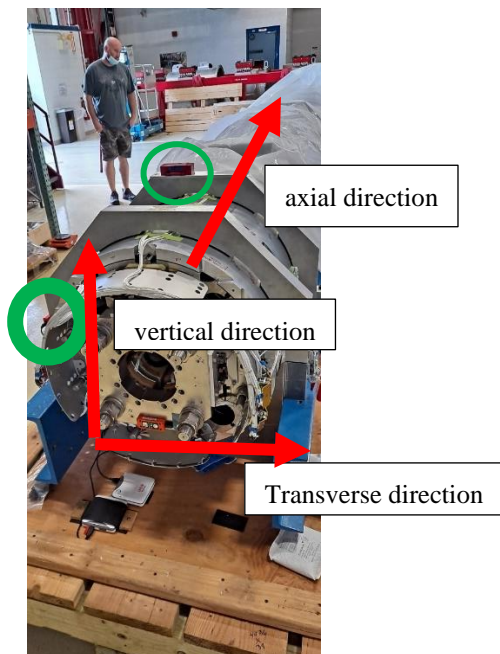
The memory of the devices on the end plate and on lead end fixture clamp was full the day before the accident, therefore only three devices were collecting data during the accident: the two GP1L devices and the slamstick on the non-lead end clamp.

The axes of the accelerometers are oriented in a different way depending on the device position. To avoid any confusion, the reader should refer to the directions defined in Fig.4. Those directions are defined for both for the GP1L and the slamstick devices.

Figure 4: Picture of the MQXFA11 magnet. The green circles identify the accelerometer positions. The red arrows indicate the shock directions used in accelerometer data analysis
