Canadian Geotechnical Journal, 13, 1, pp. 21-26, 1976-02

MUD CREEK BRIDGE FOUNDATION MOVEMENTS

Mud Creek Bridge foundation movements

M. BOZOUK

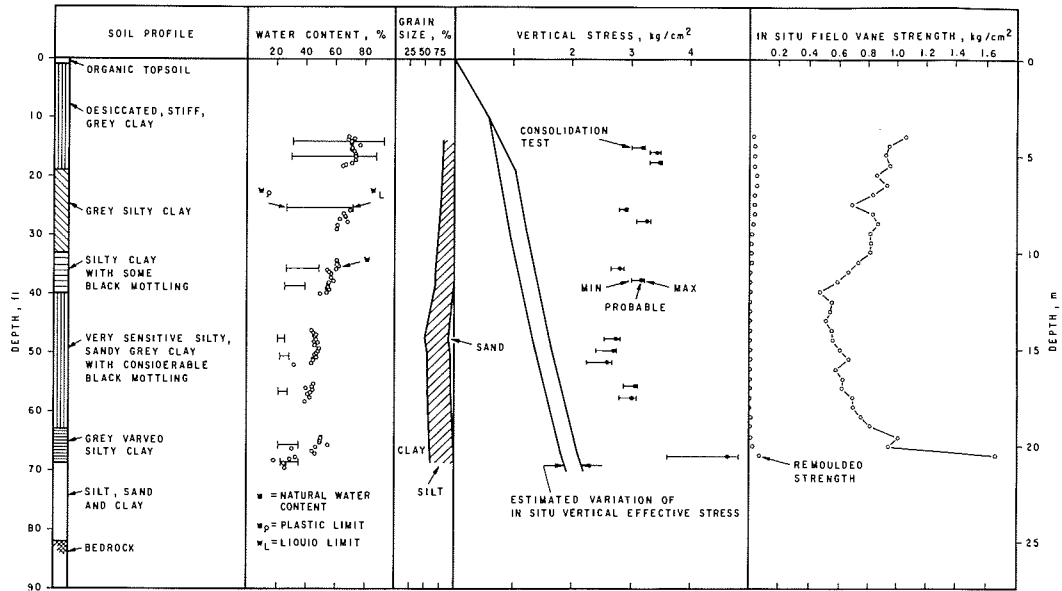
FIG. 1. Summary of soil tests near west abutment of Mud Creek Bridge.

The soil profile obtained from a test boring 400 ft (122 m) west of the west abutment is shown on Fig. 1. A desiccated stiff grey marine clay extending to a depth of 19 ft (5.8 m) is overlain by a thin organic soil. Below this is 50 ft (15.2 m) of grey silty clay, silty clay with some black mottling, very sensitive silty sandy clay with considerable black mottling, and finally grey varved silty clay. The lower 13 ft (4.0 m) is a mixture of silt, sand and clay overlying bedrock, encountered at a depth of 82 ft (25 m).

The engineering properties of the soil are given in Fig. 1. The plasticity index decreases from 60% at 15 ft (4.6 m) to 6% at 47.5 ft (14.5 m), then gradually increases to about 12% at 68.5 ft (20.9 m). The percentage clay sizes reflects this trend, decreasing from 82% at 14 ft (4.3 m) to 50% at 47.5 ft (14.5 m), then increasing to 60% at 68.5 ft (20.9 m). The natural water content of the desiccated clay is about 70%, which is less than the liquid limit. Below 35 ft (10.7 m) it is less than 60%,

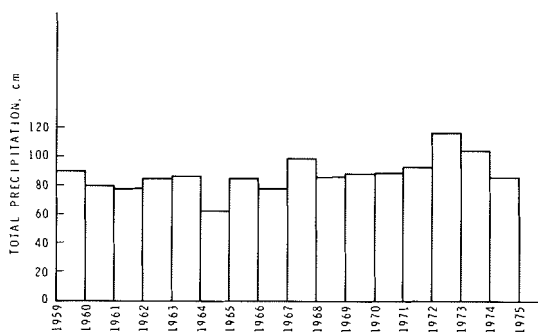
1975 is shown on Fig. 4. If this rate of convergence continued, the 13.77 cm of original clearance between finger plates would disappear in 40 to 50 years. The movements, however, are not regular with time. Comparing this figure with the total annual precipitation record in Fig. 5 (obtained from the weather station at the Ottawa International Airport, 8 mi (13 km) southwest of Mud Creek Bridge) showed that the larger movements occurred during periods of high precipitation. Prolonged periods of abnormally high precipitation could therefore accelerate the closure of the expansion joints. A wet period also precipitated the landslide that occurred in the west slope of the creek, north of the bridge, in the spring of 1973.

FIG. 5. Total annual precipitation at Ottawa International Airport, 8 mi (13 km) southwest of Mud Creek Bridge.
