Nondestructive Evaluation (NDE) of Composite-to-Metal Bond Interface of a Wind
Turbine Blade Using An Acousto-Ultrasonic Technique.

John H. Gieske and Mark A Rumsey
Sandia National Laboratories
Albuquerque, New Mexico 87185

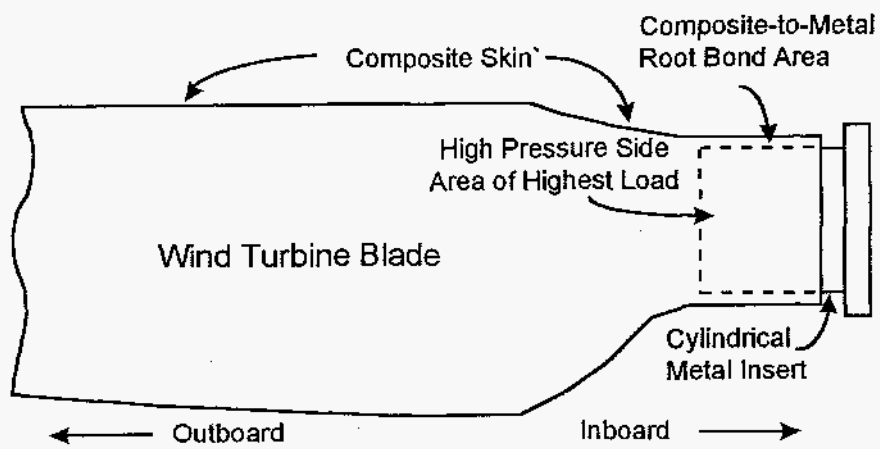
Figure 1. A schematic view of the root bond area at the cylindrical steel insert end of a wind turbine blade.

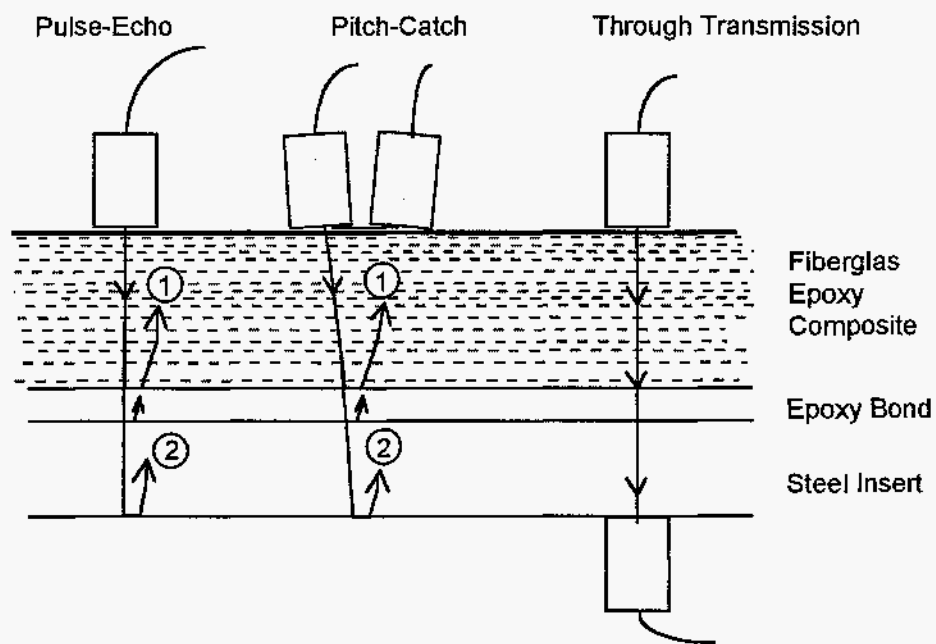
Pulse-echo and pitch-catch techniques were investigated with limited success. Clear back-surface echoes from the bond interface ① as shown in Figure 2 or from the back-surface of the steel insert at ② were not distinct from all the echoes generated from the multiple interfaces of the composite. In general, ambiguous results were obtained with the pulse-echo and pitch-catch techniques. However, a through transmission (TT) technique proved to show unambiguous results where areas of disbonds, delaminations, and voids could be mapped out and detected with certainty.

Figure 2. Ultrasonic transducer arraignment for pulse-echo, pitch-catch, and through transmission techniques.

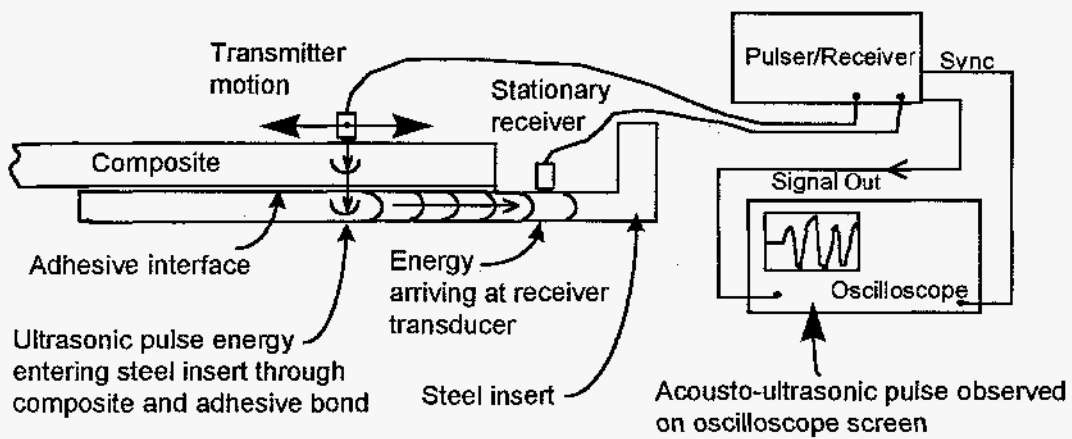
The AU technique developed is illustrated in Figure 4 where contact transmitter and receiver ultrasonic transducers are used at the OD surface of the turbine blade. The receiver transducer is attached to the OD surface of the steel insert inboard of the fiberglass composite. As illustrated in Figure 4, the ultrasonic pulse generated by the transmitter enters the composite, travels through the composite thickness, and then enters the steel insert where it propagates down the insert and finally arrives at the receiver transducer. The first arrival of the pulse at the receiver is most sensitive to the energy entering the steel insert directly below the transmitter since the acoustic wave velocity in the steel is faster than that in the composite and very little energy is lost in the steel.

Figure 4. Schematic diagram of the acousto-ultrasonic technique as applied to the root bond area at the steel insert of a wind turbine blade.

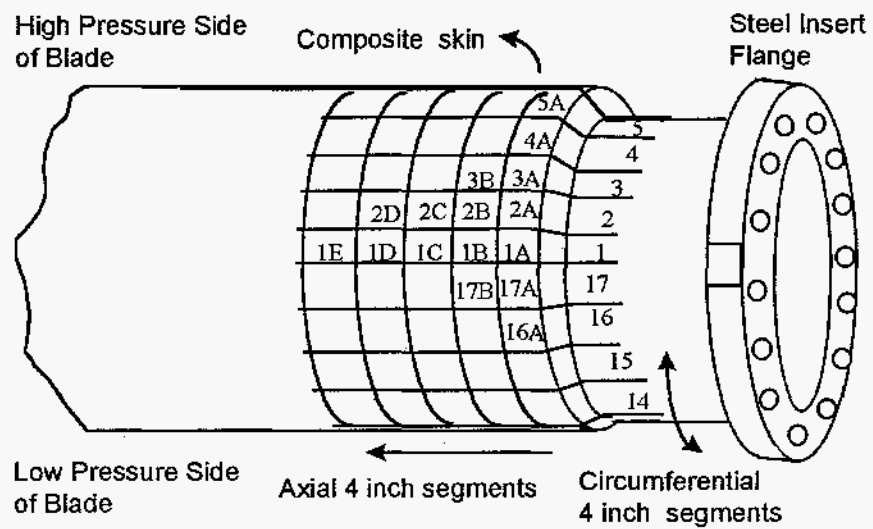
The first AU examination was performed on a wind turbine blade while it was attached to the fixture of a fatigue tester. The blade had undergone a number of high load fatigue cycles at the time of the AU examination. The AU amplitude data was taken by moving the transmitter point by point by hand along a grid line in the axial direction at one-inch increments while the receiver was stationary at the bottom of the grid line as shown in Figure 4. In a similar manner, axial AU amplitude data was taken at grid lines separated by 2 inch intervals in the circumferential direction until the entire area of the insert was examined.

Figure 5. Diagram of the layout of the grid lines scribed on the wind turbine blade at the root bond area of the steel insert.
