Published on: 01 Dec 2014 - Progress in Photovoltaics (John Wiley & Sons, Ltd)

Observed degradation in photovoltaic plants affected by hot-spots

Miguel García , Luis Marroyo , Eduardo Lorenzo , Javier Marcos and Miguel Pérez

ABSTRACT

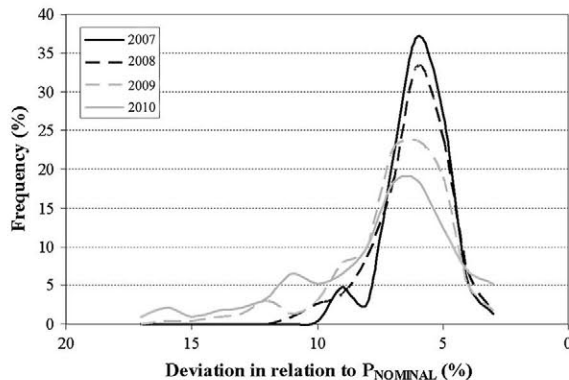
During the first year of operation, all the PV generators had an STC power of more than 90% of the nominal value. However, from 2008 onwards, a number of generators had power outputs of less than 90% of the nominal value. In 2009, the drop in production (i.e., in the STC power output) for the aforementioned generators became more pronounced and other cases also appeared. At the same time, a significant number of blackened points in the TEDLAR were observed on these PV generators, clearly due to a localized heating phenomenon. The presence of those blackened points appeared to be directly related to this lower power output (Figure 2).

Figure 1. PV generator STC power histograms for the plant from 2007 to 2010. The STC power is expressed as a deviation from its nominal value.

In 2010, the problem grew to become more serious, with more than 17% of the generators with STC power outputs of below 90% of their nominal value. However, the module manufacturer, aware of the problem, replaced the affected modules. This explains the increase in the number of generators with an STC power output of over 95% of the nominal value in 2010, as shown in Figure 1.

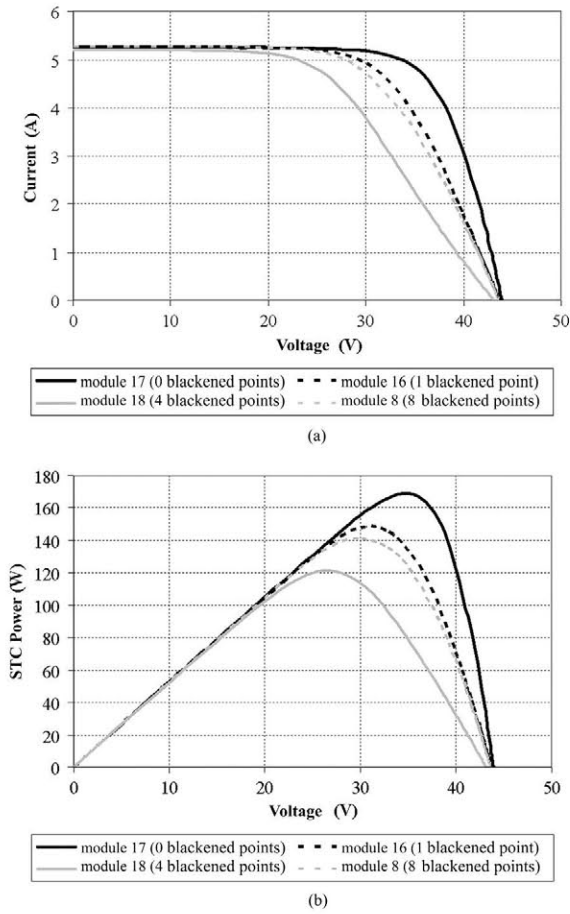
Figure 6. (a) I-V curve and (b) P-V curves, in STC for four modules of a generator severely affected by localized heatings.

conditions (STC). There was no sign of localized heatings in one of the modules, whereas it was possible to observe 1, 4 and 8 blackened points in the TEDLAR respectively, in the other three.

Figure 6 illustrates how the presence of those localized heatings has the same effect on the I-V curve as a resistor connected in series with the module. Furthermore, the impact of the localized heating is not only dependent on quantity but also on the state of degradation and on whether the localized heatings are on the same block or on different blocks. For instance, although module 18 shows fewer blackened points in the TEDLAR than module 8, it actually has a greater effect on the pressure-volume curve.

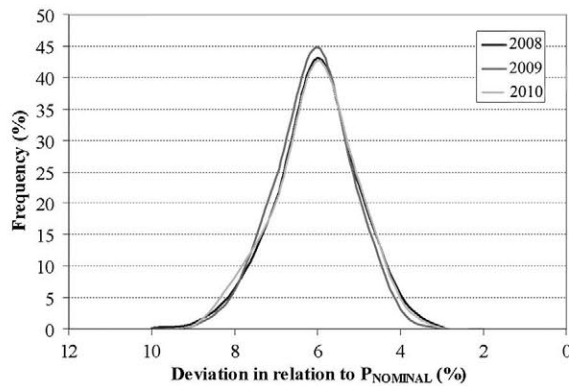
Figure 10. Histogram of the STC power for the PV generators from 2008 to 2010. The STC power is expressed at a deviation in relation to the nominal value (as a %).

histogram of the generator STC power from 2008 to 2010. The power was calculated in the same way as for the PV plant described earlier [12]. As the power outputs approximately fitted a normal distribution, there did not appear to be any trackers with an unusually low power output

The power histogram in Figure 10 shows that there is little variation in the generator STC power over the 3 years studied. This appears to indicate that the hot cell phenomenon stabilized during the first year of plant operation. Based on the thermal imaging inspection carried out in 2010, amongst other things, it was possible to determine that the total number of modules affected was 1259; 5.7% of the total number of modules installed. No new hot cells were detected over the following year, confirming the fact that there was no discernible degradation over time. However, as in the case of the other plant, it was not possible to continue the degradation study once the manufacturer had replaced the defective modules.

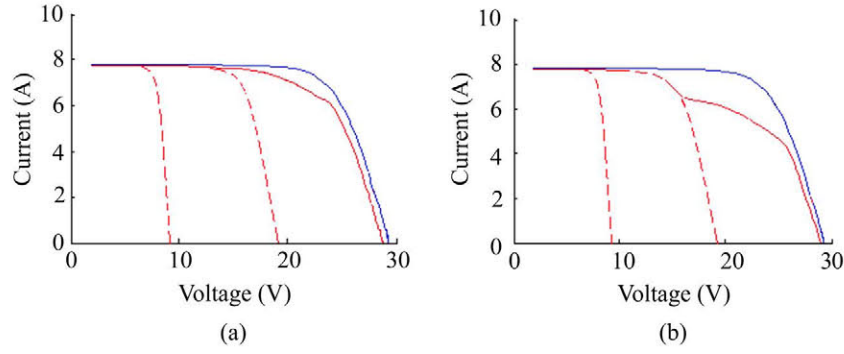
The effects of the cracked cells on the PV module electrical performance are only evident when the cracks lead to isolated cell areas [18]. Figure 12a and b show the I–V curves for two of the defective modules (red). In this case, the modules comprise three blocks. The dashed lines in Figure 12 correspond to the imaginary lines obtained by dividing the modules into blocks. Both modules had two sound blocks and one block with hot cells. Alongside these curves, the I–V curve (blue) of a sound module has also been plotted.

Figure 12. I-V curves of two modules with hot cells (red) and the curve of a sound module (blue).

Modules with hot cells, as plotted in Figure 12, show I-V curves similar to those of partially shaded modules. Several of the thermal images showed many hot cells to have some areas that were noticeably colder, corresponding to areas that were completely isolated from the rest of the cell. Depending on the size of the isolated area, the curve step (i.e. the severity of the defect) would be either larger or smaller, explaining the differences between Figure 12a and b.

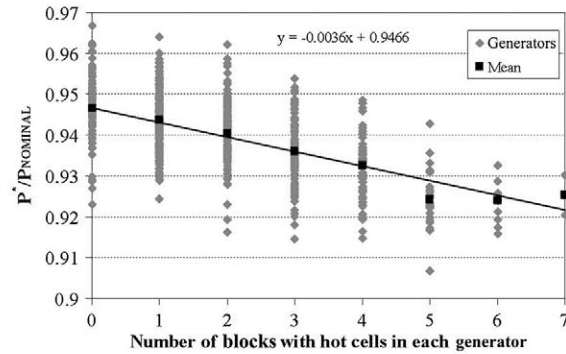
Figure 13. Generator STC power (related to the nominal value) versus number of blocks with hot cells. The black dots mark the mean power of generators with the same number of blocks with hot cells. The black line shows their linear fitting.

There is an evident correlation between the generator STC power and the number of blocks with hot cells. Each block with hot cells represents a mean decrease in generator power of 0.36%.

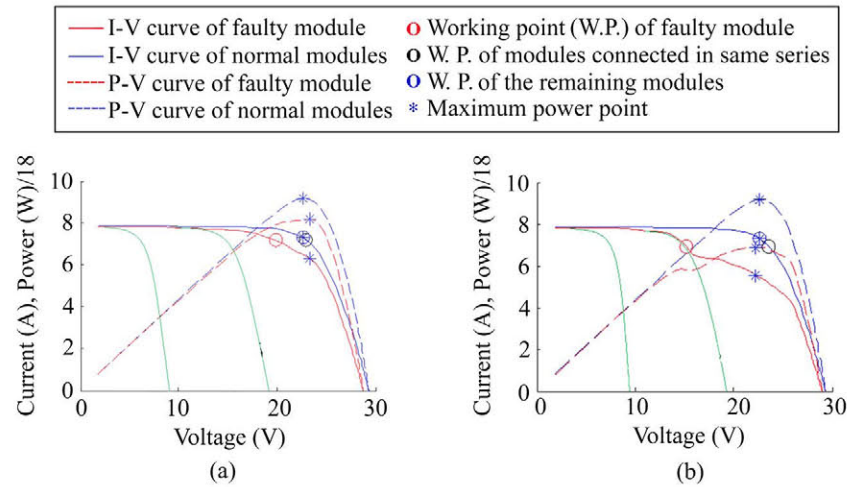
Figure 14. V-I curves, maximum power point and operating point for the PV modules making up the simulated generator: (a) Module with a slight defect and (b) Module with a major defect.

the case shown in Figure 14b, the defect in the faulty module forces the corresponding bypass diode to conduct, whereas the defect in the faulty module of Figure 14a is not severe enough to force the bypass diode to do so. Such behavior was experimentally verified, as shown in Figure 15. It is easy to understand that the maximum power loss caused by a cracked cell corresponds to the power of a whole block (when the diode is forced to conduct) plus the mismatch losses caused to the rest of the blocks. It is thus of interest to determine how often a cracked cell causes the corresponding bypass diode to conduct.

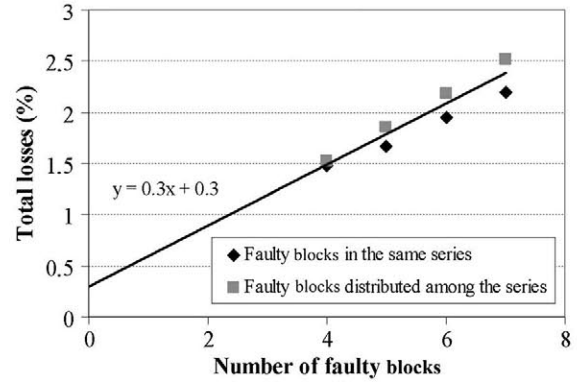
The energy loss of an entire block, as the diode starts to conduct, is 0.83% (1/120 total number of blocks in a PV generator). Adding approximately 0.3% for mismatch losses in the remaining blocks, the total power loss is 1.2% per block with cracked cells. On the other hand, simulation results (Figure 16) revealed that a defective block, with a slight defect (similar to that shown in Figure 12a) approximately involves a mean energy loss of 0.3%. However, the field measurements shown in Figure 14 suggest that each defective block has an average effect on the power loss of 0.36%. This value is much closer to the loss

Figure 16. Total energy losses in a PV generator in relation to the number and position of the faulty blocks.

caused by a slight defect (0.3%) than the power loss produced when a bypass diode conducts (1.2%). Therefore, it seems likely that in most cases, the bypass diodes do not conduct.

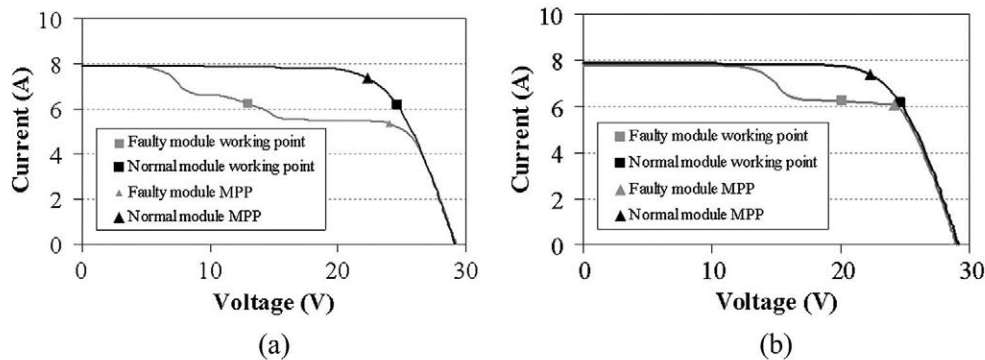
Figure 15. I-V curves and operating points measured in the field: (a) sound module and module with two blocks affected by hot cells and (b) sound module and module with one block affected by hot cells. The maximum power points are also indicated for each curve.
