Performance analysis of a 7-kW crystalline silicon generator after 17 years of operation in Madrid

Eduardo Lorenzo , Roberto Zilles , Rodrigo Moretón , Trinidad Gómez and Ainhoa Martínez de Olcoz

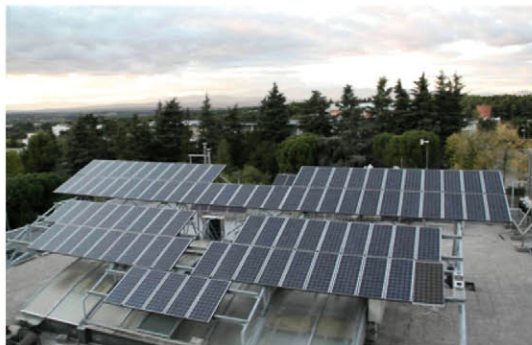
(a)

During the first 13 years of exposure to the elements, the only visual symptom of degradation appeared in the terminal boxes. In fact, although these boxes are IP65, they are not specifically designed for PV modules but for general electric installation purposes and they include several lateral holes with their corresponding cable grips. The degradation appeared in the form of cracks at these cable grips (Figure 2). However, it should be mentioned, on the one hand, that these pieces can be easily substituted by new ones and, on the other hand, that this kind of terminal box is not used any more in the PV industry, so that further in-depth comments are not required here.

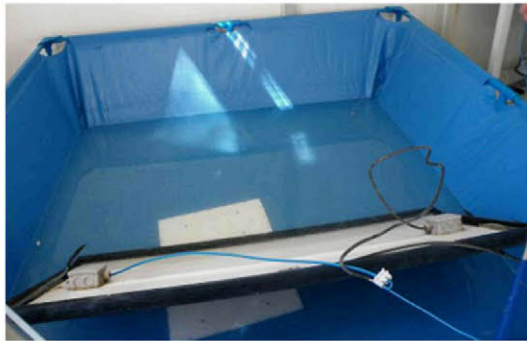
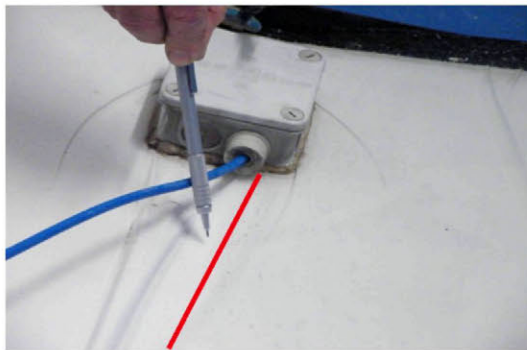
high-grade backsheet delamination to the dielectric withstanding test and to the wet leakage test described in the IEC 61215. Applied voltages have been 1216 and 500 V, respectively. For both tests, the acceptance criterion [11] is that the product of the resulting insulation resistance, R_{ISO} , and the PV module surface, S , must be equal to or larger than $40 \text{ M}\Omega \cdot \text{m}^2$ or $\text{M}\Omega \cdot \text{m}^2$. Because $S = 0.7965 \text{ m}^2$, it means R_{ISO} must be larger than $50.2 \text{ M}\Omega$. Figure 10 shows the details of the leakage wet test. Table III shows the tests results. All the modules widely succeeded in passing the tests.

Figure 10. Wet leakage test. (a) Positive and negative poles are short-circuited. The photovoltaic module is then submerged up to the terminal boxes in a water solution with $656\ \Omega\text{-cm}$ or Ωcm resistivity, and voltage is applied between the poles and the frame. (b) Detail of the partial submersion: the line indicates the liquid level. The non-submersed part of the module is sprayed with the same water solution.
