## **Performance of posttensioned seismic retrofit of two stone masonry buildings during the Canterbury earthquakes**

### **Abstract**

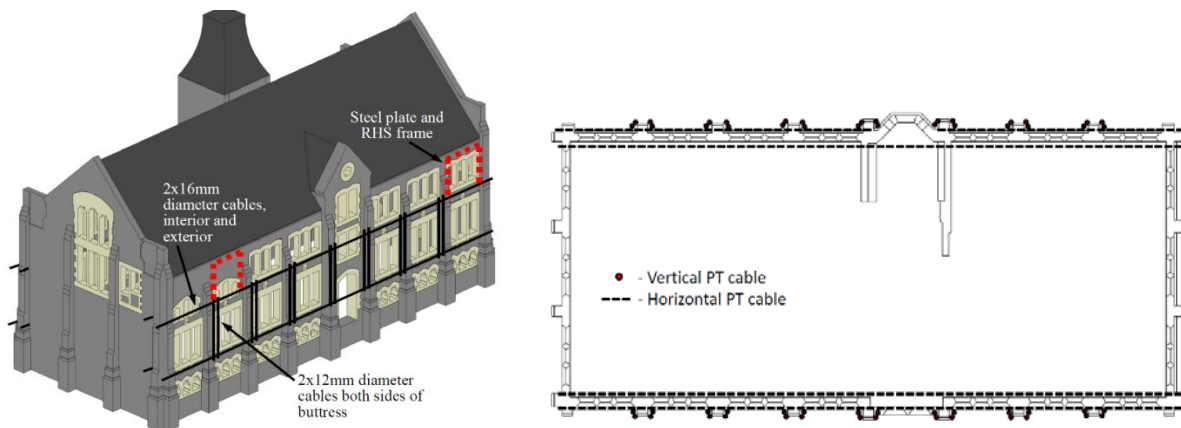
Figure 3: Chemistry building

The retrofit to the Chemistry building (as shown in Figure 3) was part of a strengthening scheme that also involved diaphragm strengthening and steel frames being applied to the attic level (see Figure 4, also, illustrated by dotted lines in Figure 3a). Vertically oriented posttension tendons were installed on the ground level along the north and south facades. These tendons were located in pairs on either side of the buttresses and were anchored into the concrete slab above the basement, stretching up to the bottom of the top level of the building (Figure 4). In total, seven pairs of vertically oriented tendons were installed on both the north and south faces. Horizontally oriented posttension tendons were also applied on the north and south faces of the building, and were paired with a companion tendon running parallel on the inside of the wall in order to enhance a frame-type action of building response. Two pairs of horizontally oriented tendons were applied to the north and south faces, one at the base of the ground level and one at the base of the first floor level.

(a) Isometric view of the building showing the location and the extent of the retrofit  
 (b) Floor plan of the building showing the location and the extent of the retrofit

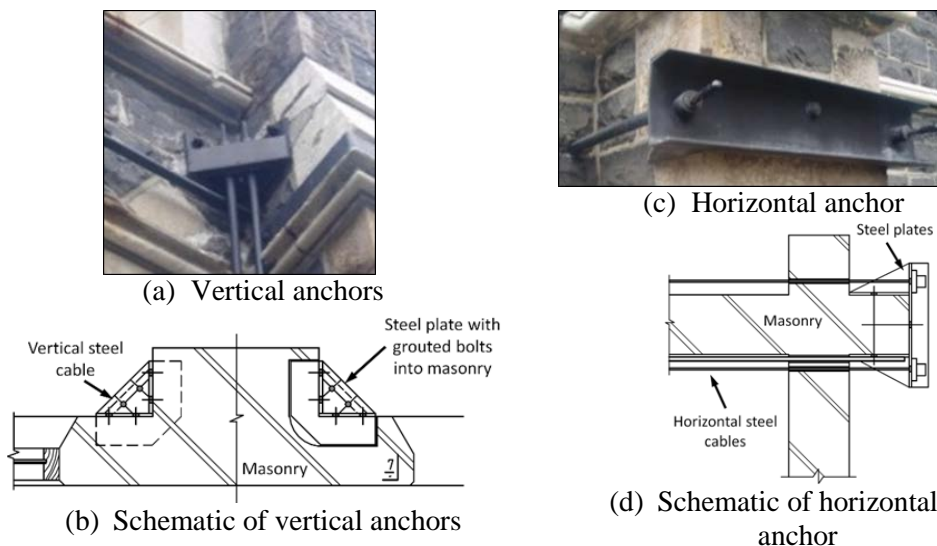
Figure 4: Posttensioned seismic retrofit of the Chemistry building

(a) Vertical anchors  
 (b) Schematic of vertical anchors  
 (c) Horizontal anchor  
 (d) Schematic of horizontal anchor

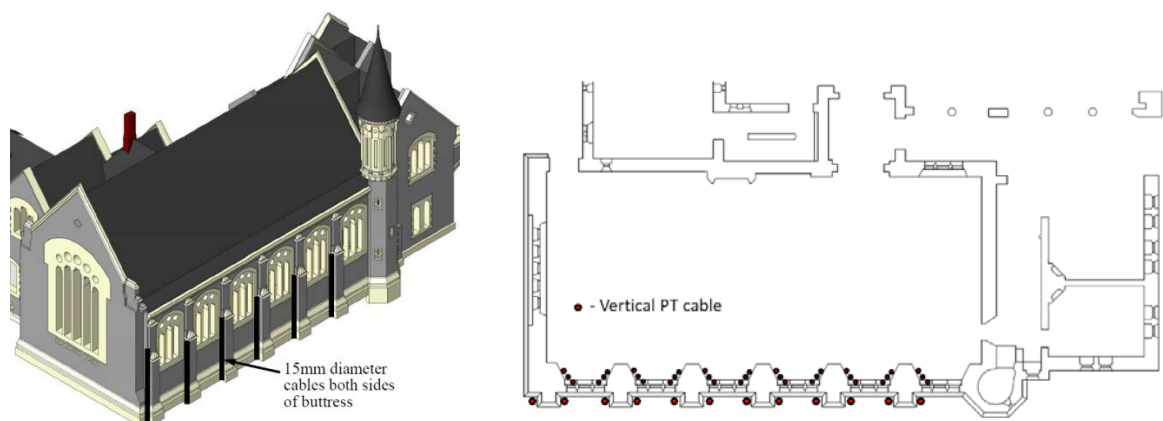
Figure 5: College Hall building

The College Hall posttensioned seismic retrofit was applied to the west side of the building (Figure 5 and 6) and was completed in conjunction with window frame strengthening and widening of the foundations for stability once the posttensioning was applied. The exterior posttension tendons extended from the new foundations to wall mid-height, while the interior posttension tendons extended from the foundation to the roof truss (see Figure 6). The exterior tendons were located in pairs on either side of the buttresses, while the internal tendons were in groups of three, again located on the internal side of each buttress as indicated in Figure 5b. The posttensioned retrofit was applied to compensate for the ineffectiveness of the roof diaphragm in the east/west direction. Therefore the walls were designed as cantilevers and during the retrofit grout was pumped into the drilled holes around the piers in order to fill any voids within the piers.

(a) Isometric view of the building showing the location and the extent of the retrofit

(b) Floor plan of the building showing the location and the extent of the retrofit
