Rapid Assessment of Buildings Affected by Earthquake: Case Study in Pidie Jaya, Aceh, Indonesia

Aldrin Febriansyah^{1*}, Rianto², Ari Kusuma Wardana², Ekha Rifki Fauzi³

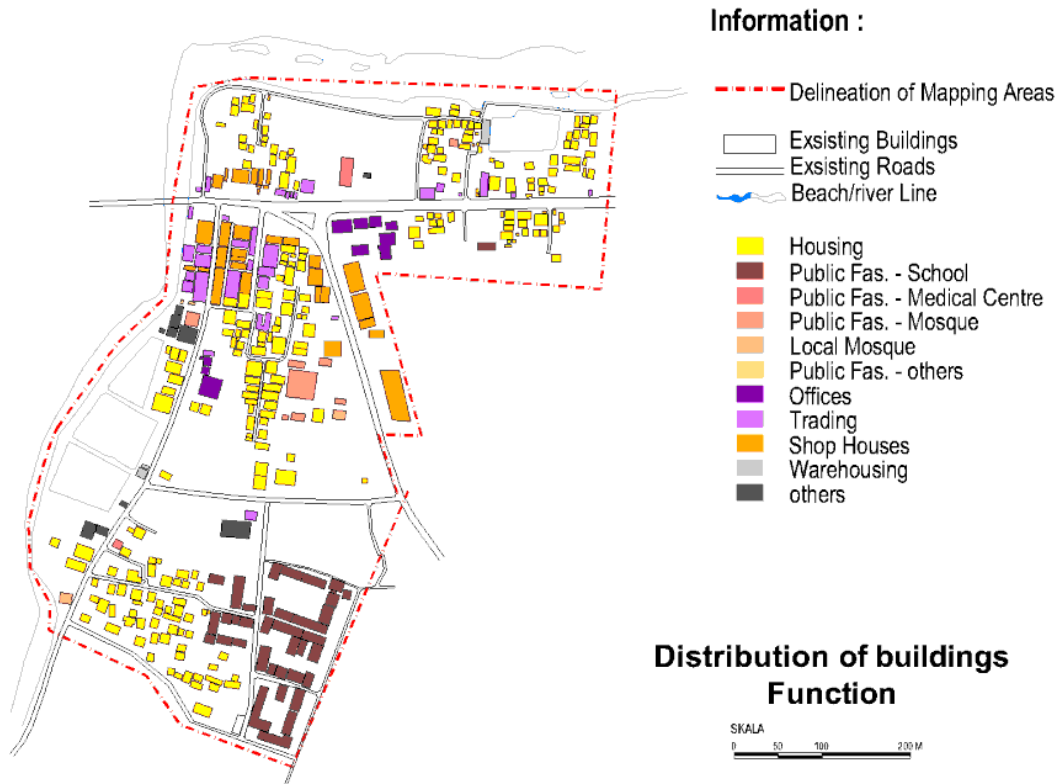
Figure 4. Buildings Function

In the picture above, it appears that the building functions analyzed in the area are mostly settlements. Then, function building public facilities such as schools, commercial and shophouses, and worship buildings [25].

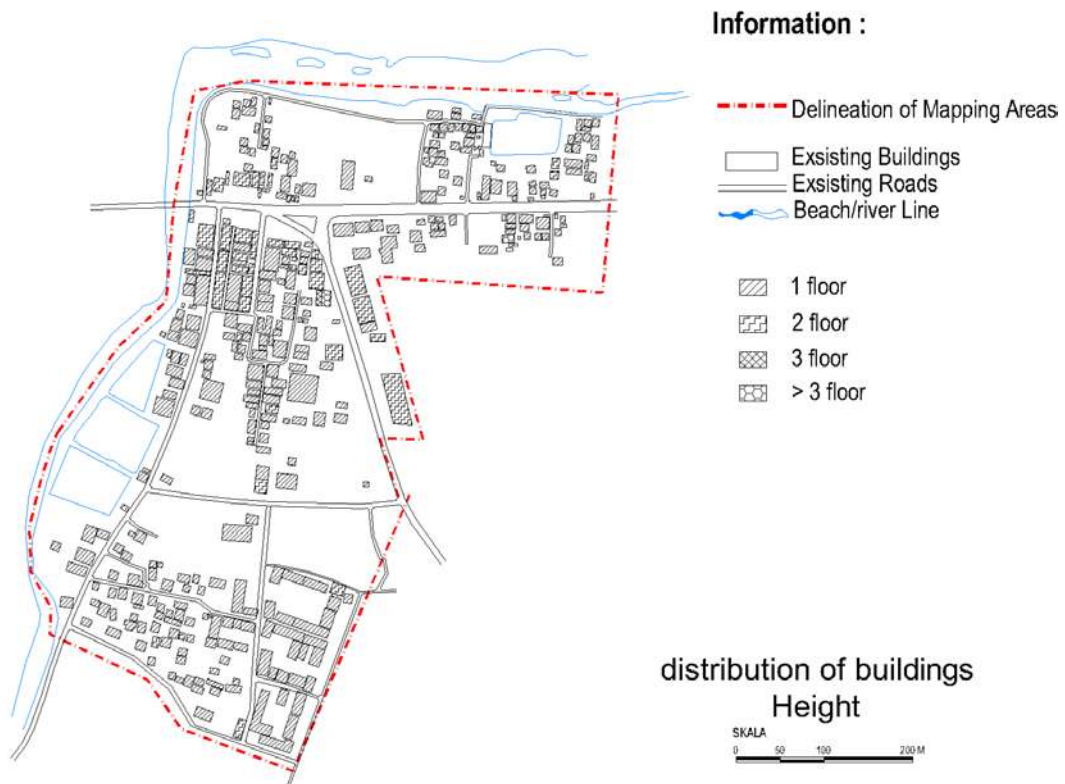
Figure 5. Buildings Height

The picture above maps the height of the building in the area. Most are 1-story buildings for settlements, and the rest are shop houses and trade or office buildings. The maximum height is three floors, and only 1 and 2 buildings are owned [24], [26], [27].

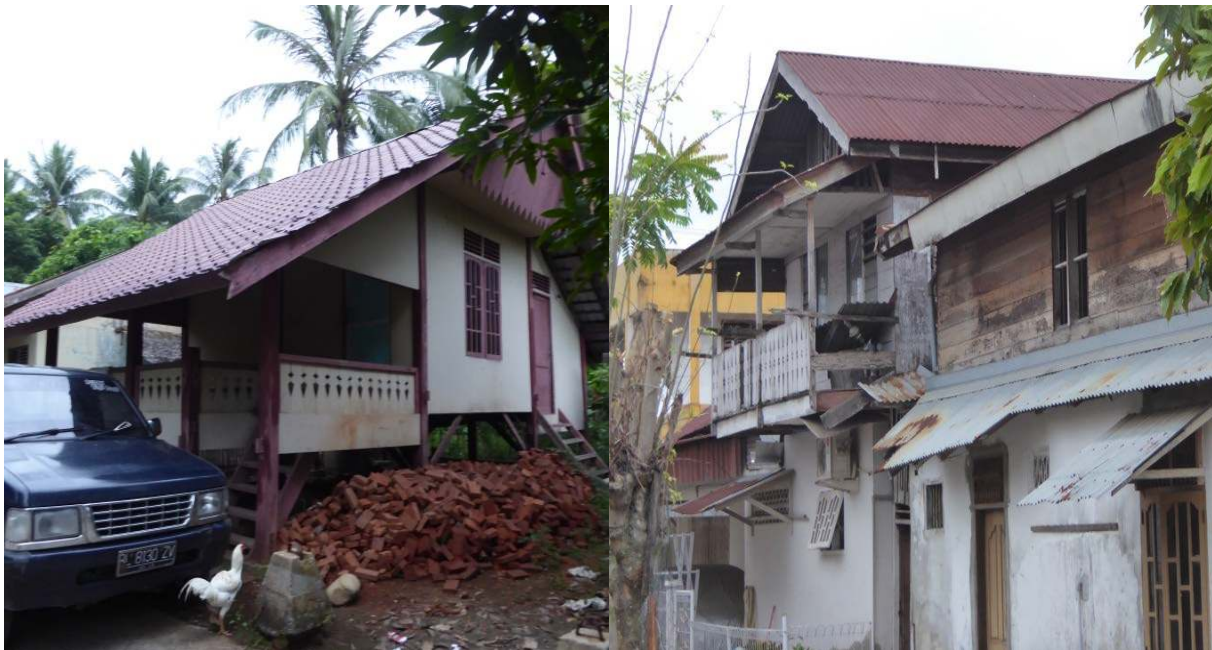
Figure 8. Heritage buildings

The picture above is a mapping of heritage buildings with age above 50 years. It found that the earthquake did not damage heritage buildings with traditional structures (wood and bamboo). Those 9 (nine) heritage building is a one-story residential building. This finding is a further question of why buildings with traditional structures can withstand the earthquake [22], [31].
