## Repair evaluation of concrete cracks using surface and through-transmission wave measurements

D.G. Aggelis, T. Shiotani \*

*Research Institute of Technology, Tobishima Corporation, 5472 Kimagase, Noda, Chiba 270-0222, Japan*

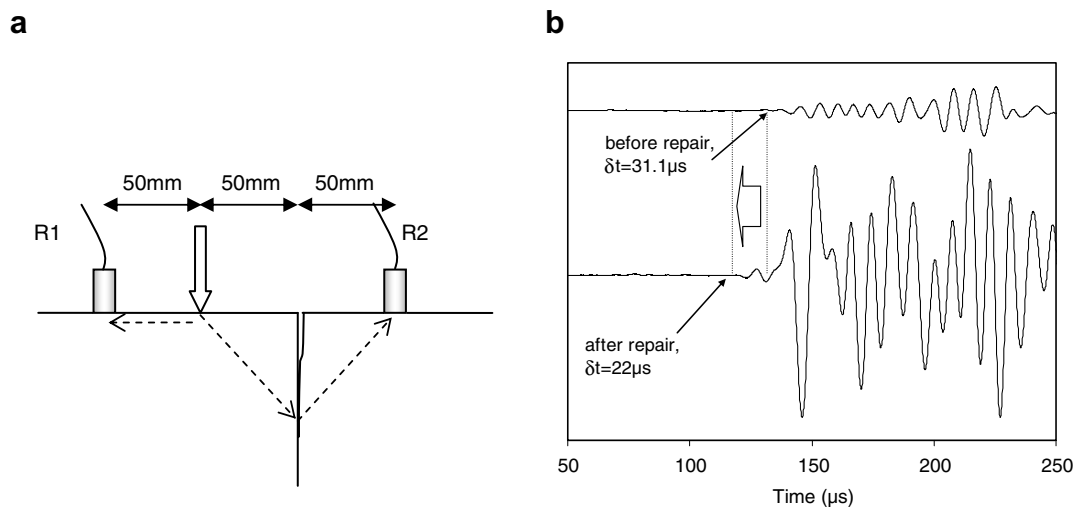
see Fig. 4a. This configuration was used (similar as in [6]) in order to estimate the difference between cracked and repaired state. The transit time of the signal, see Fig. 4b for the case before repair, corresponds to the depth of 59.5 mm, although the metal reinforcement depth is 45 mm. Therefore, it is possible that the actual onset of the diffracted wave through the rebar was weak enough and not detectable. After the impregnation with epoxy, similar measurement led to the waveform that can also be seen in Fig. 4b. An increase of energy is expected [28] since stress waves pass also through the zone provided by the repair agent. Apart from the apparently higher energy transmitted, the onset is much earlier, corresponding to a crack depth of 23 mm. However, an empty portion of that size and at that point is not likely, since the injection was conducted by the same surface that also the wave measurements were conducted. This result should be attributed to the fracture process zone that affects the longitudinal as well as the Rayleigh waves and is discussed in the next section. Anyway, it was obvious in the specific case that using the conventional one-sided ultrasonic measurement of the diffracted wave, crack properties could not be evaluated.

Fig. 4. (a) Schematic representation of one-sided crack depth measurements and (b) waveforms of the receiver after the crack (R2).

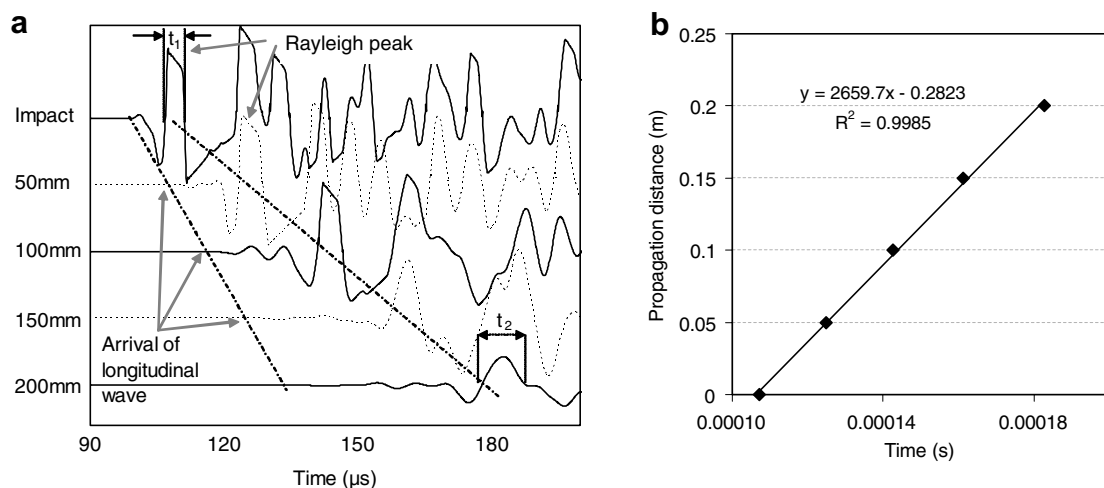
was first conducted on sound material. In Fig. 5a the response at different distances from the excitation can be seen. Near the impact, the amplitude is too strong and therefore is saturated; however this does not cause considerable experimental scatter in the determination of the peak time as will be seen in Fig. 5b. The Rayleigh wave is generally easily detectable since it corresponds to a strong peak following the first arrival of the longitudinal wave which is of certainly lower amplitude [6,29]. Plotting the arrival time of the peak with respect to distance, as seen in Fig. 5b, yields the propagation velocity which is the slope of the line. Since the material is sound with no defects, there is no variation in the Rayleigh velocity and according to the distance, the peaks' arrivals is strongly correlated with the time. The high Rayleigh velocity of about 2660 m/s is indicative of the sound internal condition of the material that has not yet suffered any deterioration. Indeed, the P-wave velocity was measured at around

Fig. 5. (a) Waveforms of surface measurements at different propagation distances for sound concrete and (b) correlation plot of distance to Rayleigh peak arrival time.

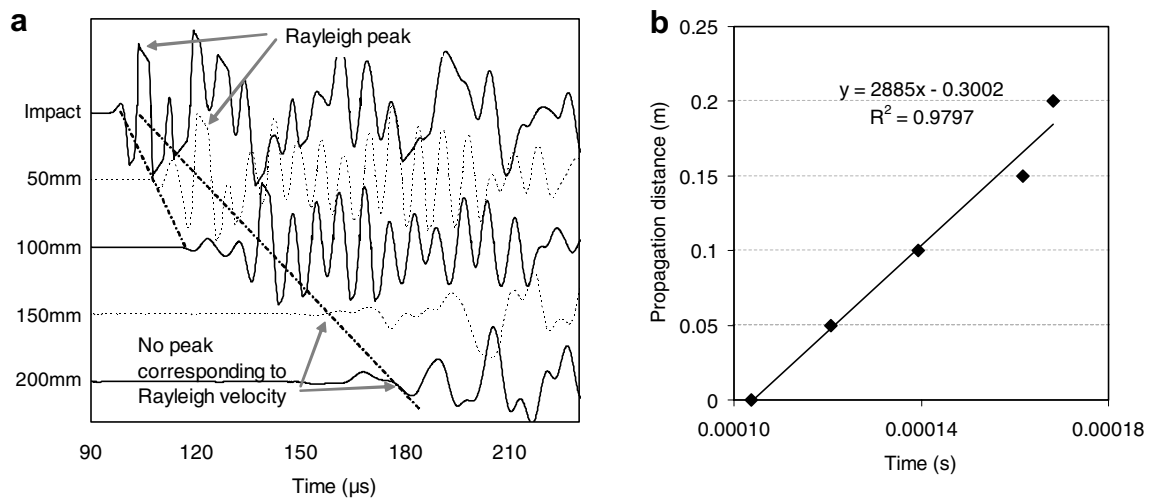
When the same sensor configuration was used to measure a portion containing a crack, different trends were observed, as shown in Fig. 6. The first three waveforms, collected before the crack, are quite clear, while after the crack the waveforms are hardly visible. This shows that a very small part of energy is transmitted through the crack. In Fig. 7a the same waveforms are depicted, with the two waveforms after the crack magnified by a factor of 20. It is obvious that no peak corresponds to the Rayleigh velocity of the material. Plotting the arrival time vs distance using the peaks closest to the expected time for the two last waveforms, results in weaker correlation as seen in Fig. 7b. Therefore, it seems that the Rayleigh wave does not survive after the crack, due to the discontinuity.

Fig. 7. (a) Waveforms of Fig. 6 (these corresponding to 150 mm and 200 mm are magnified by 20) and (b) correlation plot of distance to Rayleigh peak arrival time.

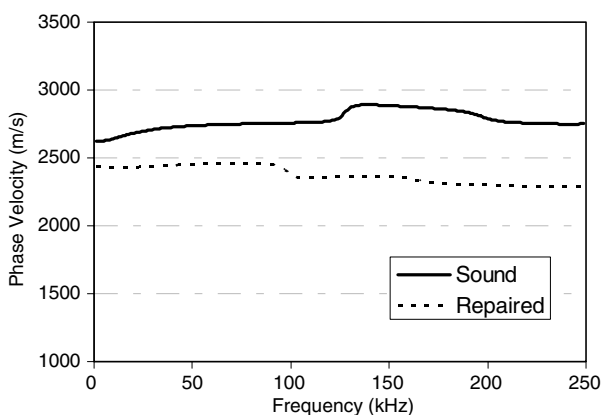
Fig. 9. Concrete phase velocity of Rayleigh waves vs frequency.

length. In this case, it seems reasonable that all the frequencies are delayed (lower curve for “repaired”) due to the presence of the epoxy through the whole thickness of the deck. Therefore, horizontal propagation of Rayleigh waves on shallow as well as larger depths is influenced by the same vertical layer of the lower mechanical properties of the epoxy and are therefore delayed in a similar way. However, a higher discrepancy of the curves above 100 kHz can be noticed and it will be explored later in the analysis.

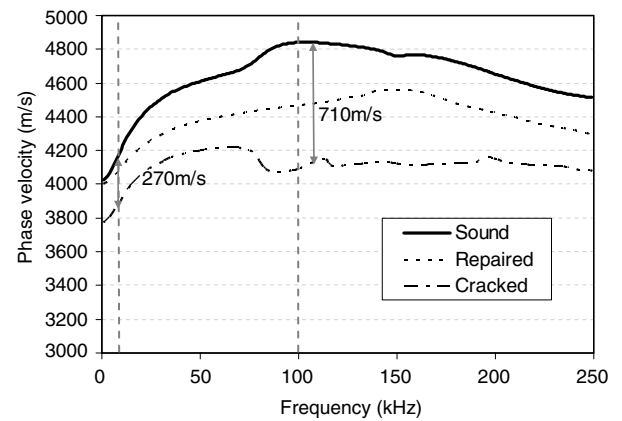
Fig. 12. Concrete phase velocity of longitudinal waves vs frequency.

velocities are depicted in Fig. 12. The specific curves are calculated from diagonal paths; 6–5, as seen in Fig. 2 for the cases of: sound material, path containing a crack and the same path after filling with epoxy. It is seen, similarly to the Rayleigh wave curves, that the velocity of sound material increases with frequency up to 100 kHz, while the cracked path results in much lower curve. Low frequencies around 10 kHz exhibit phase velocity of 3800 m/s, 270 m/s lower than the intact state. Correspondingly, frequencies at the vicinity of 100 kHz, present even greater discrepancy of more than 700 m/s (4100 for cracked and 4800 m/s for intact). The velocity of the repaired material is in any case in between. Since the velocity differences between the cracked, the repaired and the sound situation are not the same for each frequency component but seem to be highlighted for frequencies around 100 kHz, it was assumed reasonable to repeat the tomography procedure using velocities of different frequencies. Therefore, for all different wave paths (total number 50) between each impact point and receiver, the corresponding dispersion curve was calculated. Then for any selected frequency the corresponding phase velocity of all the wave paths was picked and fed to the tomography software. Herein, two indicative cases are discussed corresponding to lower and higher frequency bands acquired, namely 10 kHz and 100 kHz as seen in Fig. 12. In Fig. 13a and b one can observe the tomogram of the region of interest before and after the impregnation for 10 kHz, while Fig. 13c and d concern the case of 100 kHz. The frequency of 10 kHz corresponds to the low frequency limit of the acquisition setup and therefore, tomograms of lower frequencies are not presented although they can be obtained. On the other hand, after propagation through the deck of 419 mm the signal did not contain enough energy content above 100 kHz, therefore the use of higher frequency for tomography would result in questionable reliability. For both frequencies the repair effect is obvious, elevating the average velocity of the cells by 300 m/s for the case of 10 kHz and by about 450 m/s for 100 kHz. The areas showing the defect are substantially eliminated in both cases. However, the tomogram of 100 kHz seems more accurate concerning the location of

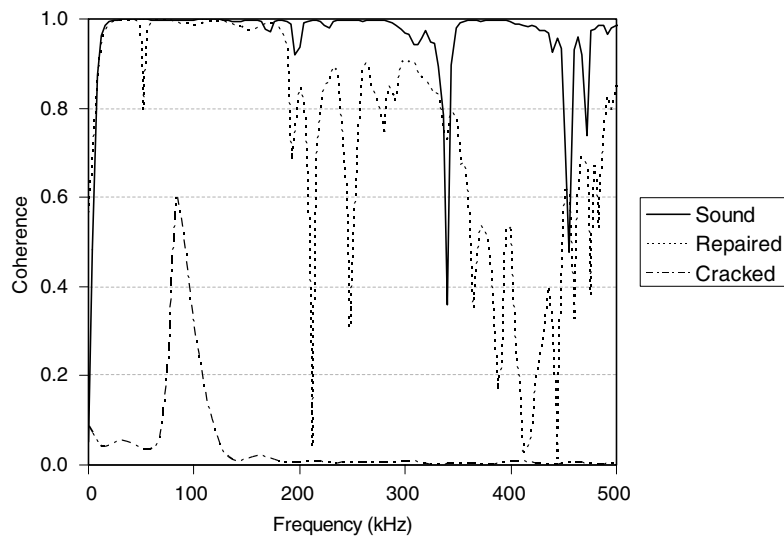
Fig. 14. Coherence function between signals collected at different states of concrete.

is observed up to 200 kHz. It is interesting to see that for the case of cracked material, due to the large thickness of the crack, the signal seems so distorted that the coherence function exhibits very low values for the entire range although there was no source of external noise.

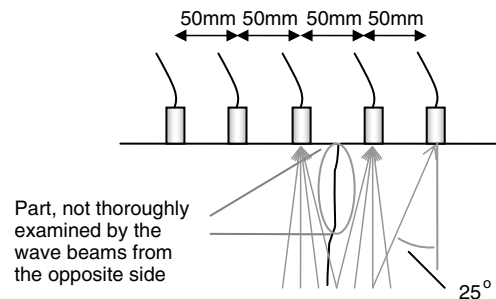
Fig. 15. Detail about interaction of wave beams with the near surface part of the crack.

demonstrated that at least a large portion of the surface layer of 35–40 mm was successfully filled, allowing the propagation of energy in the form of surface waves. In a big concrete structure this information obtained relatively easy and fast is considered adequate, although further detail should be desirable through more accurate correlations between the amplitude and frequency of the Rayleigh wave and the crack depth filled with epoxy. This would be of more importance in case there is no access to both sides. At that point the amplitude or frequency content of the Rayleigh waves should be used for the characterization of the crack from one side. Such correlations have been studied for metals [20] but for concrete there is still limited work [19,22]. Further investigation concerning the accurate characterization of the crack depth and degree of filling is currently undertaken by the authors combining numerical parametric study with experimental results of surface measurements on concrete material.
