# Report on the Loss of the Mars Polar Lander and Deep Space 2 Missions

JPL Special Review Board

22 March 2000

JPL D-18709

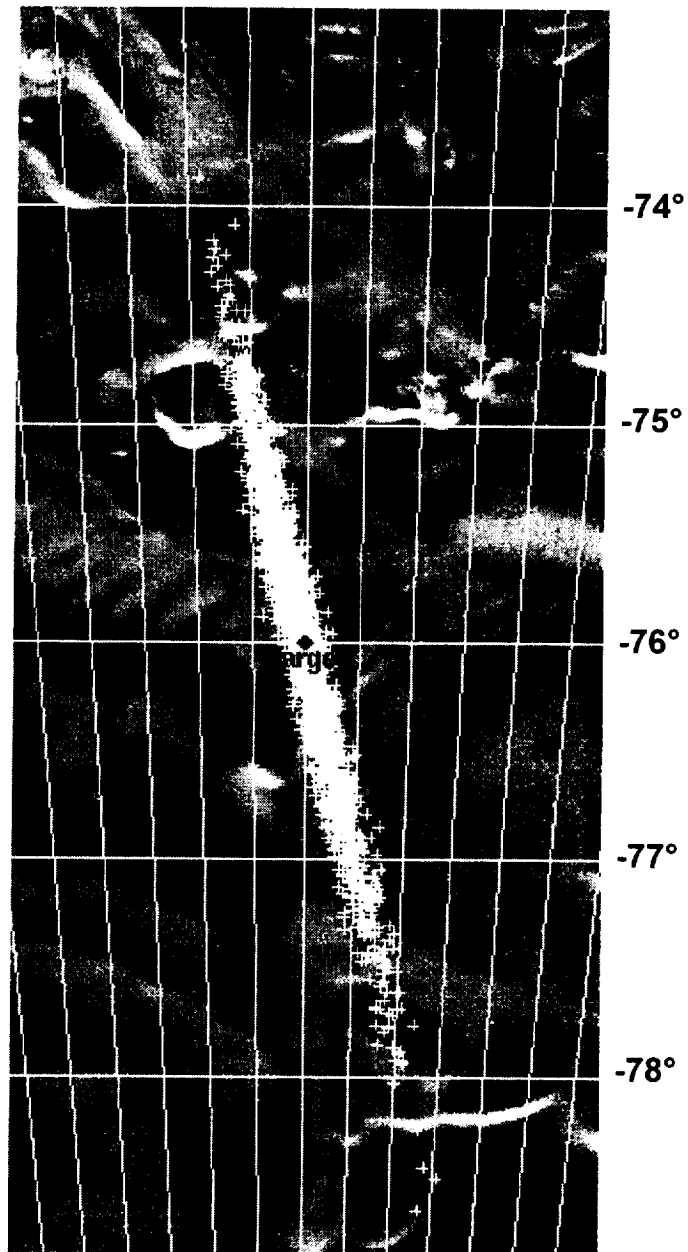
**Figure 7-1. Site Selection Ellipse —  
Based on LMA Scatter for 75° S, Rotated for 76° S Landing Site**

Additionally, in order to achieve the desired landing ellipse on the surface of Mars, the analysis assumed that the spacecraft center of mass could be controlled to within 2.8 millimeters of the centerline of the entry body. The resulting surface ellipse had dimensions of 85 kilometers semi-major axis (along-track) by 5.4 kilometers semi-minor axis (cross-track), both 2 sigma. Figure 7-1 shows the landing ellipse estimate at the time of the site selection several months before EDL, based on earlier 3DOF/4DOF LMA Monte Carlo simulations, adjusted in orientation to the new landing latitude of  $-76^\circ$  S. (*Note: The landing latitude was  $-75^\circ$  at launch.*)

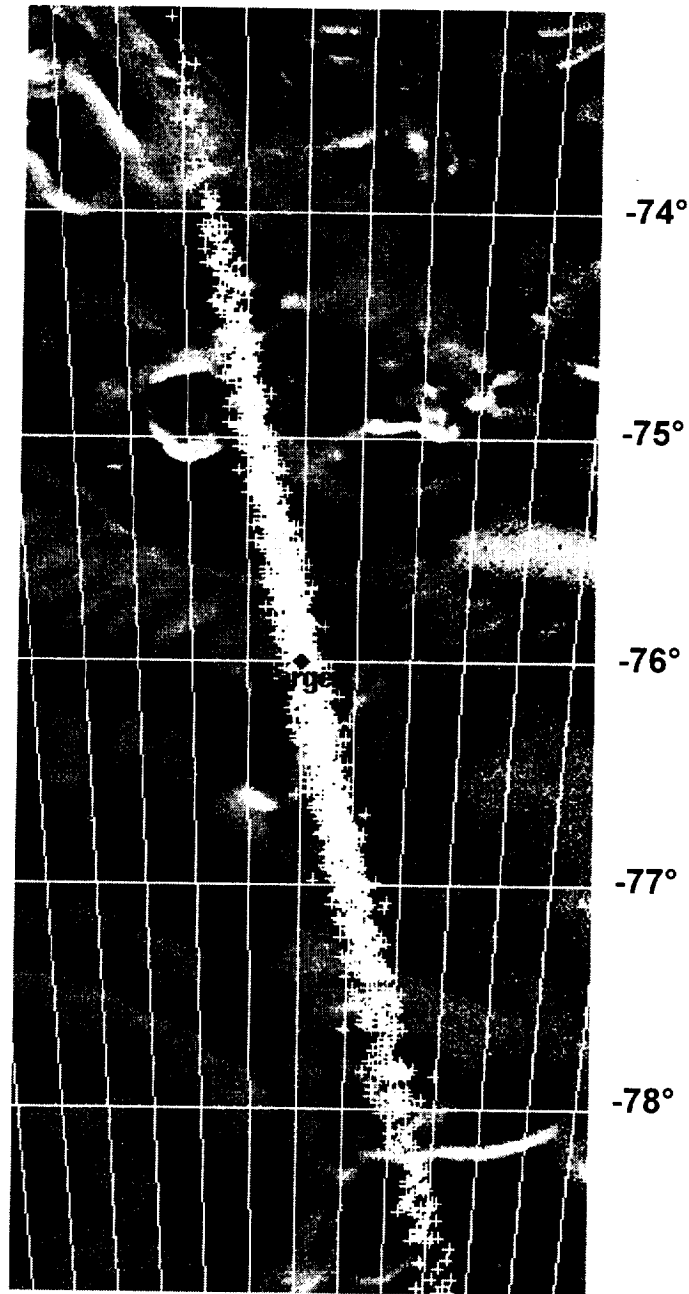
Figure 7-2. TCM-4 Planning Ellipse — LaRC 3DOF Scatter, 11/23/99

As noted above, after the loss of MCO, additional navigation expertise was added to the project to help ensure a successful delivery to atmospheric entry. At this point, the assessment of small-forces assumptions and the improvements to be expected from near-simultaneous tracking were revisited. A new set of entry statistics was calculated on 10 November 1999 that resulted in an expected B-plane error ellipse of dimension 19.3 kilometers  $\times$  3.0 kilometers, 3 sigma, including orbit determination and maneuver-execution errors (for the magnitude of TCM-4 assumed in the pre-launch navigation plan). This corresponded to a 3-sigma entry flight-path angle of 0.94 degree, 3 sigma, which was still believed to be within the spacecraft design capabilities, even though this was considerably larger than previously planned for. The resulting surface ellipse, including the effects of an updated atmosphere model, had dimensions of 138 kilometers semi-major axis (along-track) by 5.4 kilometers semi-minor axis (cross-track), both 2 sigma. Figure 7-2 shows the TCM-4 planning ellipse, based on 3DOF LaRC simulations. Both the width and orientation of the landing ellipse are comparable to the estimates developed based on navigation analyses before the MPL launch; however, the length of the ellipse is considerably larger. This graph represents the data set available to the project to make the TCM-4 decision.

Analyses performed after EDL revealed that the effects of maneuver-execution errors were larger than expected. The TCM-4 planning ellipse was based on a maneuver magnitude of 0.35 meter per second, the best estimate available at that time. The final TCM-4 maneuver magnitude was 0.6 meter per second. This maneuver magnitude resulted in considerably larger execution errors than had been previously assumed. For very short burns, execution errors are small because little time is available for pointing errors to develop. For longer burns, errors are also small because the control system will steer back to the desired attitude. The executed burn magnitude fell in between these extremes and, therefore, was subject to a larger set of expected errors. This increased the size of the 3-sigma B-plane error to as high as 20.5 kilometers  $\times$  13.8 kilometers, using worst-case requirement estimates of maneuver-execution errors. (Typical or "expected" maneuver-execution errors led to substantially smaller B-plane errors (18.3 kilometers  $\times$  6.2 kilometers). This widening effect is illustrated in Figure 7-3, which shows both the narrow TCM-4 planning ellipse, based on the assumed maneuver magnitudes and associated error statistics, and the wider ellipse, based on the actual maneuver magnitude and associated error statistics. This graphic represents the difference between the delivery accuracy that the project assumed was achievable at the time of TCM-4 versus what is now believed to be the best estimate, after the fact. Also shown is the center of the final navigation solution based on tracking data after TCM-5 through the loss of signal.

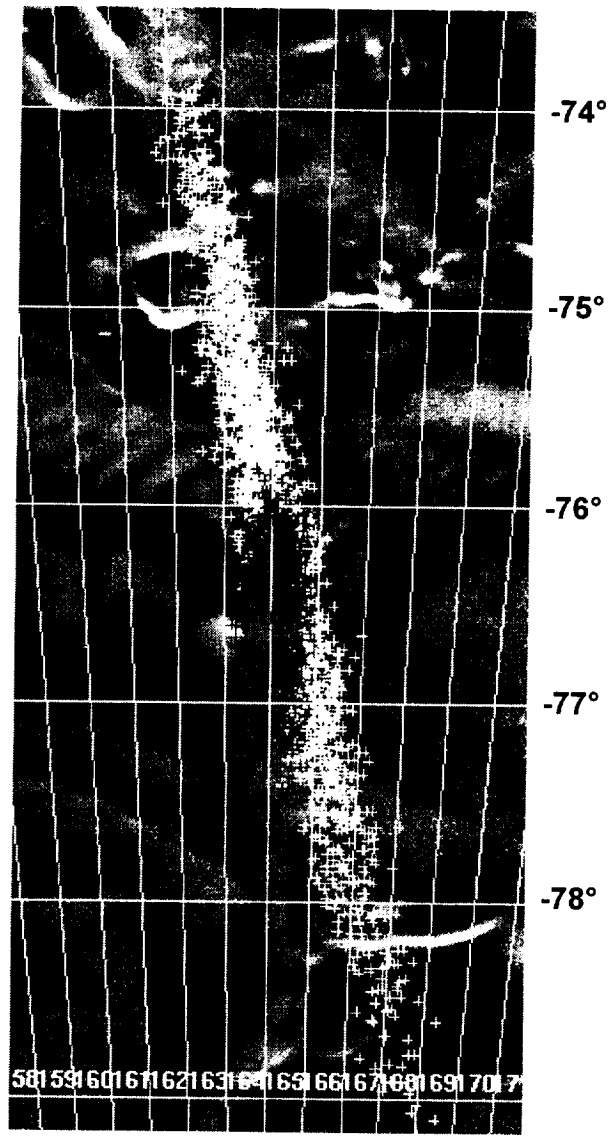
**Figure 7-4. Required Maneuver-Execution Errors, LARC 6DOF 3/3/00 (Yellow [Light]) and Final Estimated Ellipse, LARC 6DOF 3/3/00 (Green [Dark])**

On the basis of the final pre-entry tracking, the desired in-plane entry conditions appear to have been met. The entry flight-path angle was reconstructed at  $-13.10$  degrees against the target zone of  $-13.25 \pm 0.94$  degrees (revised from the original  $-13.25 \pm 0.54$  degrees). The cross-track error in the B-plane was within 7.2 kilometers of the planned target, which corresponds to a motion of approximately 8 kilometers at the surface. This distance is marginally consistent (within approximately 2 sigma) with the eventual understanding of the uncertainty surrounding the spacecraft small-forces environment and TCM-4 execution errors, which are discussed above. In Figure 7-4, the yellow (light) data once again reflect the best estimate of the delivery accuracy after TCM-4; these data are based on analysis after the fact. Also in Figure 7-4, the green (dark) data represents the best estimate of where the lander actually did go, eliminating effectively all navigation errors by using the final tracking data arc through loss of signal, but continuing to represent scatter around that final solution due to atmospheric and aerodynamic uncertainties.

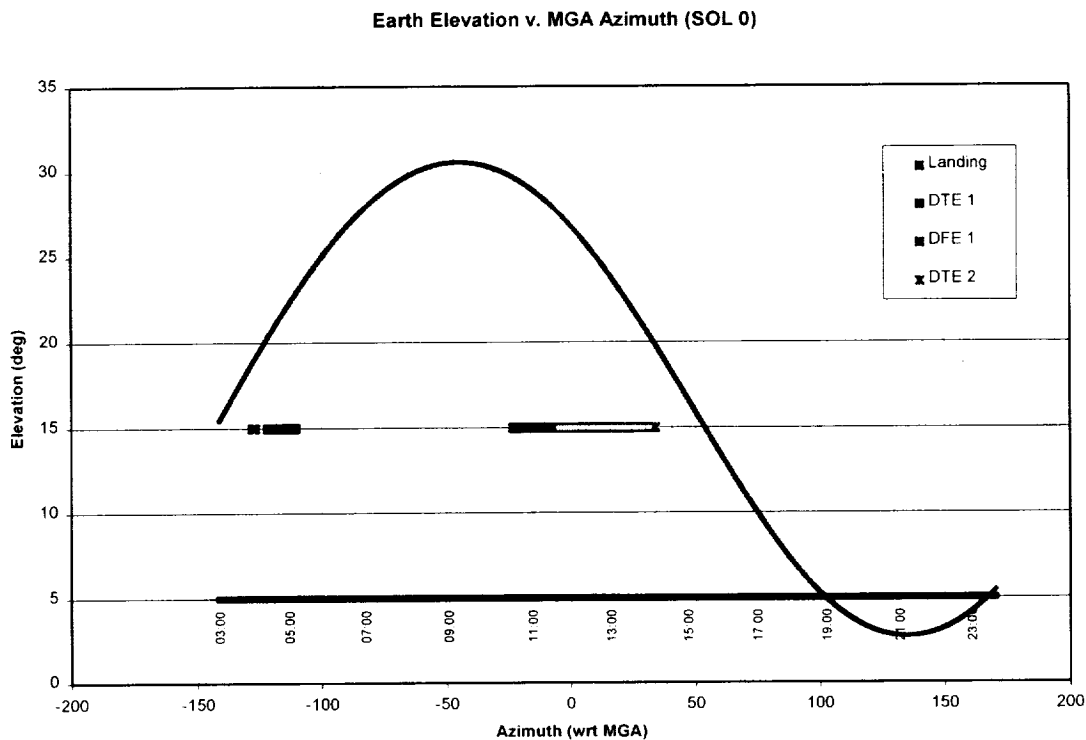
Figure 7-5. Earth Geometry for the Nominal Landing Orientation and Site on Sol 0

On sol 0, Earth was above 10 degrees elevation for azimuth angles of  $-150$  degrees to  $+75$  degrees (in the nominal landing attitude). Earth elevation peaked at  $\sim 32$  degrees above the horizon. The azimuth and elevation "soft stop" ranges are:  $-138$  degrees  $< AZ < 51.5$  degrees,  $2$  degrees  $< EL < 57$  degrees. The sol 0 Earth geometry is shown in Figure 7-5.

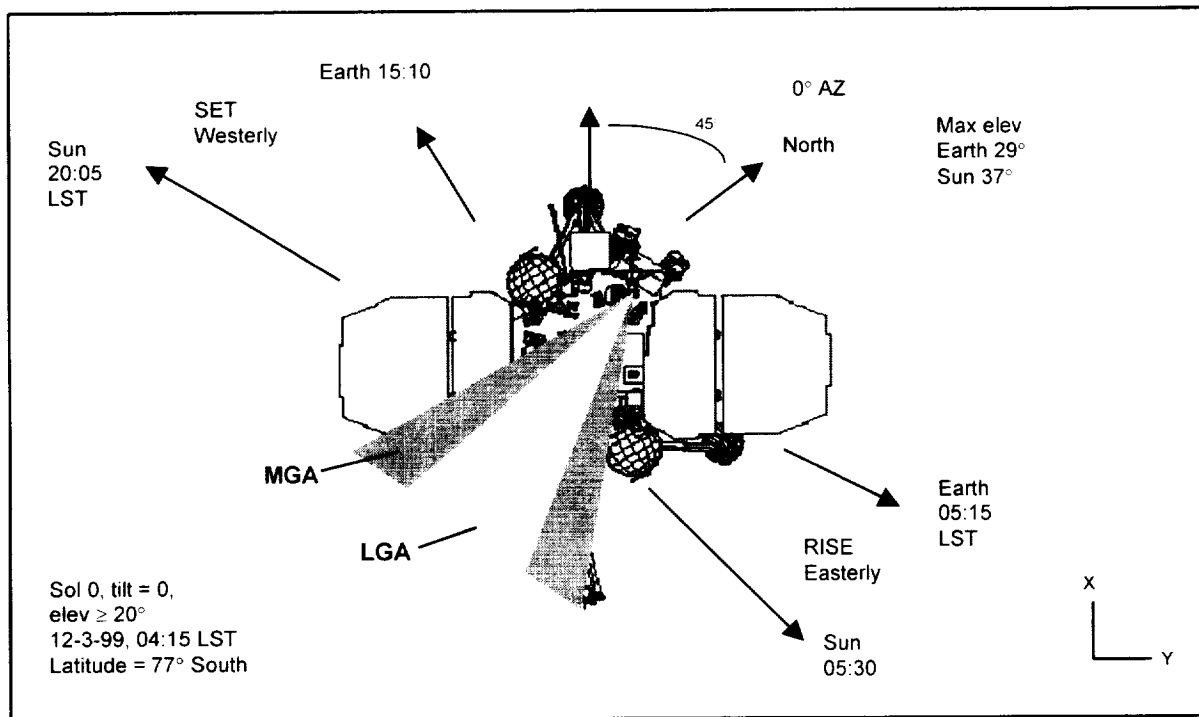
Figure 7-6. Command-Blind Zones in Azimuth for MGA (125 bps) and LGA (7.8125 bps)

For downlink, the "blind" zone is similar if no "touchdown power-on reset (POR)" scenario occurs that would kick off the autonomous Find the Earth (FTE) sequence (see Figure 7-6). Otherwise, the Telecom Subsystem would have been configured for carrier-only downlink for the duration of the sequence, which increases the field of view around the MGA to approximately 30 degrees. In carrier-only mode, a downlink signal would almost certainly have been observed from Earth during the FTE sequence, if the landing azimuth error had been less than 36 degrees (6 degrees FTE minimum "pad" plus 30 degrees field of view).
