**Seismic performance of precast industrial facilities following major earthquakes in the Italian
territory**

Abstract

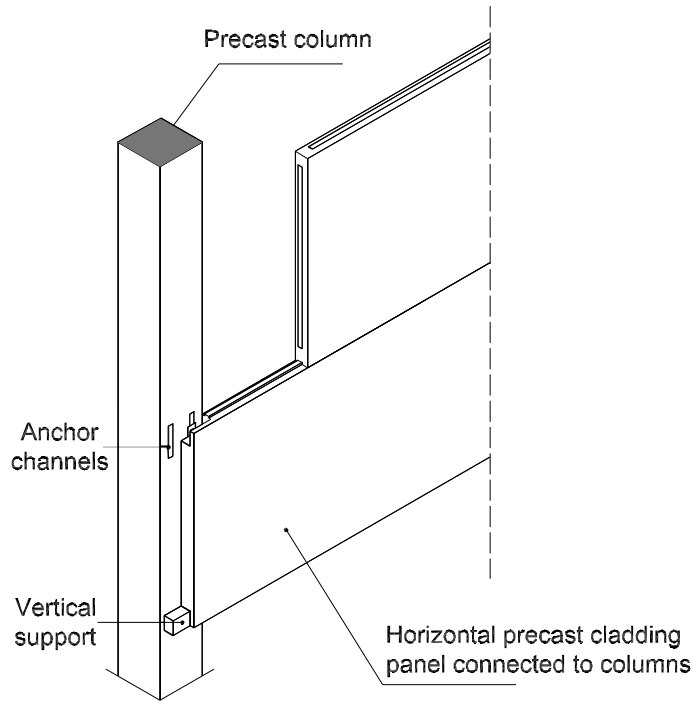
Figure 3
[Click here to download Figure: Fig3.eps](#)

Conversely, category B presents longer spans, up to 27 m, covered by tapered I-beams which form gable roofs. As in category A, no moment continuity exists between beams and columns; the lateral load capacity of the structure is provided only by the cantilever action of the columns at the footings, which are not tied together. RC forks are provided at top of the columns as support of the beams but they are not designed to carry seismic induced lateral loads. Highly flexible roof diaphragms are the result of double-T pre-stressed joist or micro-sheds simply supported on the main beams with no mechanical connections. Both horizontal and vertical precast cladding panels are traditionally connected to the columns or to gutter beams by mechanical devices, typically anchor channels (Fig. 3).

7 **Fig. 3. Horizontal RC precast panel-to-column connection**

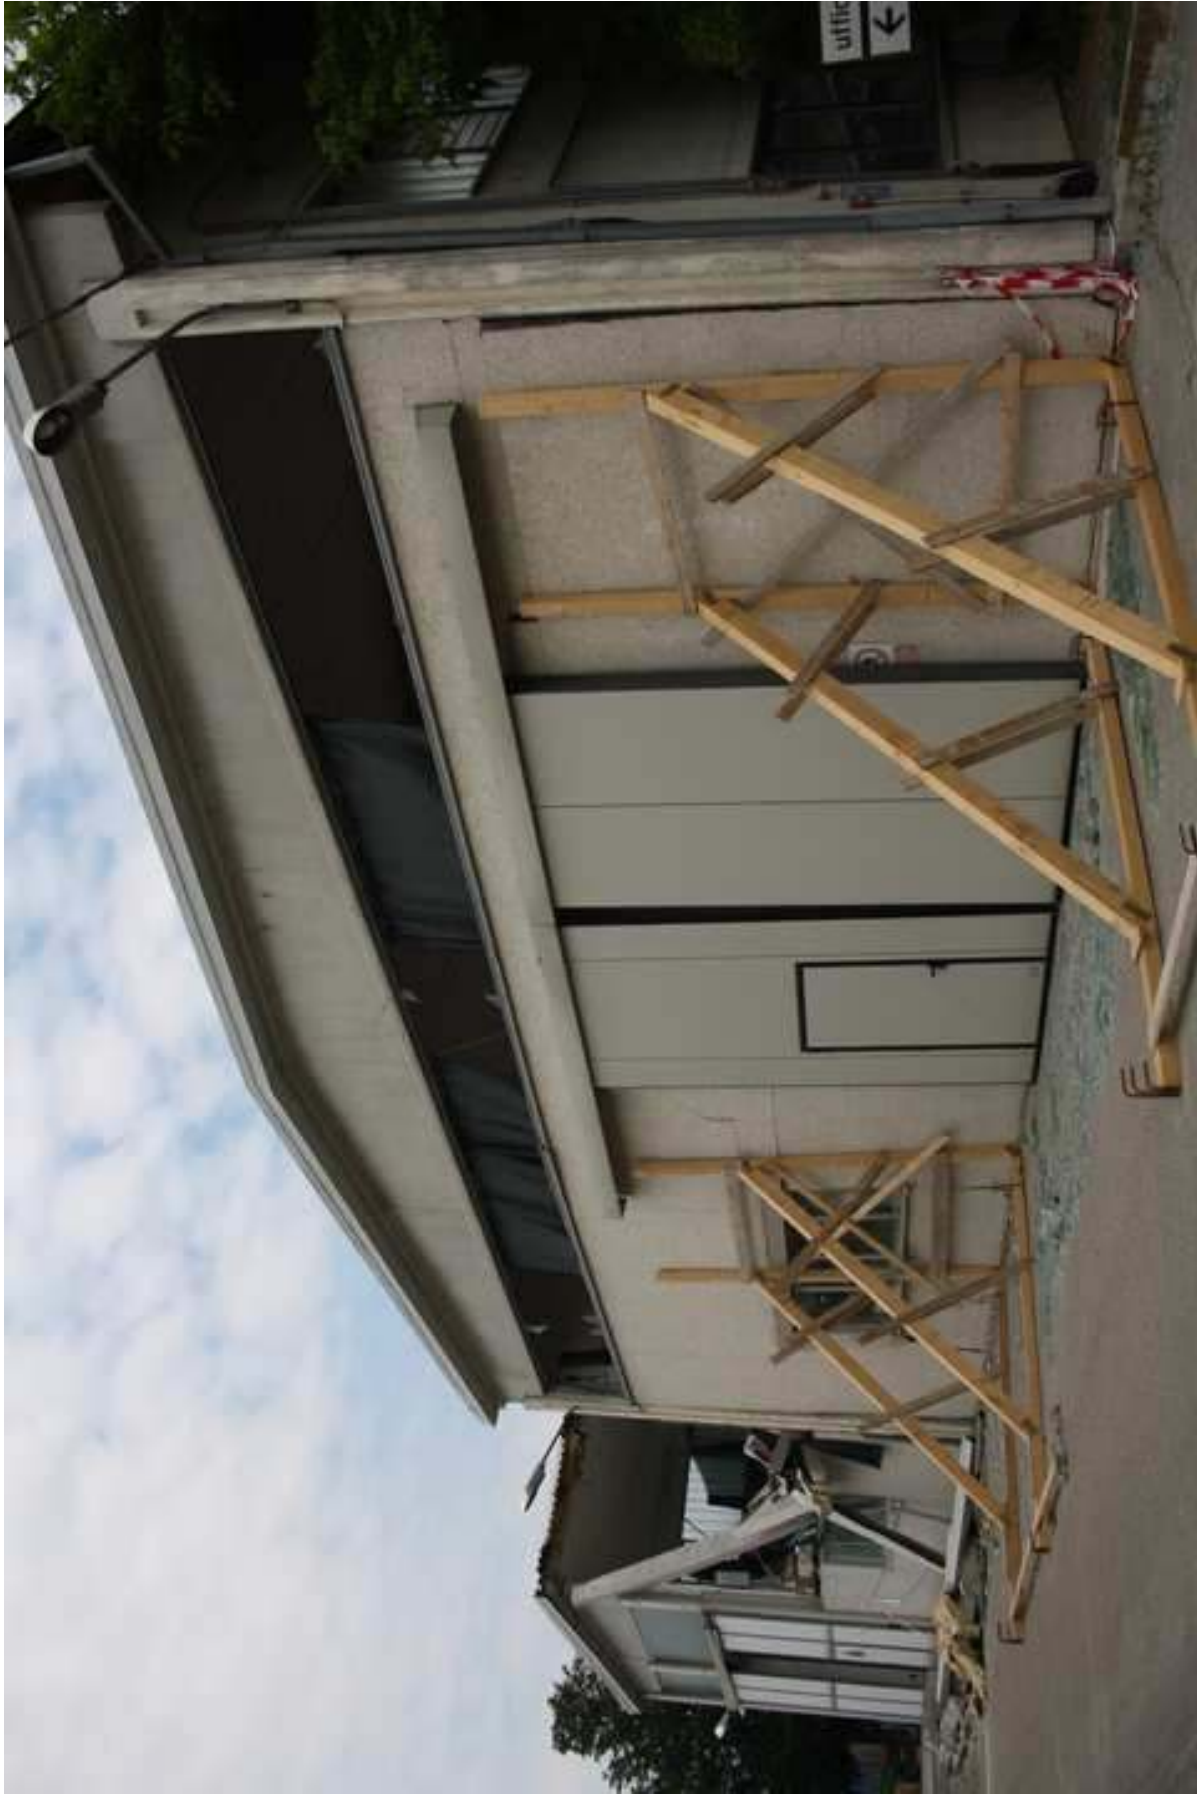
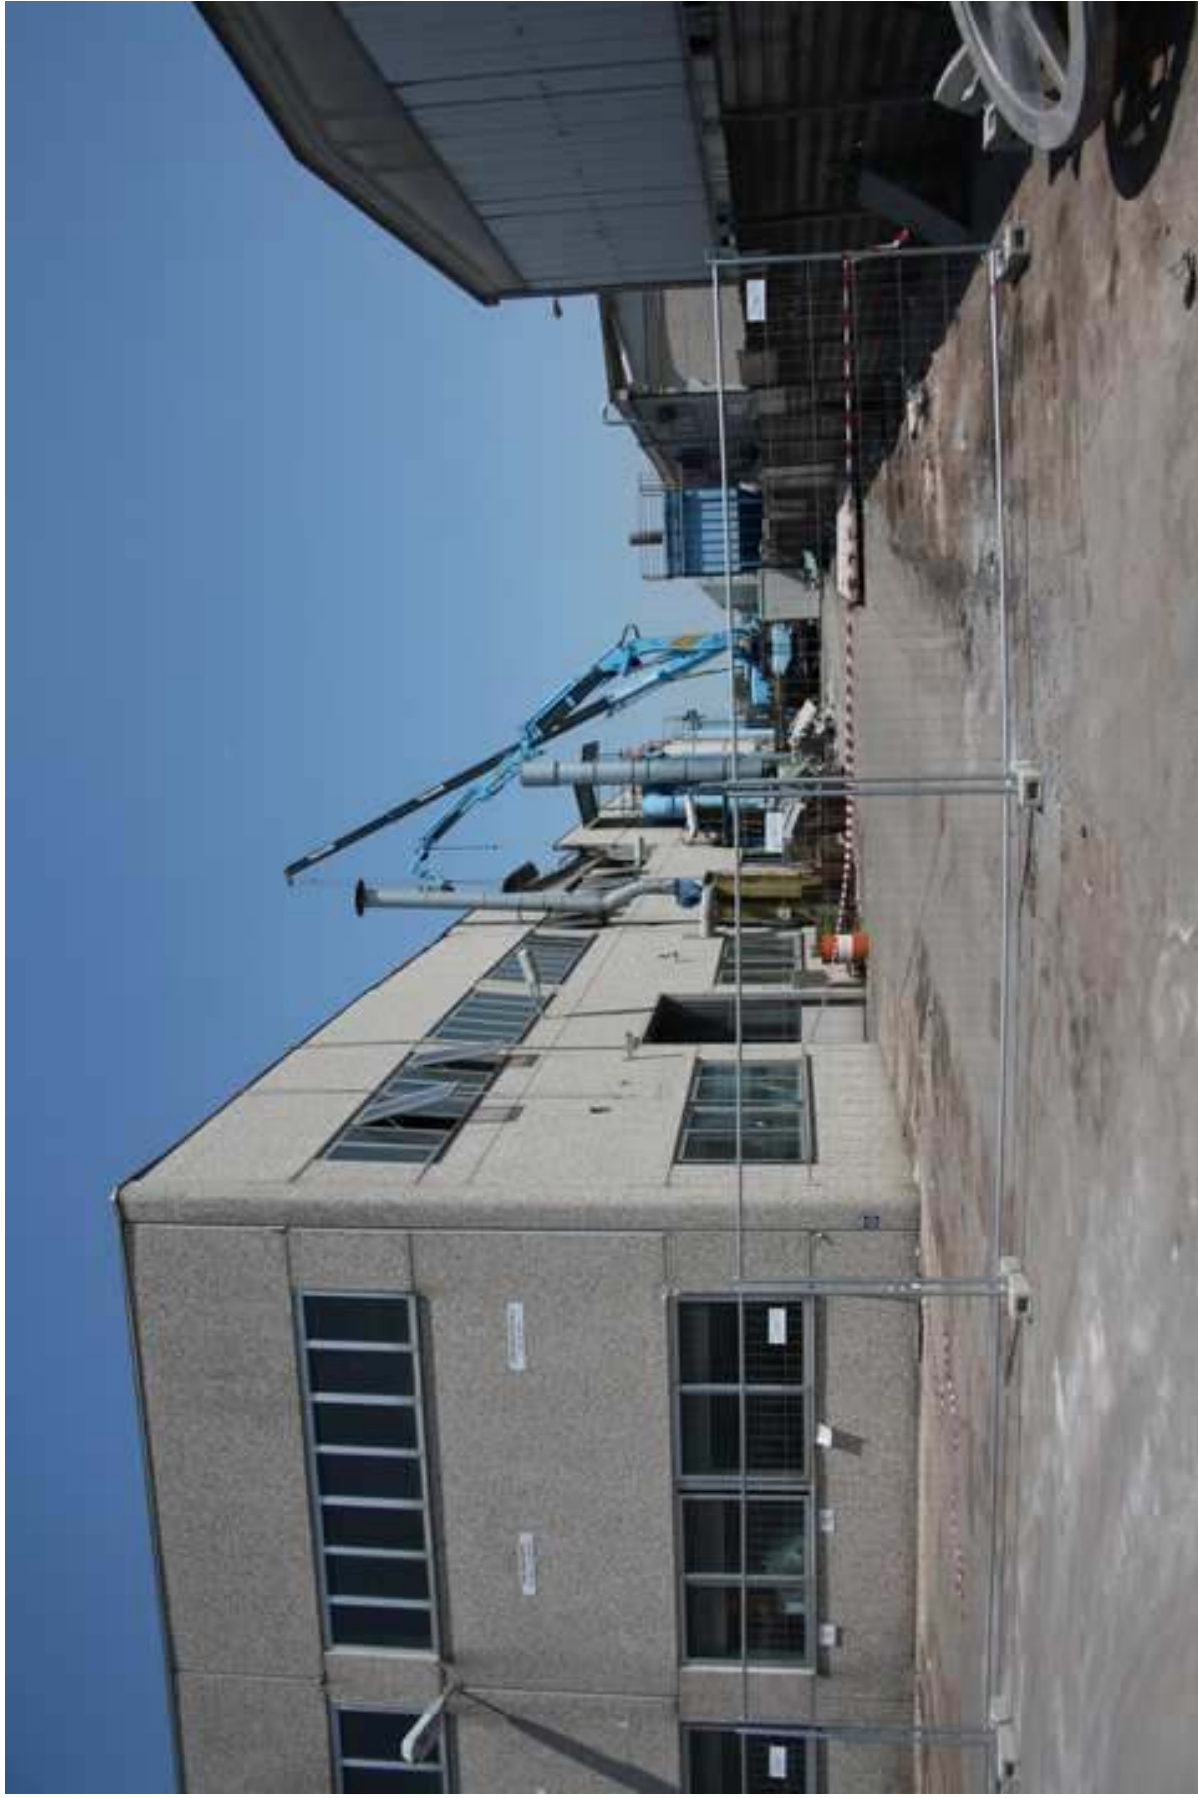
Figure 4a
[Click here to download high resolution image](#)

Examples of the two structural typologies (category A and B) are shown in Fig. 4a and 4b respectively.

9 **Fig. 4. (a) Example of one-storey precast structure built between the 70's and the 80's; (b) Example of more**
10 **recent one-storey precast structure with longer spans and precast cladding panels**

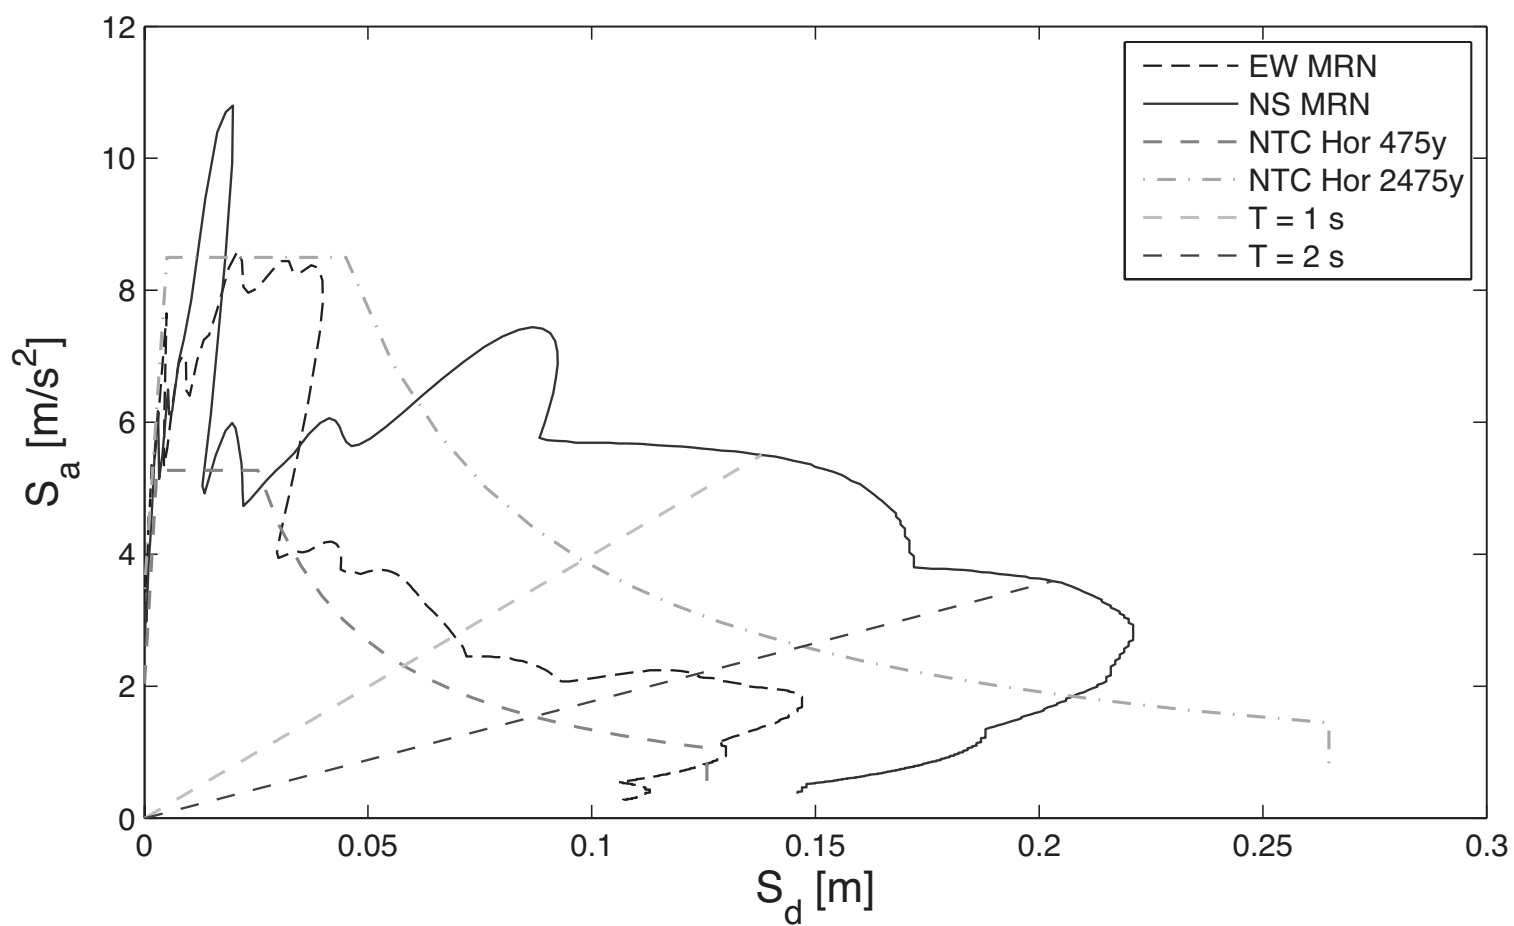
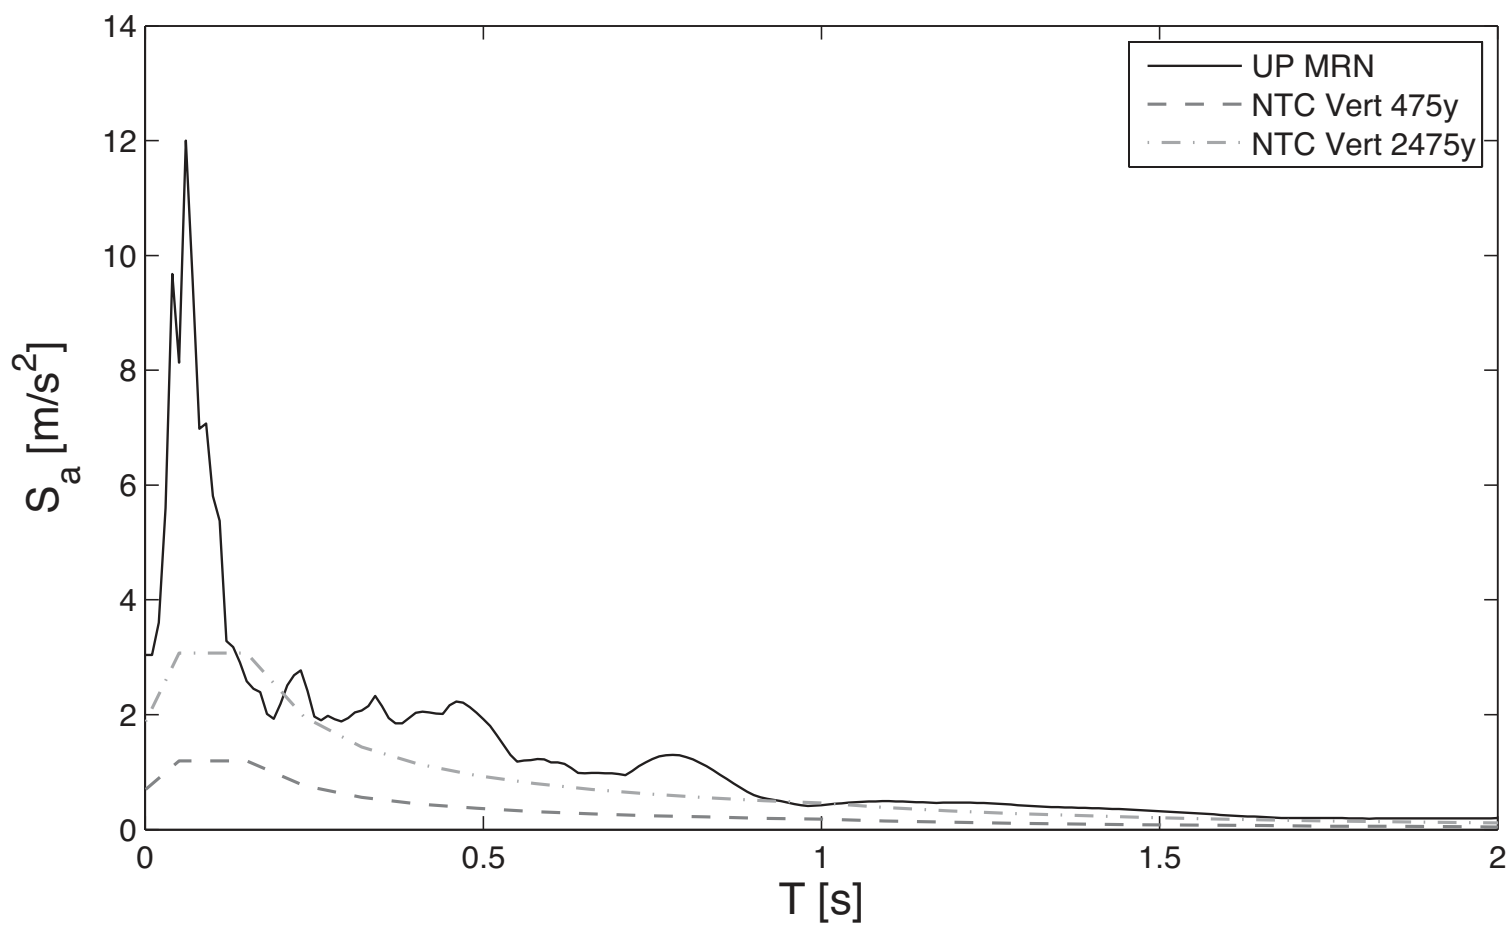
Figure 7a
[Click here to download Figure: Fig7a.eps](#)

Qualitative explanation of such collapses, mostly due to the loss of support of the friction based connections, may be searched in the preliminary computations described in the following. Fig. 7(a) shows the elastic ADRS (acceleration displacement response spectrum) graphs (5% relative damping) of the horizontal components, North-South (NS, solid line) and East-West (EW, dashed line), of the May 20th event at Mirandola and the elastic ADRS graphs determined for two return periods, respectively 475 and 2475 years, in accordance with the current Italian Building Code (D.M. 14/01/2008). Fig. 7(b) shows a similar comparison regarding the vertical component. Mirandola, MRN according to the Italian RAN (Rete Accelerometrica Nazionale) network nomenclature, is chosen as it represents the station closest to the epicentre. The accelerograms recorded include site effects according to D.M. 14/01/2008: soil class C ($180 \text{ m/s} < V_s < 360 \text{ m/s}$) and no topographic amplification.

16 **Fig. 7. (a) Elastic ADRS graphs from recorded time histories (NS and EW) and in accordance with the Italian**
17 **building code (NTC). (b) Elastic pseudo-acceleration response spectra of the vertical component. Note: $\xi = 5\%$**

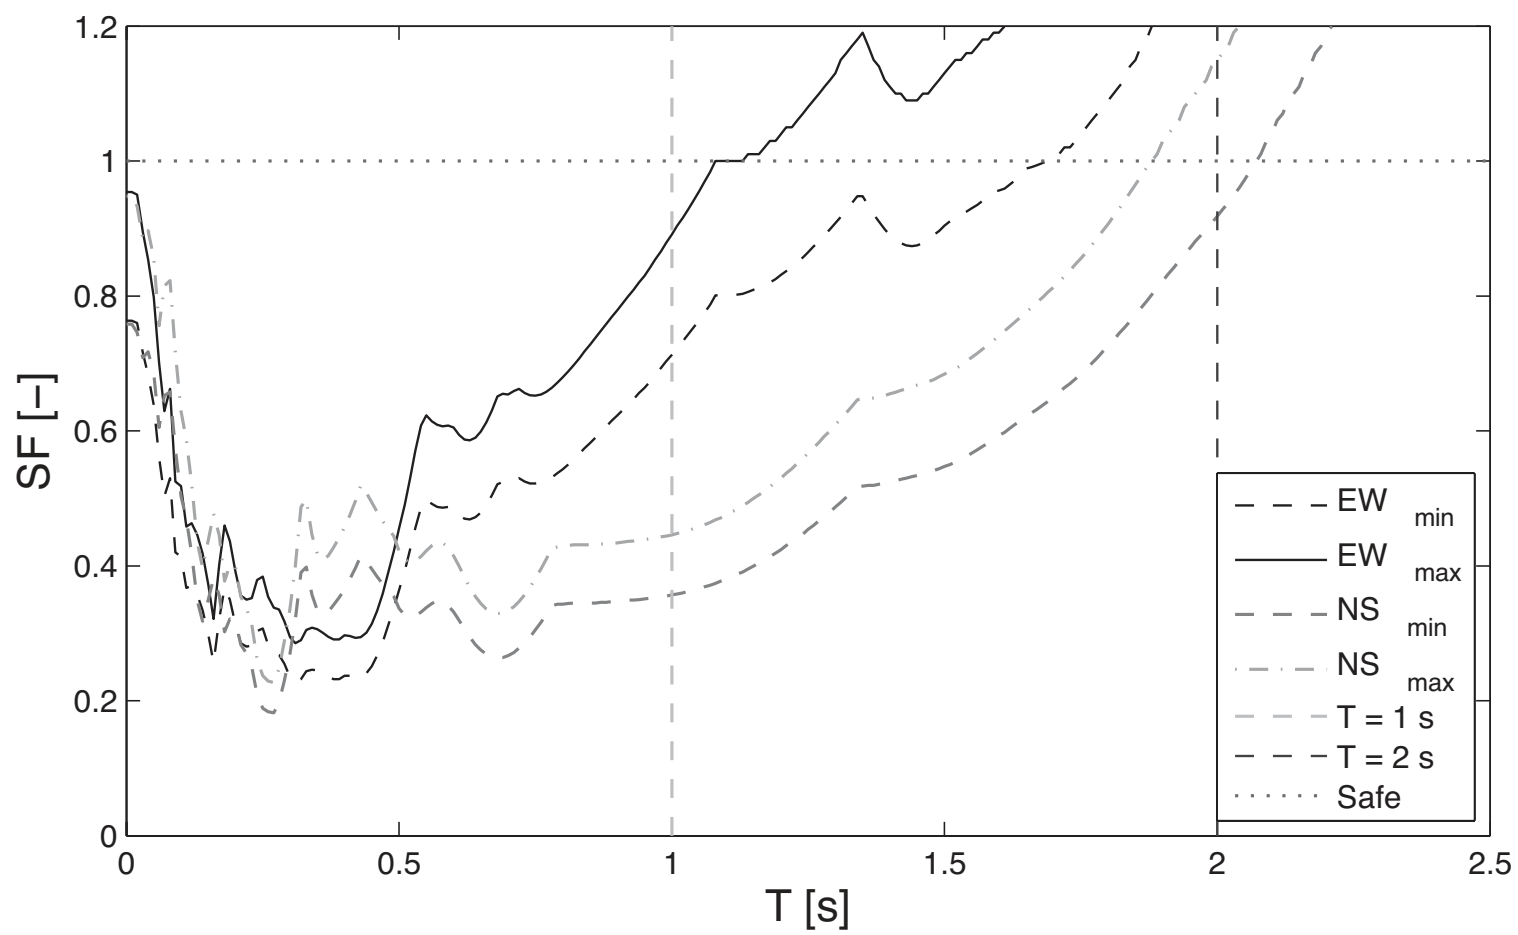
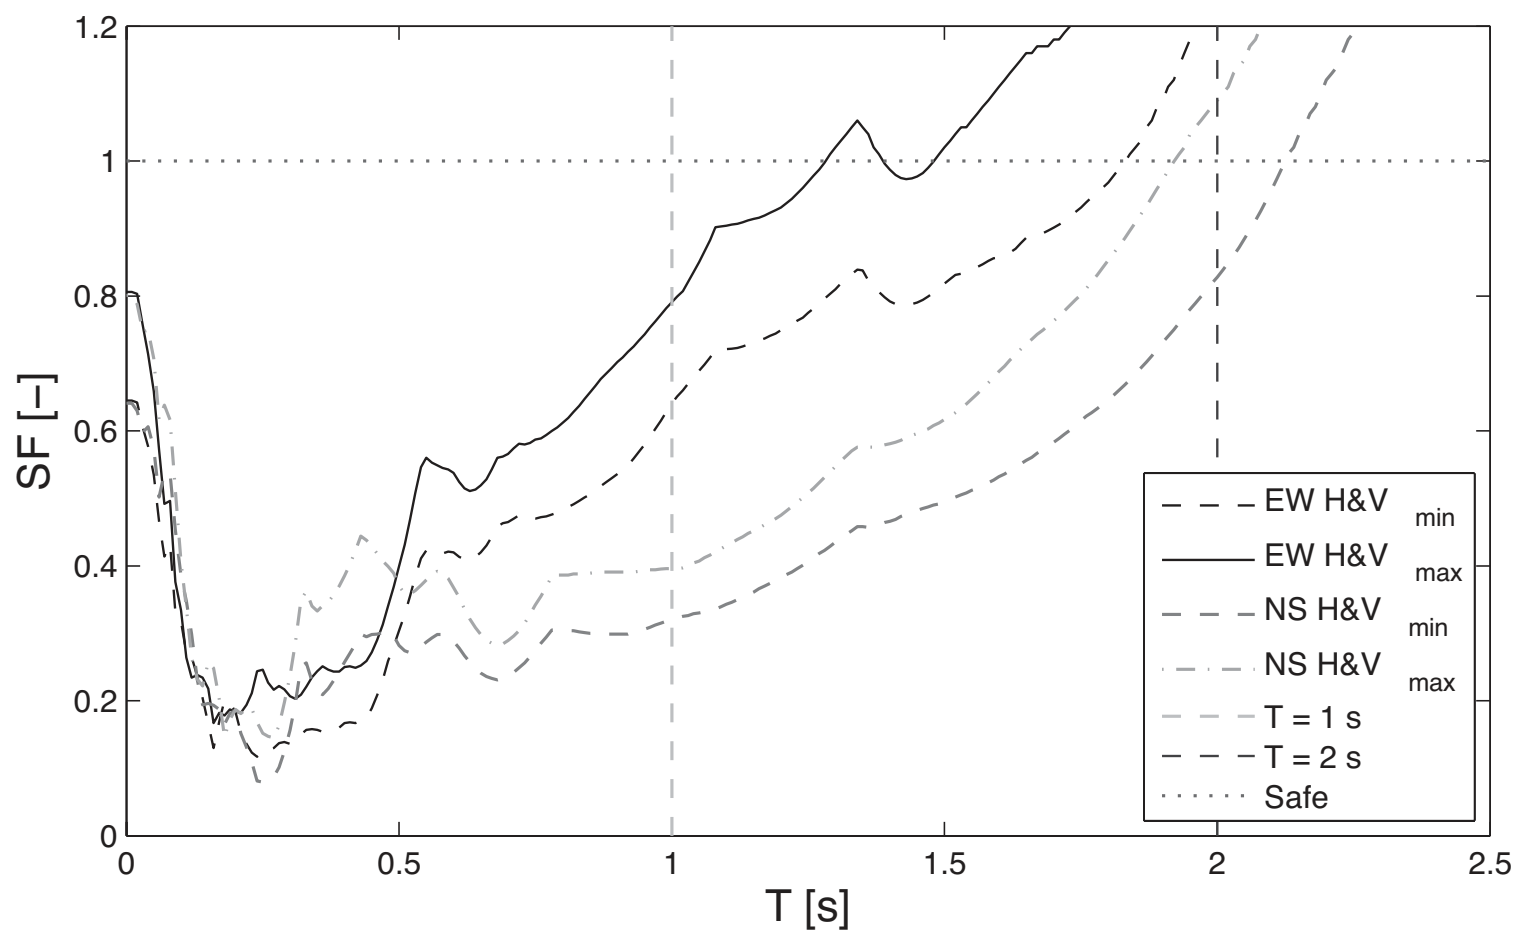
Figure 8a
[Click here to download Figure: Fig8a.eps](#)

Fig. 8(a) and (b) present the computed safety factor against the activation of the shear slippage at the beam-to-column connection level, by neglecting and considering the effect of the vertical component ($\pm\Delta N$) respectively. Roughly 10% decay of SF is observed if the vertical component is included, thus confirming the not so prominent effect of the vertical component even though peaks larger than suggested by D.M. 14/01/2008 occurred during the 2012 Emilia seismic sequence.

19 **Fig. 8. Variation of the SF against the activation of the shear slippage at the connection level, (a) by neglecting**
20 **and (b) considering the effect of the seismic vertical component**
