MISCELLANEOUS PAPER CERC-87-20

# SIDE-SCAN SONAR INVESTIGATION OF BREAKWATERS AT CALUMET AND BURNS HARBORS ON SOUTHERN LAKE MICHIGAN

Andrew Morang

December 1987

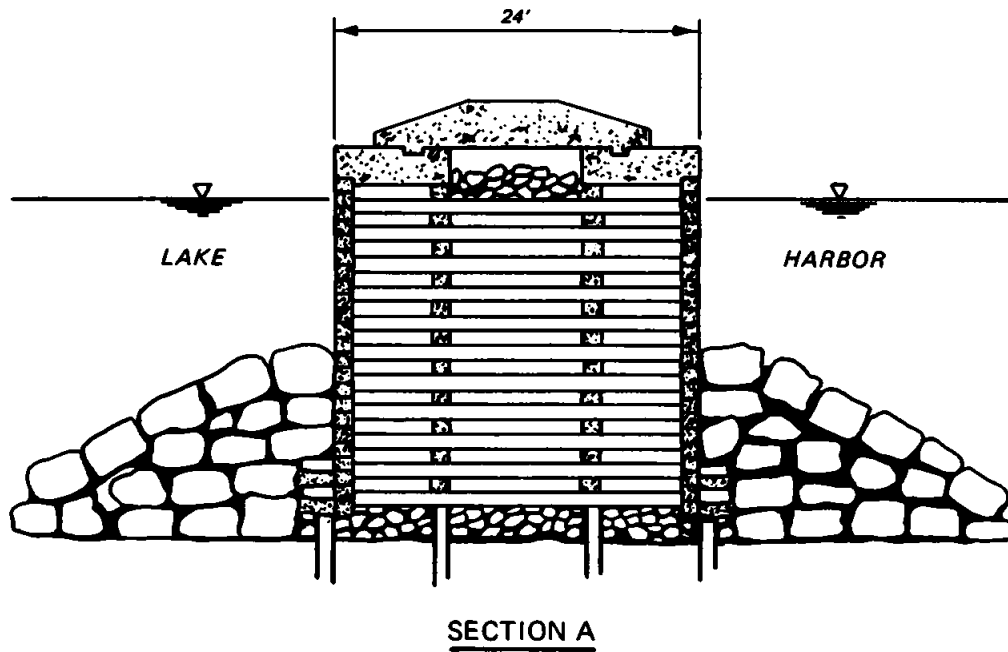
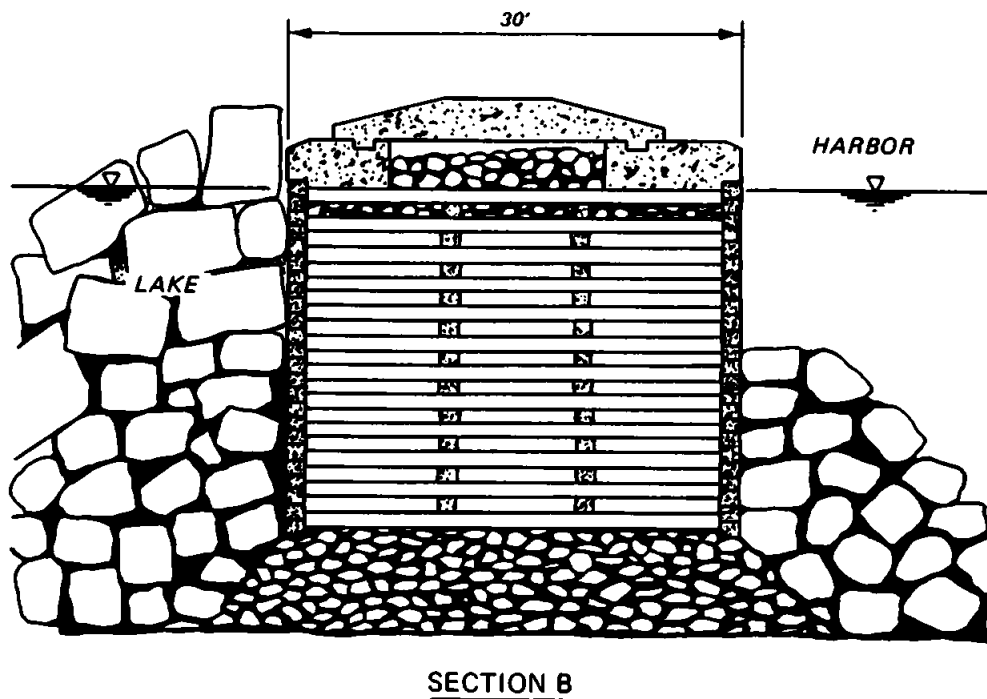
Figure 4. Wooden cribs forming Sections A and B of the Calumet Harbor attached breakwater

7. Sections A, B, and C of the Calumet Harbor breakwater were surveyed on 24 September (Figure 3) at horizontal range scales of 25 and 50 m. Sections A and B consist of wooden cribs (Figure 4) which were built on land by skilled carpenters, floated into place, and filled with stone rubble. This breakwater was completed in 1904, a concrete cap was added in the 1920's, and toe armor was added at various times.

9. Most of the exposed face of the wood cribs appears to be intact along the harbor side of Section A. An exception occurs near sta 15+00 where a section of the crib has been displaced inward (northward toward the lake) less than 0.5 m. The side-scan sonar records obtained on the lakeside of the breakwater reveal more clearly that this crib unit is out of alignment, but it is not possible to determine if it has broken or has tilted in one piece.

11. The lakeward face of the Section A breakwater is discontinuous and irregular, and numerous individual cribs project outward from the main body of the breakwater (Figure 5). Displaced units occur near sta 4+00, 8+00, 9+00, 12+00, and 15+00. The unit at sta 15+00 has been noted earlier in conjunction with a displacement evident on the harbor side. Numerous irregular reflections occur up to 3 m behind the face of the breakwater, and it is hypothesized that they occur at gaps in the damaged face of the cribs where the acoustic signal has entered a void and has reflected from the fill material within the cribs. These void reflections occur near sta 4+00 and 6+00 through 10+00, 12+00, and 13+00 (Figure 5). In support of this hypothesis, these reflections do not occur on the harbor side of Section A where the physical environment is less severe and where the faces of the cribs appear to be in better condition.

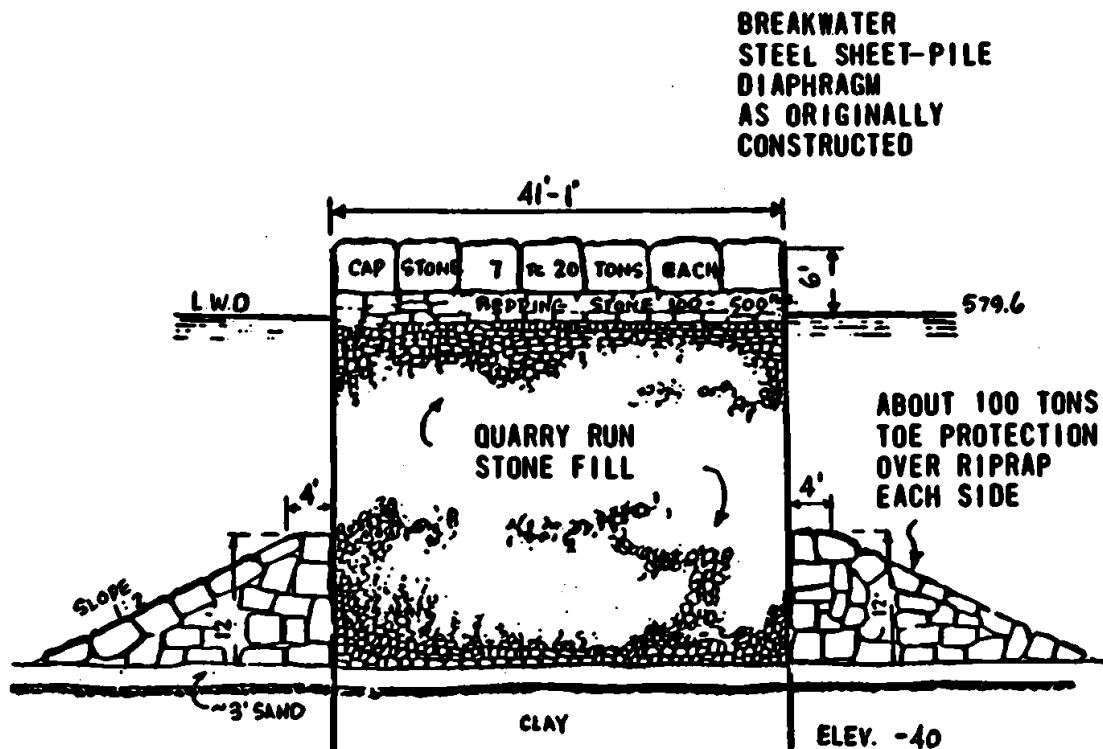
Figure 8. Cross section of Section C, Calumet Harbor detached breakwater

19. The Calumet Harbor detached breakwater constructed in 1935 is composed of 131 stone-filled diaphragm sheet-pile cells (Figure 8). According to the Calumet Harbor Reconnaissance Report (NCC 1985), the piles were driven approximately 2 m into an essentially sandy lake floor, and project maps indicate that some areas were composed of hard limestone.

20. The side-scan sonar survey shows that the harbor floor along most of Section C is predominantly featureless and of low-reflectivity, probably clay. There is no evidence of sand waves or ripples, even near the breach where storm waves in 1984 destroyed two cells and where the wave regime should be more than energetic enough to move noncohesive sediments. Only at the far south end of the breakwater does the lake floor become darker (i.e. demonstrating higher reflectivity), and large fields of ripples can be seen in the records. Here, too, wave action may be moving accumulations of sand which may be spreading over some of the clayey harbor floor.

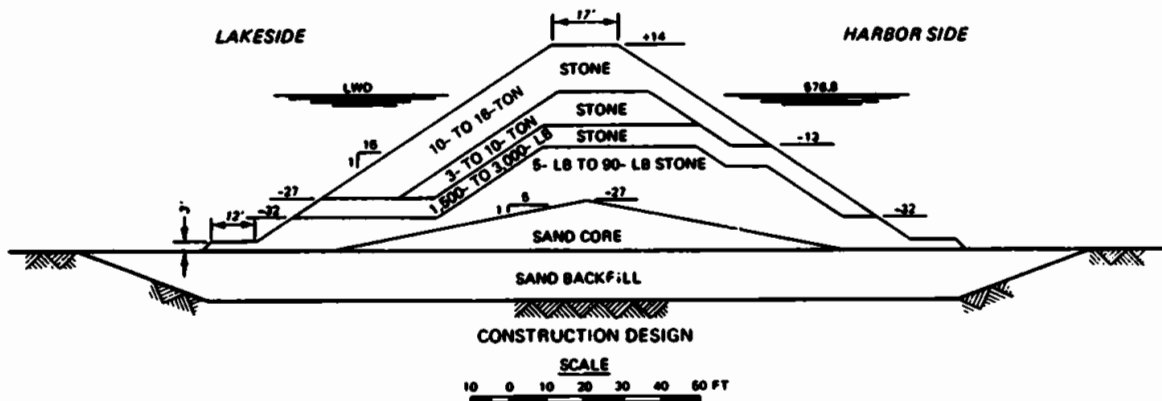
Figure 12. Two-layer rubble-mound breakwater design using 10- to 16-ton limestone blocks

26. Burns Harbor Waterway is located on the southern shore of Lake Michigan in Porter County, Indiana, 30 miles southeast of Chicago. The side-scan sonar survey at this location was conducted on 25 September 1986 (Figure 11). The breakwater, which was constructed between 1967 and 1970, is a two-layer rubble-mound design using 10- to 16-ton limestone blocks (Figure 12) (Krampitz 1985). Soil borings indicated that about 3 m of soft clay was underlain by much harder clay, and, before construction, the soft clay was to have been excavated and replaced with a sand mat. A 1978 plan indicates that the sand mat was supposed to extend at least 10 m beyond the toe of the structure (Krampitz 1985). The excavated clay was discarded onto the lake bed about 50 to 100 m from the toe in 15-m water depths.
