O'Kelly B.C., Ward P.N. and Raybould M.J. 2008. Stabilisation of a progressive railway embankment slip, *Journal of Geomechanics and Geoengineering*, Vol. 3, No. 4, 231–244.

Stabilisation of a progressive railway embankment slip

Abstract: A walkover survey of a side embankment on the West Coast Mainline railway (UK) revealed significant movement of the twin-track; a waterlogged trackbed and general deterioration of the slope. Ground monitoring and investigations indicated that in addition to shallow washout failures and formation pumping problems at trackbed level, the embankment was at limiting equilibrium with progressive downslope movement occurring along a deep-seated shear zone ($\bar{\varphi}'_{postpeak} = 22^\circ$) within underlying strata of glacial till and laminated clay (weathered mudstone/siltstone). Phreatic level increases during rainstorm events, in combination with winter groundwater maxima, induced artesian pressures on the underside of the steeply-sloping shear zone triggering step increases in shear displacements. Other factors included the gradual post-peak decline in shear strength due to creep; internal weathering; cyclic, transitory stress increases by pas

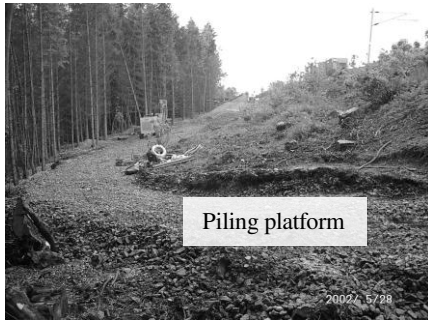
(a) Haul road to piling platform.

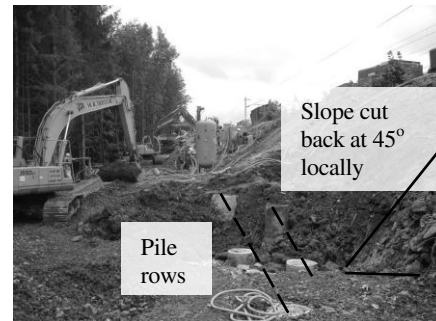
(b) Piling works.

The stabilising piles (0.45 m in diameter and 7.0 m in length) were aligned in two rows, set a distance of 1.0 m apart. The piles in each row had a centre spacing of 2.0 m with alternate piles staggered in plan arrangement. The pileheads were located 0.3 m below the base of the gabion wall. Hence, the effective pile lengths above and below the mid-height of the shear zone were 4.7 and 2.3 m, respectively, for the most unfavourable ground conditions expected (Figure 10).

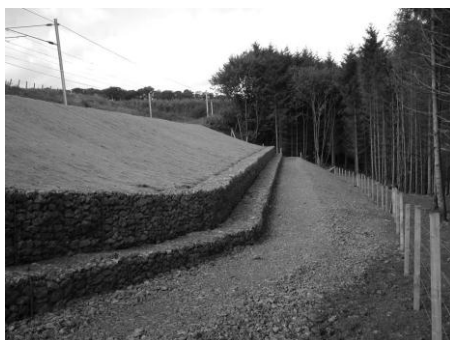
(e) Upgraded embankment slope.

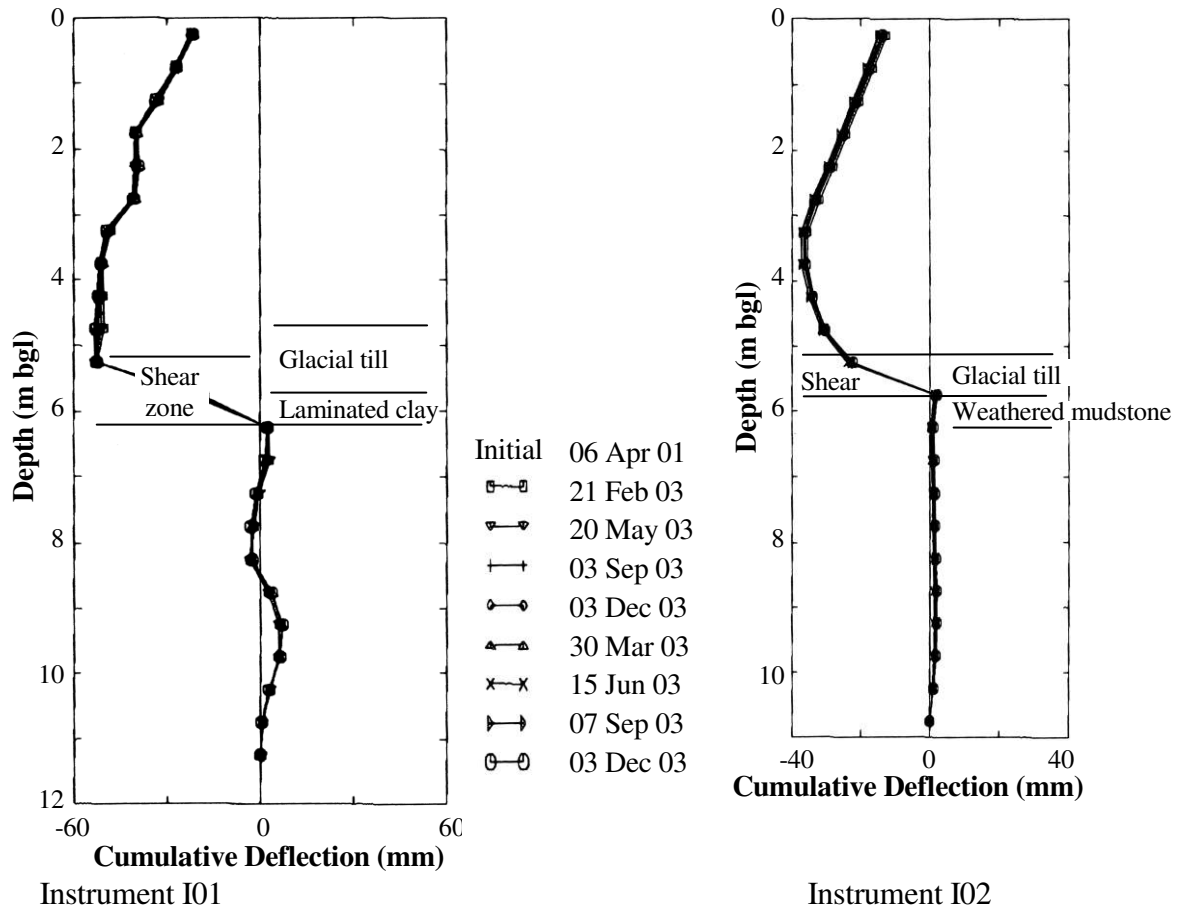
Figure 12. Inclinometer data for upper embankment slope.

Post-construction monitoring of the inclinometers and track levels continued but at a reduced frequency until December 2004 and February 2003, respectively. The monitoring data indicated that the remedial works were fully effective in stabilising the upper embankment-slope (Figure 12(b)), thereby limiting future track

(b) Post construction.
