# Study on the Causes of Secondary Cracks of the Eave Wall Mural of Daxiong Hall at Fengguo Temple in Yixian, Liaoning, China

**Abstract:** Built in Kaitai nine years of Liao Dynasty (1020 A.D.), the Daxiong Hall of Fengguo Temple in Yixian County, Liaoning Province, is one of the largest existing ancient single-eave wooden structure in China. There are nearly 470m<sup>2</sup> murals of Yuan Dynasty on the four walls of the hall. Since the in-situ reinforcement and protection of the mural were carried out in the 1980s in cooperation with the maintenance and restoration project of the main hall, the seriously developed cracks have become the primary factor affecting the structural stability of the mural. In order to find out the macroscopic causes of secondary cracks, endoscope, infrared thermal imager, three-dimensional laser scanner and other equipment were applied to study the relations between cracks' attitude and structural defects of the eave wall, as well as the pathway that external environment act on the mural noumenon through comprehensive investigation, and the idea of restoring the stability of the mural by blocking the air channel and offsetting the environmental stres

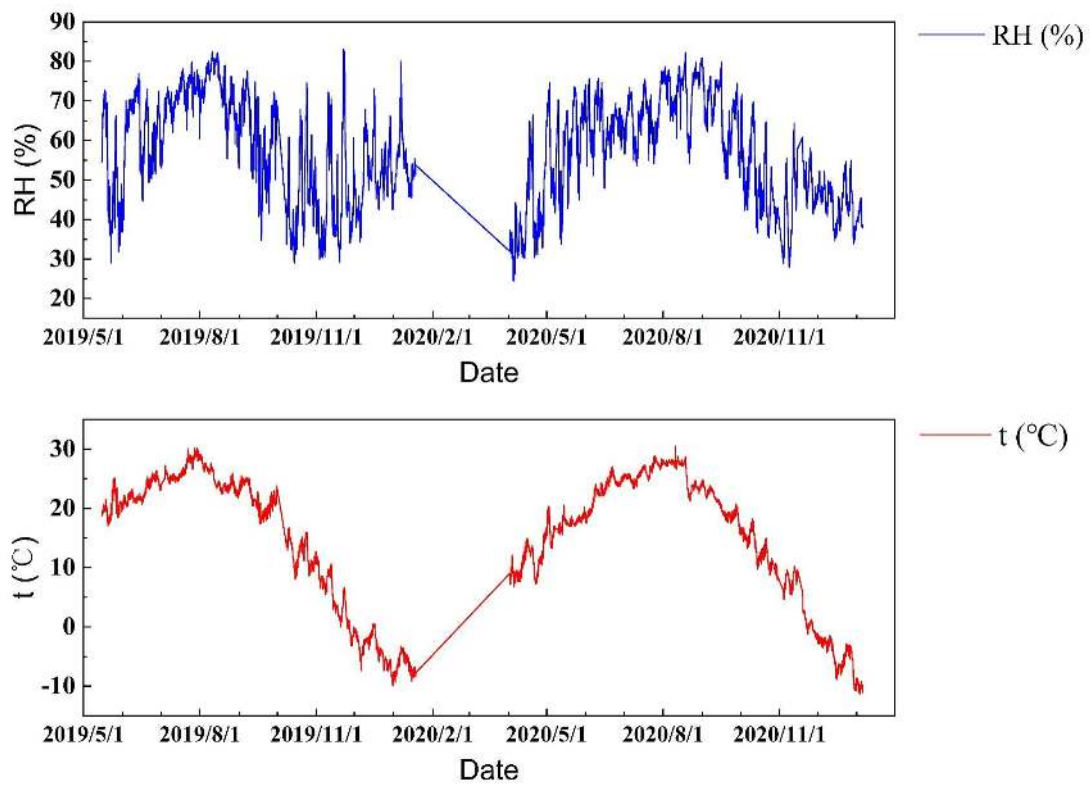
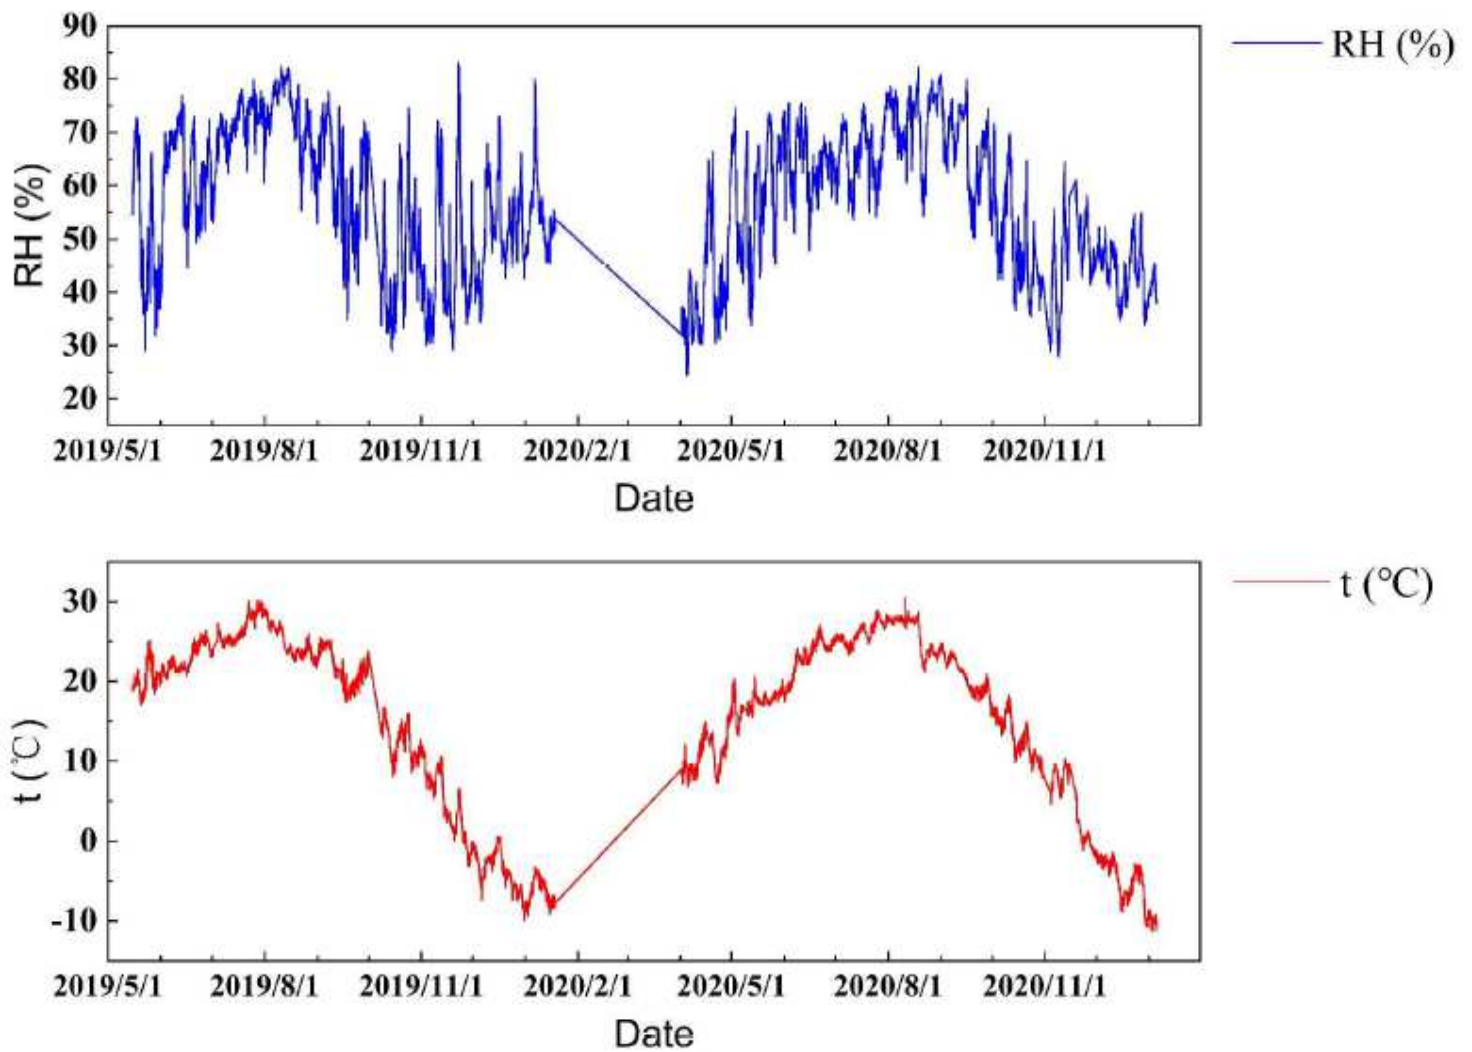
Figure 9

Hourly change curve of air temperature and humidity in Daxiong Hall from May 2019 to January 2021

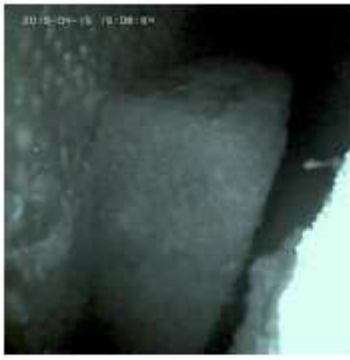
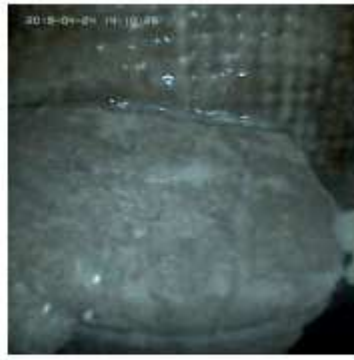
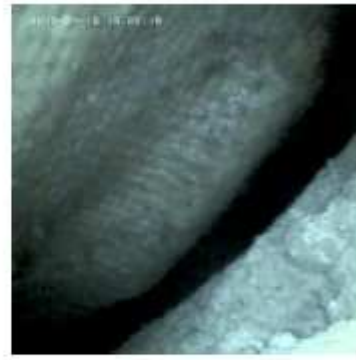
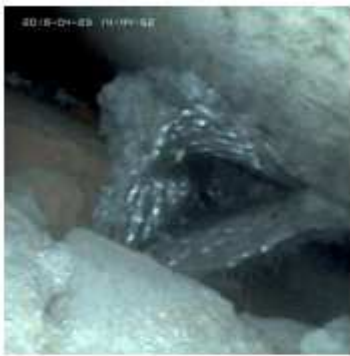
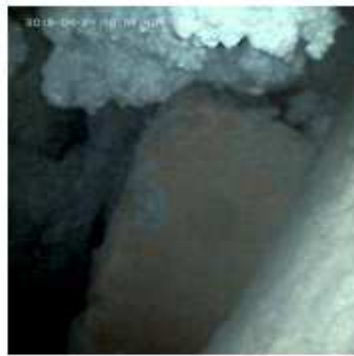
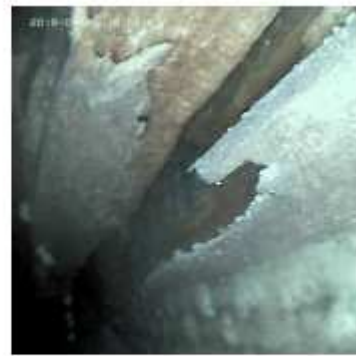
**Figure 2**

The filed investigation results(As shown in Figure 2 and Figure 3) show that there is a cavity with a thickness of 2 ~ 10cm between the GFRP backing and the red brick wall in addition to the structure mentioned in the engineering report. The red brick wall was built roughly and the brick joints are relatively large. Furthermore, there are 5~6 rows of horizontal wood keels adhered to the GFRP backing, which are parallel to each other. Their thickness is about 3cm, height is about 10cm, and length is basically equal to the width of a unit. However, there is no physical connection between the wood keels and the red brick wall, and some of the wood keels split near the bonding surface due to the deformation of the material. The wood keels of the two adjacent units are discontinuous and their upper and lower positions are staggered to a certain extent. The ends of some wood keels are covered by the upturned fiberglass cloth of the adjacent units, which is consistent with the description in the engineering report that the reinforcement was carried out unit by unit. The combination of "wood keels + GFRP backing" was commonly used as the support for the detached mural in China in the

(f) Splitting of the wood keel

Endoscopic photographs of internal structure details of the eave wall

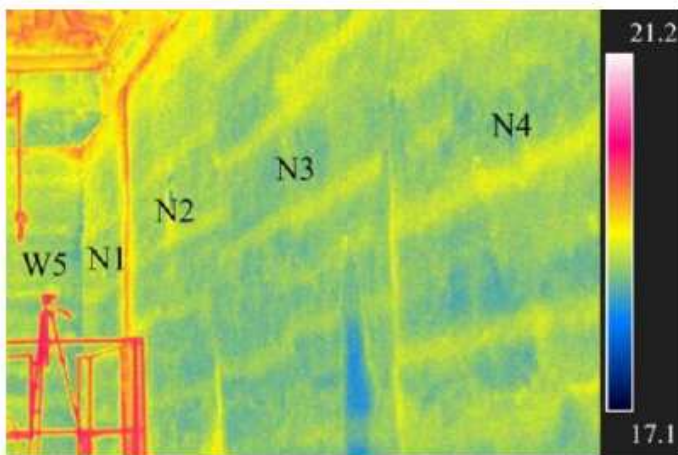
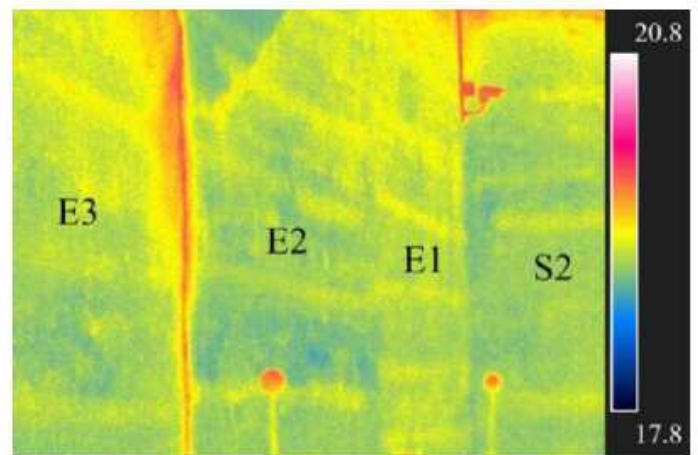
**Figure 3**

Infrared thermal images of the arrangement of wood keels behind the mural backing

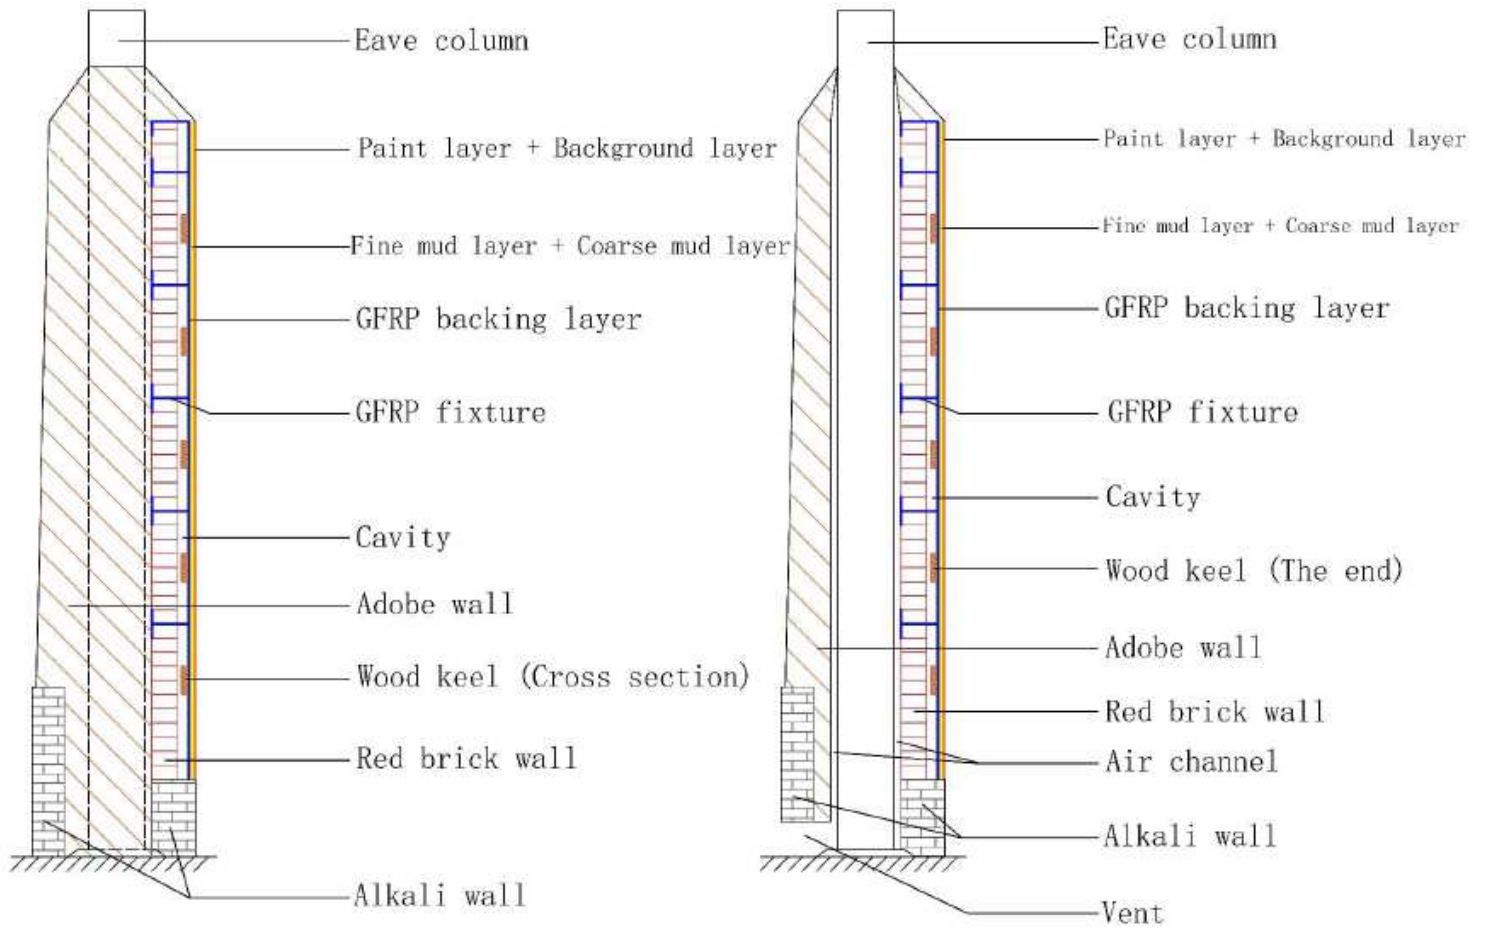
**Figure 4**

The structure of the wall at the junction of the two adjacent units, where is the joint part of wood keels and GFRP backing with a weak strength, is somewhat different from the wall in the unit due to the existence of inner columns. In order to protect against corrosion and buffer the expansion stress, two layers of reeds and flat tiles are wrapped around the wooden column, and a vent is arranged at the position of the column root on the external wall. The loose reeds form a ring of air channel about 5cm thick around the wooden column, which is connected to the cavity through the red brick wall joints. The existing basic structure of the eave wall mural is shown in Figure 4.

Cross-section of the eave wall mural's existing structure

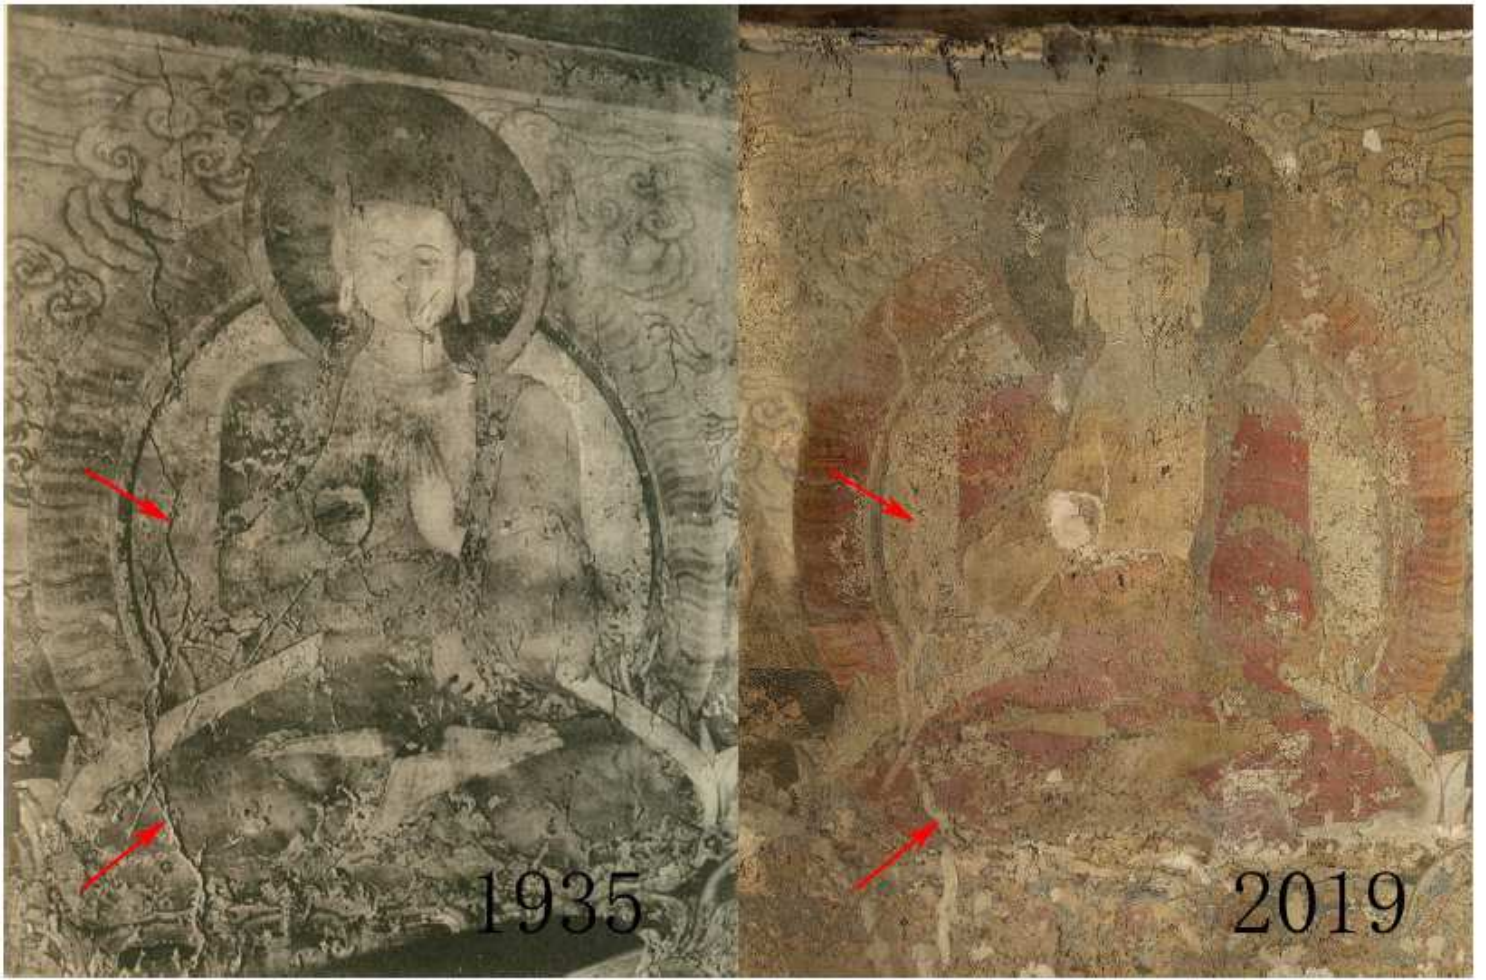
**Figure 5**

In the 1930s, the Japanese scholar Sekino Tadashi took a group of black-and-white photos of the eave wall mural of Daxiong Hall during his investigation in Fengguo Temple<sup>[16]</sup>. After comparing them with the existing murals, it is found that most of the initial cracks at that time have been filled with the same material (Figure 5), and it is one of the coordination measures of the reinforcement and protection project in the 1980s. Then the secondary cracks can be basically distinguished after eliminating very few initial cracks which have not been filled. In addition, some cracks obviously penetrate through the FRP backing layer, and can be directly judged as secondary cracks by the intrusion relation.

Comparison of the eave wall mural in Daxiong Hall between the present and the past (East wall E4)

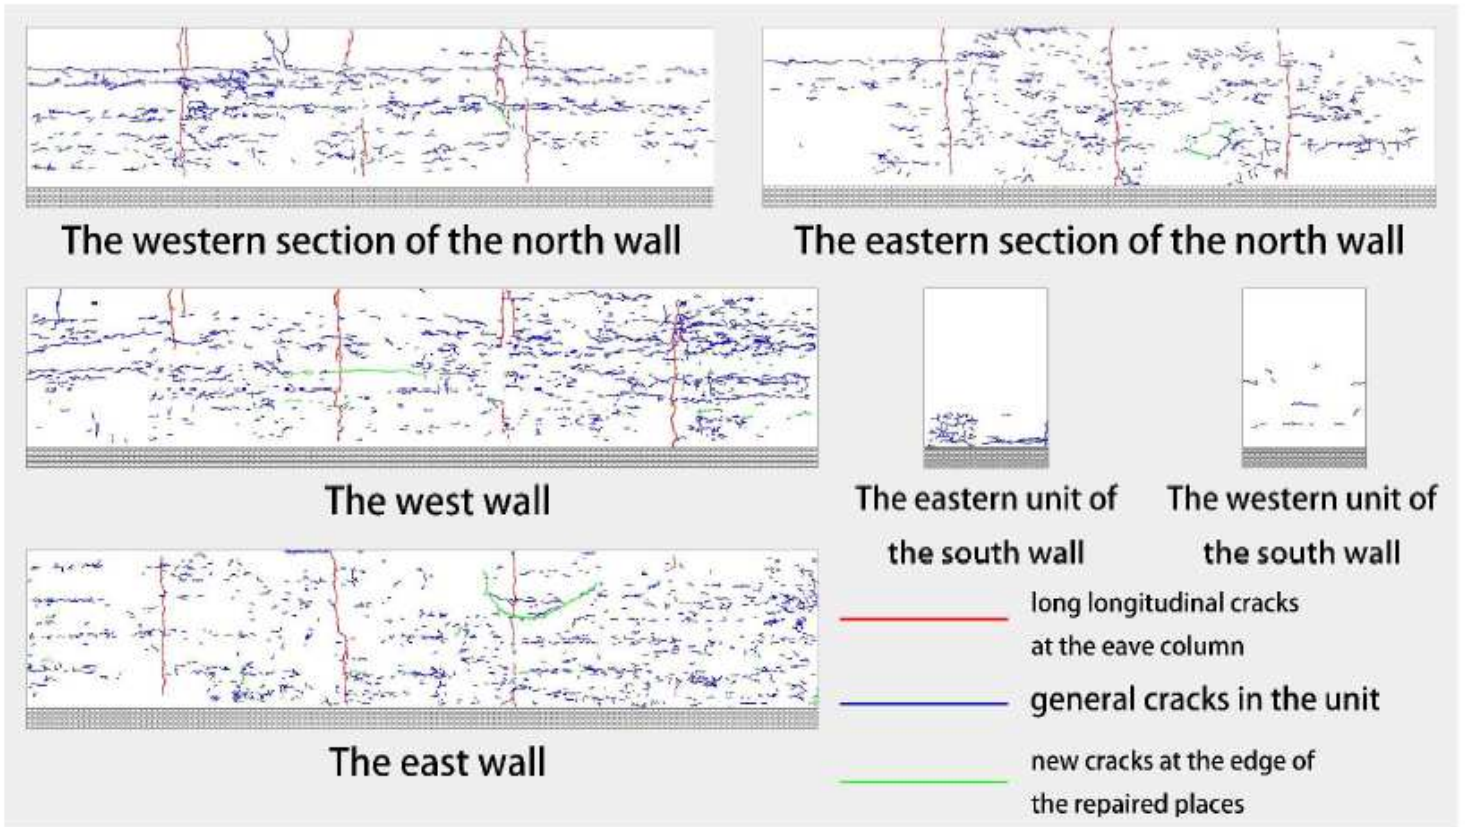
Figure 6 shows the planar distribution of secondary cracks on the surface of eave walls, which can be divided into three categories according to their attitude. The first category are the long longitudinal cracks at the eave column position, which are developed vertically and generally run through the whole wall from top to bottom, dividing the mural into units. Some of them are developed into upper and lower sections but have not yet been connected with each other. Most of these cracks have caused the tear of the GFRP backing, and the wall on both sides of them often has the phenomenon of dislocation due to shear failure. In terms of the orientation, the cracks in the north wall are obviously more serious than those in the east and west wall, especially the crack at the junction of N1 and N2, whose widest point can even reach 5cm. And the ends of horizontal wood keels are arranged on both sides of this kind of cracks. The second category are the general cracks in the unit. In addition to the long transverse cracks that intersect with the longitudinal ones at some locations, others mostly form transverse development trends in the form of short cracks groups. Several rows of parallel distribution are formed among different short cracks groups in the same unit, and their development locations are mostly near the edge of the horizontal wood keels. The third category are the new cracks at the edge of the repaired places, which are mainly the results of the release of internal stress along the weak part of the repaired edge.

The vector diagram of the distribution of secondary cracks of the eave wall mural

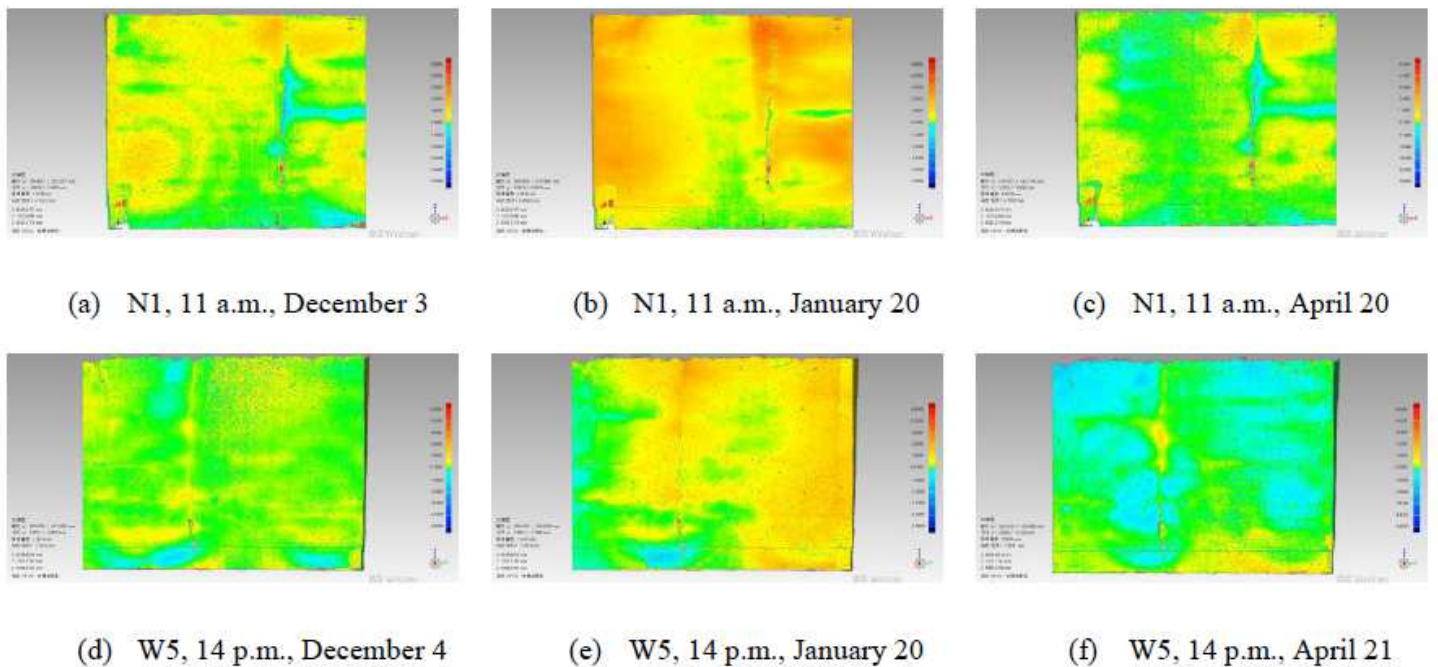
Figure 7

The 3D scanning point cloud data of the north wall (N1) at 11:00 on December 2, 2018 and the west wall (W5) at 14:00 on December 2, 2018 were respectively packed into a grid model as a reference, and the other three 3D scanning point cloud data of the corresponding wall from December 2018 to April 2019 were compared with it, and the deviation chromatogram was made as shown in Figure 7. It can be seen that the surface

Deviation chromatogram of surface deformation of the eave wall mural in the northwest corner of Daxiong Hall

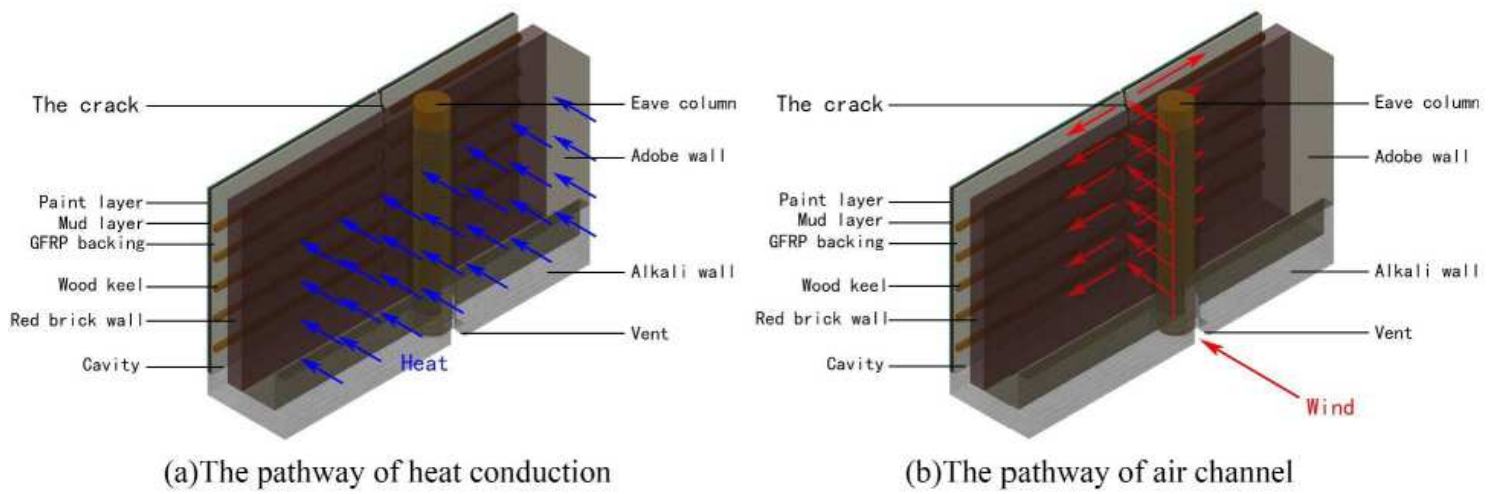
**Figure 11**

The pathway of external environment acting on the mural noumenon
