VIII. T-111 ALLOY CRACKING PROBLEMS  
DURING PROCESSING AND FABRICATION\*

R. A. Ekvall,<sup>†</sup> R. G. Frank,<sup>†</sup> and W. R. Young<sup>†</sup>

SUMMARY

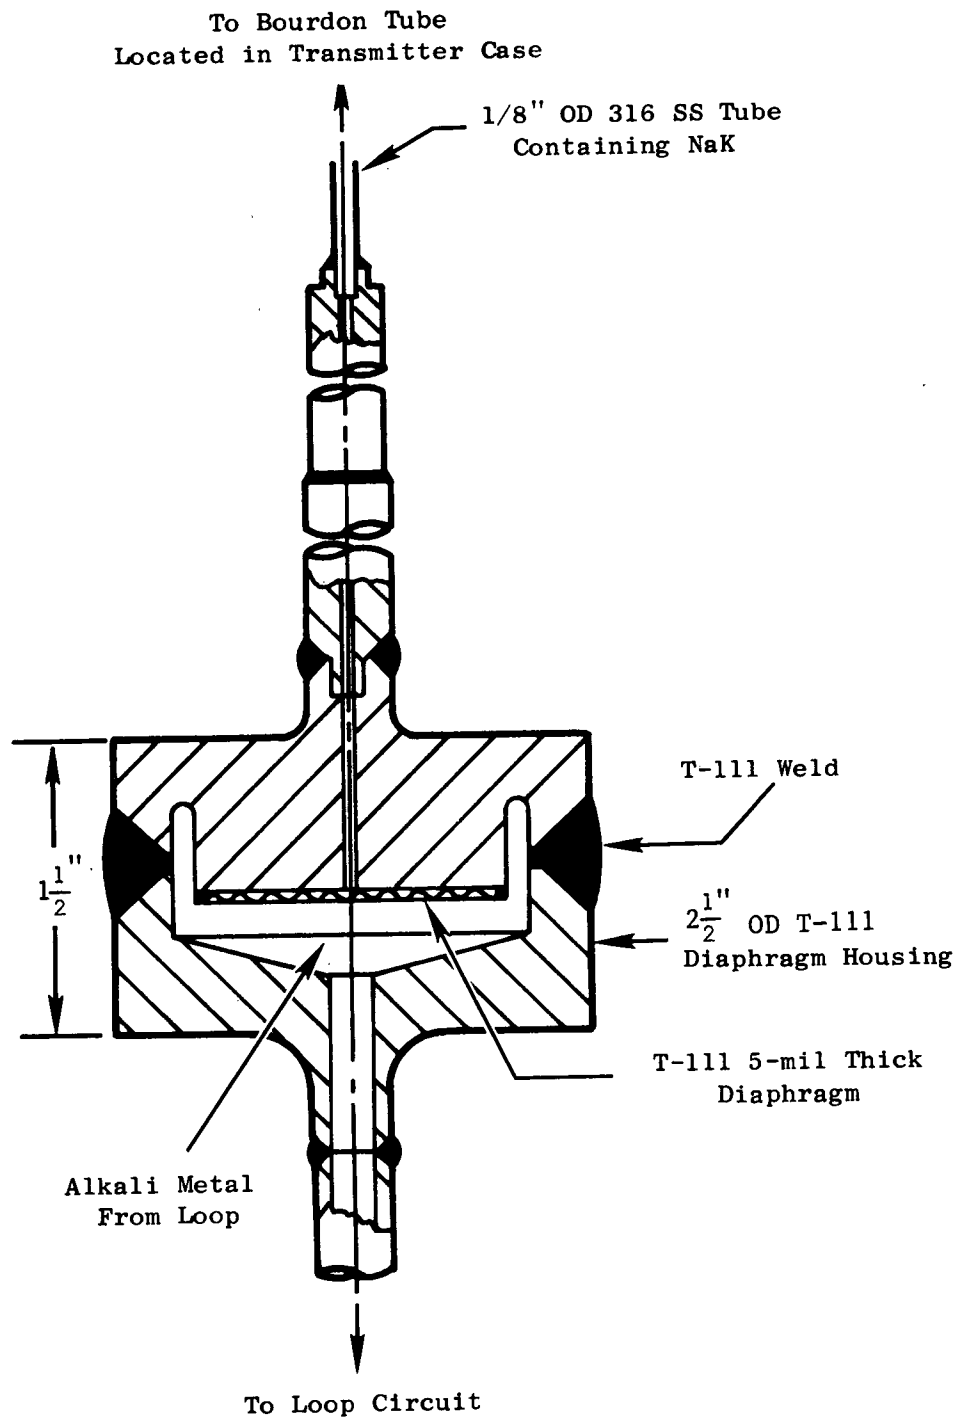
Figure VIII-13. - Full section view of Taylor pressure transducer showing its functional relation to loops of boiler test rig.
