**The 11 March 2011 East Japan Earthquake and Tsunami:
Tsunami Effects on Coastal Infrastructure and Buildings**

Abstract: The 11 March 2011 East Japan Earthquake and Tsunami caused unprecedented damage to well-engineered buildings and coastal structures. This report presents some notable field observations of structural damage based on our surveys conducted along the Sanriku coast in April and June 2011. Engineered reinforced concrete buildings failed by rotation due to the high-velocity and deep tsunami inundation: entrapped air in the buildings and soil liquefaction by ground shaking could have contributed to the failure. The spatial distribution pattern of destroyed and survived buildings indicates that the strength of tsunami was affected significantly by the locations of well-engineered sturdy buildings: weaker buildings in the shadow zone tended to survive while jet and wake formations behind the sturdy buildings enhanced the tsunami forces. We also found that buildings with breakaway walls or breakaway windows/doors remained standing even if the surrounding buildings were washed away or destroyed. Several failure patterns of coastal structures (seawalls) were observed. Flo

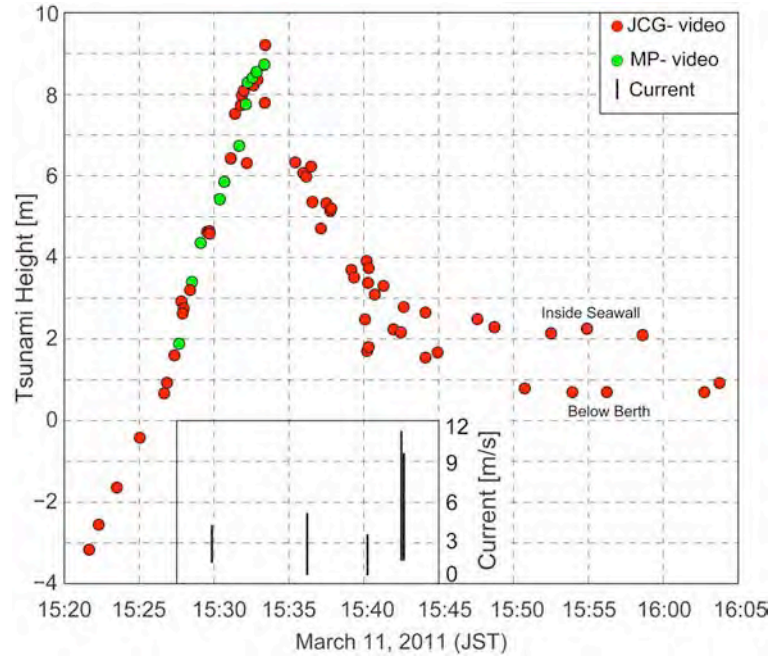
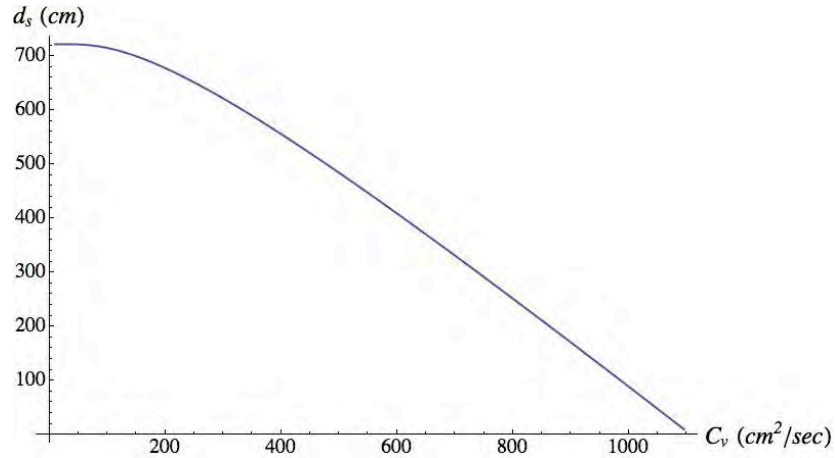
Applying (4) to the tsunami runup-and-return-flow data measured in the town of Kesen-numa (Fritz et al. 2011), a layer thickness of fluidized soil d_s is calculated and the results are presented in Fig. 7. Note that Fritz et al. (2011) extracted the temporal variations of flow velocities and water-surface elevations from the video footage with the aid of ground based Lidar measurements. Here we used $\Delta p / \rho g = 8.5$ m and $\Delta T = 10$ minutes taken from the inundation history shown in Fig. 7, and the buoyant specific weight of the soil $\gamma_b = 880$ dynes/cm³. Creating the condition to test for (3) and monitoring the pore pressures in the laboratory, Yeh et al. (2004) obtained the average value of consolidation coefficient $c_v = 750$ cm²/sec with a range from 400

to $1200 \text{ cm}^2/\text{sec}$ for Ottawa Fine Sand with $D_{50} = 0.26 \text{ mm}$. Such a wide range of the variations is attributed mainly to a variety of soil compaction used in the experiments. The uncertainty in the value of the consolidation coefficient c_v as well as its high sensitivity to the fluidization depth d_s – see Fig. 7 – does not allow us to make an accurate estimate for the fluidized soil layer. Nonetheless, the result in Fig. 7 demonstrates that the rapid return flow of the 2011 Tsunami is capable of fluidizing the sandy soil down to a substantial depth. For example, the fluidized layer thickness is $d_s = 290 \text{ cm}$ for $c_v = 750 \text{ cm}^2/\text{sec}$, $d_s = 410 \text{ cm}$ deep for $c_v = 600 \text{ cm}^2/\text{sec}$, and $d_s = 520 \text{ cm}$ for $c_v = 450 \text{ cm}^2/\text{sec}$. The maximum possible liquefaction depth is $d_s \rightarrow \Delta p / \gamma_b = 720 \text{ cm} > 7 \text{ m}$! Therefore, the results suggest that the substantial development of excess pore-pressure gradients can trigger upward forces from underneath, which could have caused the scenes of ripped-out asphalt slabs shown in Fig. 4, as well as the severe scour hole and the undermined road (Fig. 6) in the town of Tohni: recall that flow velocities in those areas could not have been large judging from the surrounding damage conditions.

The traditional scour mechanism for steady flow is the bed shear stresses, but the excess pore-pressures play little role in the soil instability. On the other hand, tsunami flows are transient with the timescale of tens of minutes. The result shown in Fig. 7 demonstrates that the effects of pore-pressures can be substantial for the 2011 Tsunami. It is likely that the excess pore-pressure gradients contributed the damages such as the scour holes between the buildings shown in Fig. 3a and Fig. 4c, as well as the seawall failure in Kirikiri (Fig. 5c).

pressurized and saturated soils at the time of maximum inundation; such condition occurred unlikely in the 2011 event because the runup process was not slow as shown in Fig. 7. In other words, the soils must have been less pressurized than the assumption, which could overestimate the fluidized depth d_s .

Figure 7. (a) Time history of tsunami inundation depth in the town of Kesen-Numa, extracted from video footage (after Fritz et al., 2012). (b) Predicted liquefaction thickness vs. the consolidation coefficient c_v due to rapid reduction of the tsunami inundation depth as described in equation (4).
