**THE BUMP AT THE END OF THE BRIDGE**

**KYHPR-64-17; HPR-1-(4), Part II**

**June 1969**

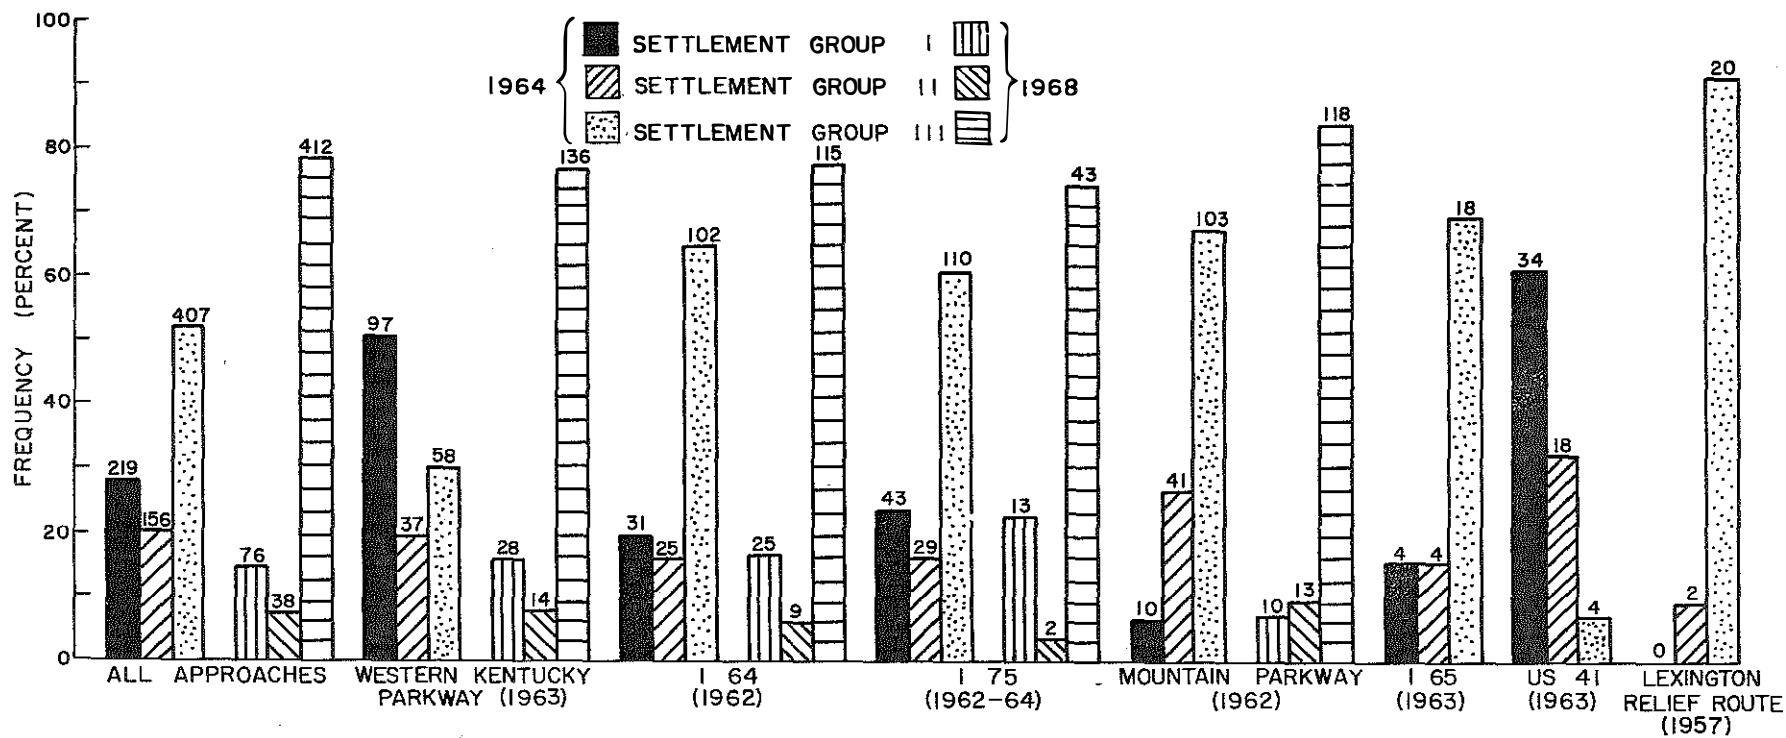
FIGURE 3. COMPARISON OF BRIDGE APPROACHES BY ROUTES

The criterion used to distinguish between Groups I and II was whether or not a 'bump' was evident when an automobile passed onto or off the bridge deck. Additional information was obtained by visually inspecting each approach. Figure 3 summarizes the 1964 and 1968 data, showing the total number and percentages of approaches classified in accordance with each settlement group. In addition, the ages (approximate dates opened to traffic) of the approaches are shown. The majority of approaches were at least two years old in the 1964 survey. From these data, it is evident that present design and construction procedures are not sufficient to obtain smooth bridge approaches.

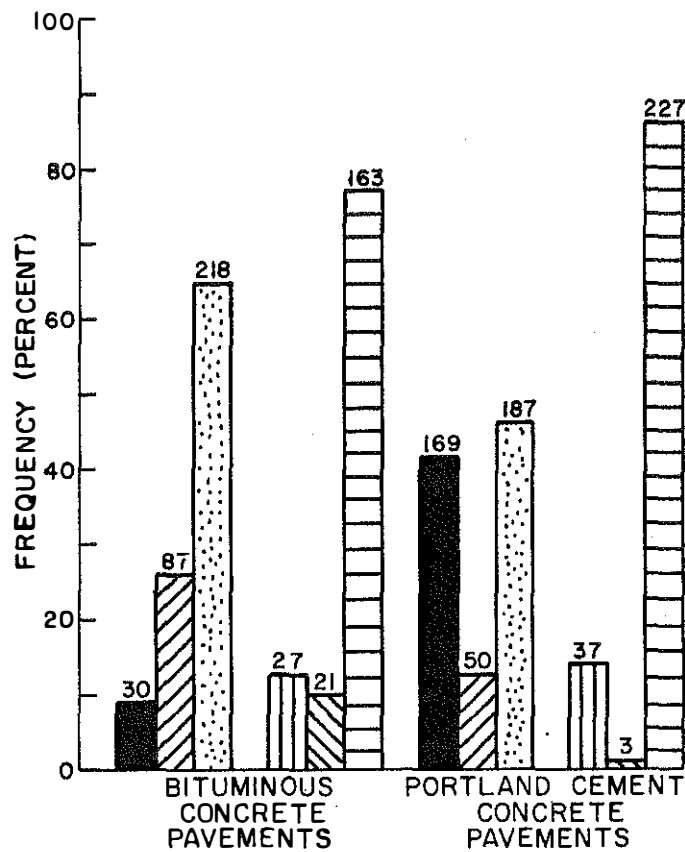
FIGURE 4. COMPARISON OF BRIDGE APPROACHES BY PAVEMENT TYPE

A comparison of portland cement concrete and bituminous concrete approaches, Figure 4, shows a markedly higher percentage of bituminous concrete approaches with patching than rigid approach pavements with mudjacking in 1964. In addition, there was a much greater percent of smooth approaches (Group I) for concrete approaches than for bituminous approaches. However, in 1968, the difference in percentage of mudjacked and patched approaches, as well as smooth approaches, was almost insignificant. Furthermore, the 1968 data, when compared to 1964 data, showed that there was an appreciable percentage decrease in smooth approaches and an increase in maintained approaches for both types of pavements. Apparently, at least for a short period of time, the rigidity of portland cement concrete pavement reduced the occurrence of the approach fault by bridging the presumed depression behind the abutment. Generally, the approach settlement appeared to be confined within 100 feet of the end of the

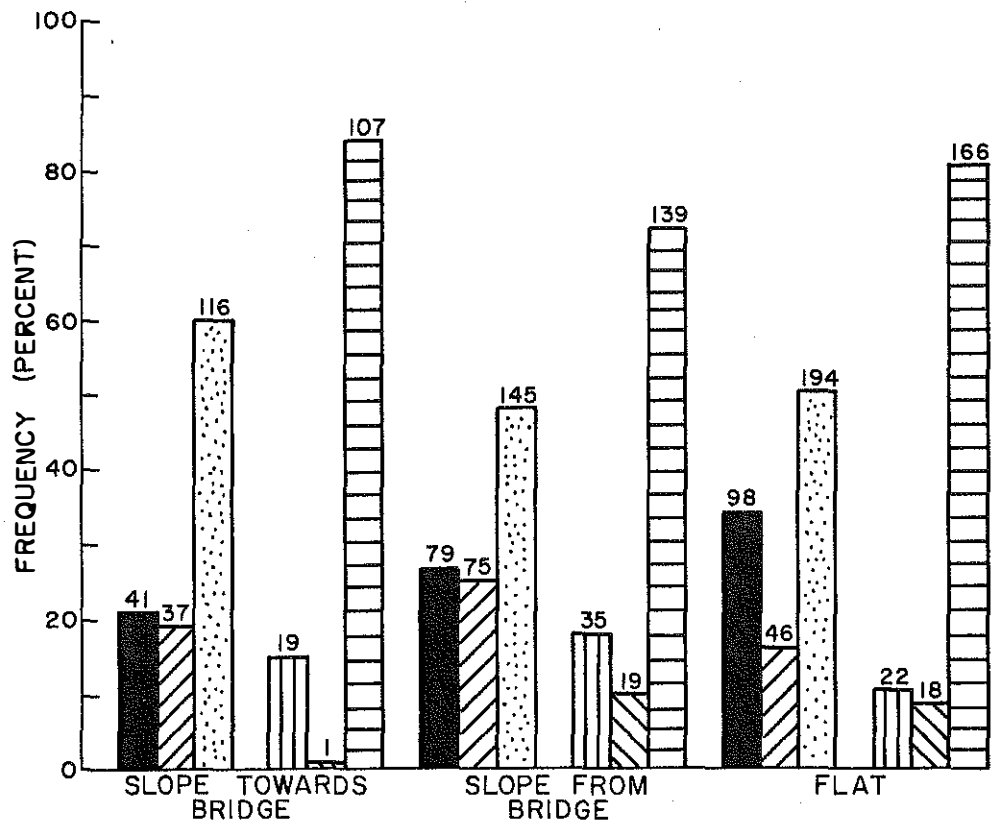
FIGURE 11. COMPARISON OF BRIDGE APPROACHES BY SLOPE OF APPROACH PAVEMENT

Other supporting evidence that seepage may, in some cases, result in settlement of the approach is presented in Figure 11. A comparison was made among those approaches which sloped toward the abutment, those which sloped away and those which were relatively level with respect to the three settlement groups. Those which sloped toward the abutment had a higher percentage of Group III approaches than the other two categories.

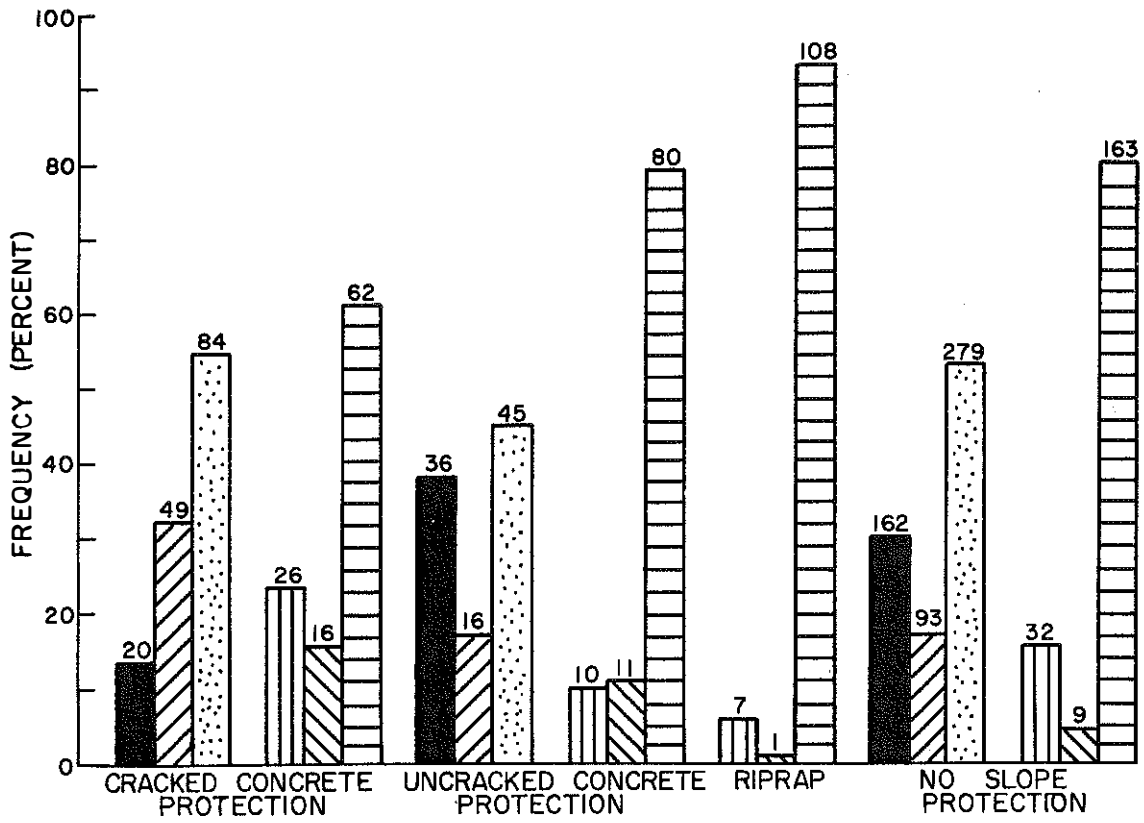
FIGURE 12. COMPARISON OF BRIDGE APPROACHES BY TYPE OF SLOPE PROTECTION

There was suggestive evidence that progressive failure, or creep, of the approach embankment may, in some cases, contribute to development of the approach fault. Figure 12 is a comparison of approach embankments with cracked concrete slope protections, embankments with uncracked concrete slope protections, and embankments with no slope protection, suggesting a relationship between cracked slope protections and bridge approach settlement. One possible explanation for the cracked slope protections could be progressive failure of the embankment, as shown in Figure 13, resulting in a loss of subgrade support. In some cases, slope protections did appear to be bulging outward.

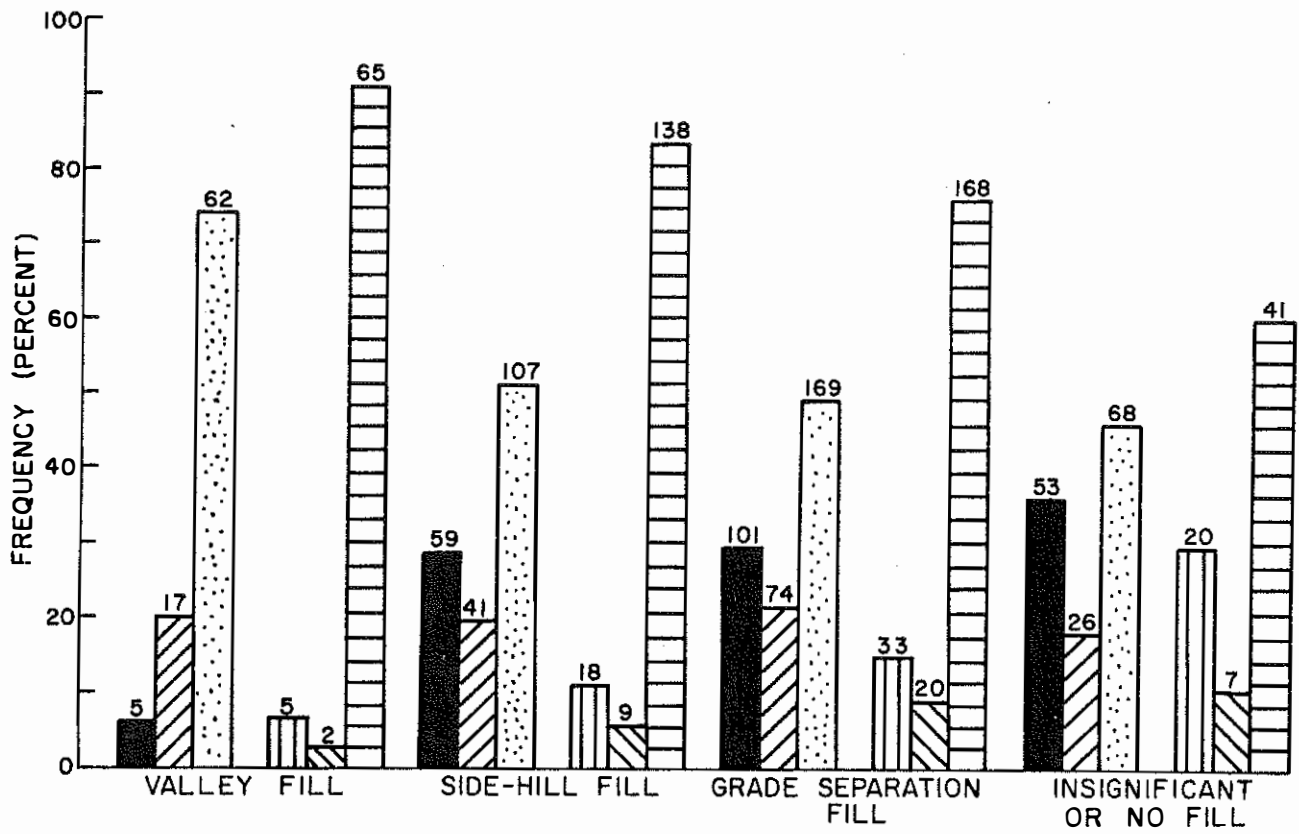
FIGURE 16. COMPARISON OF BRIDGE APPROACHES BY TYPE OF EMBANKMENT

Different types of embankments were studied with respect to the settlement groups. These data, Figure 16, show that embankments located in valleys of major streams had a much greater percentage of Settlement Group III approaches than embankments at other locations. Side-hill fills were considered to be those embankments which were generally part fill and part cut. Grade separation embankments were those considered to be built-up on a relatively flat plain. It is reasonable to assume that valley fills were located on foundations which were thicker than the other types of fills. Hence, these data probably reflect the importance of the foundation as a variable in bridge approach settlement. Those faulted approaches with embankments three feet or less in height may reflect improper backfill placement and compaction and such other causative factors as erosion or swelling and shrinkage.

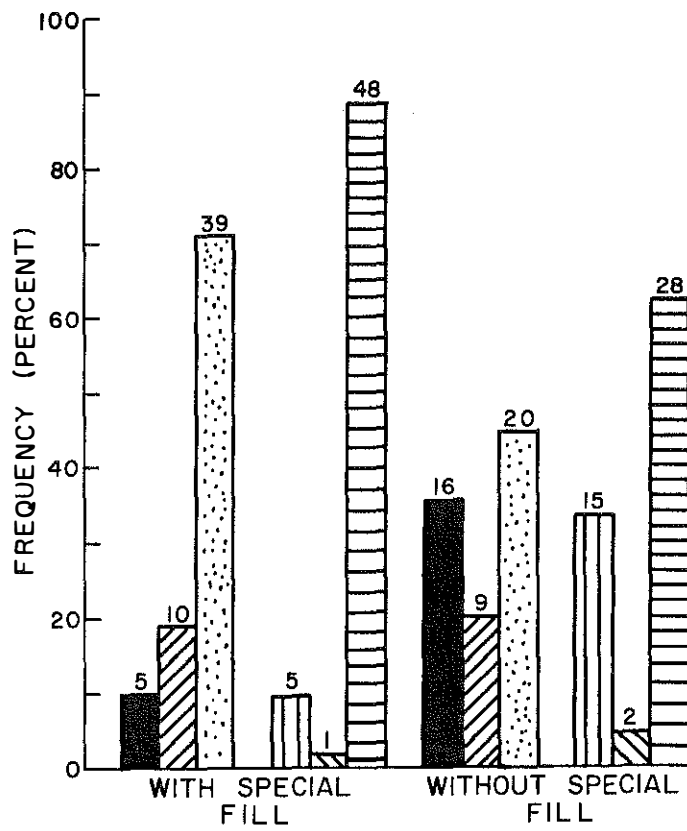
FIGURE 20. COMPARISON OF BRIDGE APPROACHES BY USE OF SPECIAL BACKFILL MATERIAL

The performance of bridge approaches associated with the special granular backfill is shown in Figure 20 and compared with bridge approaches not associated with the special backfill on the same route. The data show that backfilling behind abutments in a manner specified by Kentucky Standard SF-1 did not check the development of faulted approaches. Moreover, for cases involving the special backfill when compared to cases without the special fill, there was an increase in frequency of faulted approaches.
