The Effect of Humidity on the Reliability of a Surface Micromachined Microengine

Danelle M. Tanner, Jeremy A. Walraven, Lloyd W. Irwin, Michael T. Dugger, Norman F. Smith, William P. Eaton, William M. Miller, and Samuel L. Miller

Sandia National Laboratories, P.O. Box 5800, MS 1081, Albuquerque, NM 87185-1081
<http://www.mdl.sandia.gov/Micromachine>
 email: tannerdm@sandia.gov

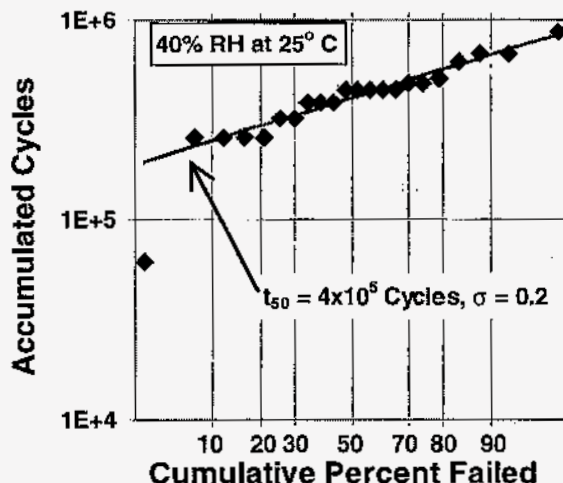
The data from each of the experiments could be described by a simple unimodal distribution such as seen in Figure 3. The regression analysis yielded a median of 4×10^5 cycles to failure with a correlation coefficient of 0.98. The shape parameter, σ , was determined to be 0.2. The above analysis was completed for each experiment and a value for the median and sigma of each distribution was calculated. We performed nine experiments during which a total of 262 parts failed. A larger number of experiments were performed with the FTS process simply because of their greater availability.

Figure 3. Lognormal distribution of accumulated cycles to failure for the 40% RH stress. The early failure, with less than 10^5 cycles, was omitted from the regression analysis.

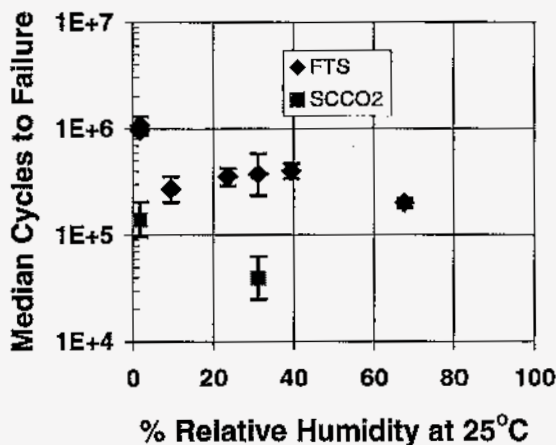
Table 2 has the results of lognormal fits to all of the humidity experiments. The data is also graphically represented in Figure 4 with 95% confidence bounds represented by error bars. The figure shows a rather flat dependence on humidity for the FTS-coated microengines with the exception near 0%. The SCCO_2 data shows the failure roughly an order of magnitude earlier, indicating a less reliable microengine.

Figure 4. The effect of humidity on the lifetime of the microengines shows a rather flat distribution with the exception near 0%. The y error bars represent 95% confidence bounds. The microengines were stressed with large forces to accelerate failures in these experiments.

The behavior of the microengines tested at levels near 0% was quite different. In this low humidity case, there was a dramatic increase in the amount of wear debris, regardless of the coating method. We first noticed the formation of wear debris after accumulation of roughly 10^5 cycles. The debris was typically thrown out from the hub and collected on the gear face and surrounding substrate. In general, the gear hubs were worn down and the gears exhibited severe wobble during operation. In 55% of the failures (31% for SCCO_2), the pin joint actually wore down and severed. We suspect that the large wear rate removes any asperities that would cause the gear to seize in the same manner as the higher humidity levels. Therefore, wear of polysilicon would continue until the pin joint is worn away, causing failure at a much higher number of cycles. The increase in median cycles to failure observed at 1.8% RH in Figure 4 resulted from this change in failure mechanism and was not a true indication of increased reliability.

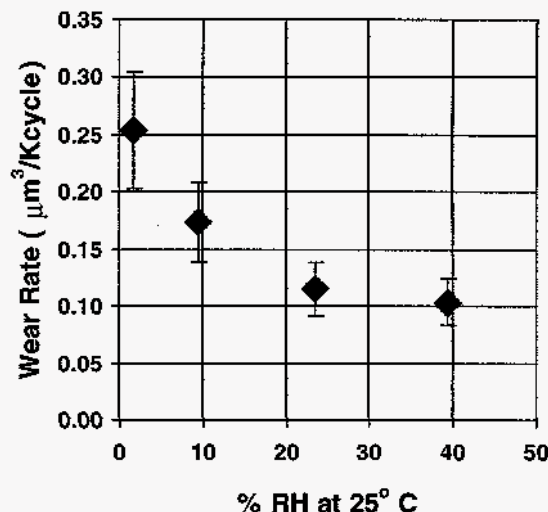
The locations exhibiting the most wear were the hub and pin joint areas so we made our estimates there. Measurements of the diameter of worn hubs, gears, and pin joints were made. The cross sectional area was calculated and compared to the control to yield a value for worn area. This value was then multiplied by the thickness to yield the volume of the material worn away. The technique assumes that the wear is symmetrical around the hub and pin joint. We estimated the error in the technique as $\pm 20\%$ of the calculated worn area. The wear volume was normalized by the total number of cycles to failure to yield wear rate which is shown in Figure 13 as a function of % RH at 25°C.

The wear rate shown in Figure 13 agrees with studies of a SiC/SiC system [20] where the decrease in wear rate has been attributed to a tribochemical reaction leading to the formation of a protective film of hydrated amorphous silica. Silicon nitride sliding on silicon nitride was also investigated [21] and the main mechanism of wear was the tribochemical oxidation of the silicon nitride to form silicon oxide. The wear rate increased in drier conditions in the silicon nitride case also.

Figure 13. This plot of wear rate of FTS-coated microengines as a function of humidity shows the increase in wear rate as humidity decreases. (FTS)
