# The Ice Particle Threat to Engines in Flight

**This paper discusses jet engine powerloss and damage due to ingestion of ice particles. In the mid-90s several commercial airplane jet engines experienced more frequent powerloss in ice particle conditions, resulting in a focused investigation, and a greater awareness that led to recognition of similar events on other aircraft. Since the mid-90s, events have been more numerous, and costly, and have generated greater industry interest. These events have been predominately associated with flight at high altitude near deep convective systems, often in tropical regions. Data are presented from flight-testing and an event data base to support the contention that the events are caused by ingestion of high concentrations of ice particles, and that supercooled liquid water is either of secondary importance or not required. The basic theory of how ice accretes in the engine by this process is described. Complex issues facing industry to mitigate the problem, and simulation of the ice particle environment are discussed.**

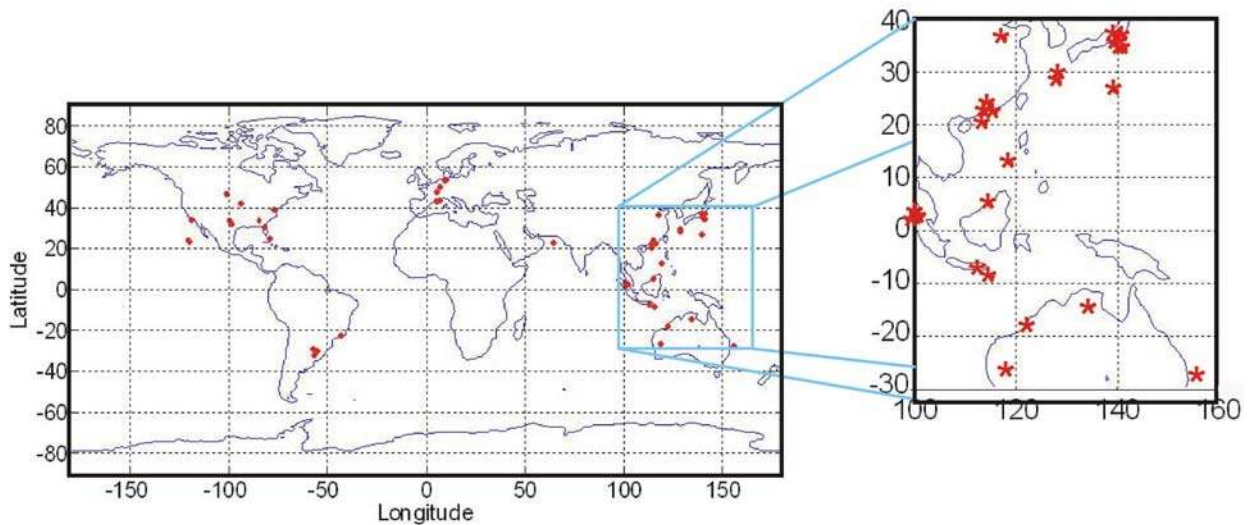
**Figure 2: Locations of small commuter and large transport engine events for 46 events chosen for this study, with inset of events in Asia-Pacific region.**

Data from 46 engine powerloss or core damage events were considered for this report. This event database includes nine different aircraft types, both large transport and commuter jets, and eight different engine types. While other engine powerloss events are now thought to be attributable to ice particles, insufficient event data are available for these events to draw significant conclusions. In addition, review of past event data (some as recent as 2002) shows that in some cases, events were attributed to icing, and successful corrective action was taken, without recognition that ice particles were responsible. These events have been included when sufficient data for analysis exists.

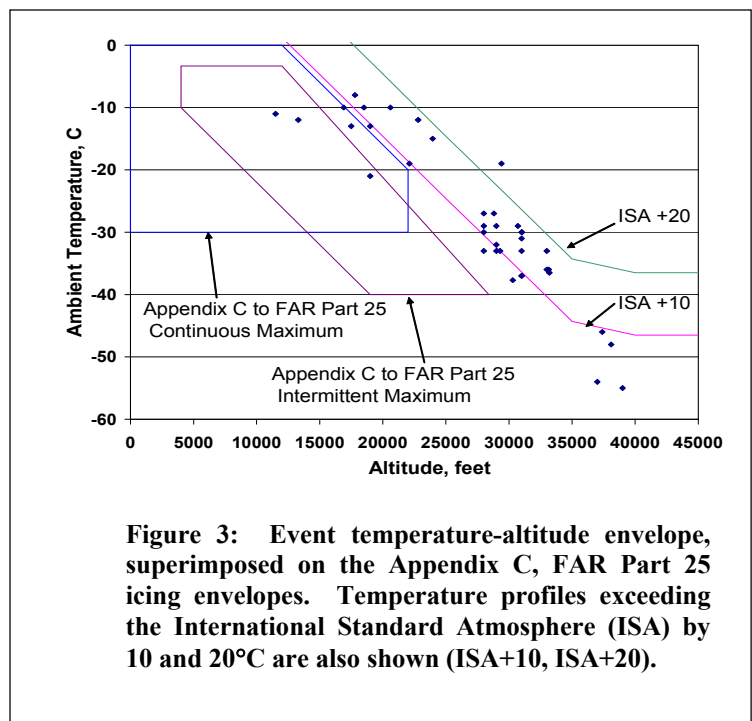
**Figure 3: Event temperature-altitude envelope, superimposed on the Appendix C, FAR Part 25 icing envelopes. Temperature profiles exceeding the International Standard Atmosphere (ISA) by 10 and 20°C are also shown (ISA+10, ISA+20).**

outside the FAR Part 25 Appendix C envelope<sup>23</sup>, and are generally found in a warmer atmosphere. Events occur as cold as ISA-5, but generally occur from ISA+10 to ISA+20. In the small number of cases (5) where the event occurred near the freezing level, other data, such as the aircraft total air temperature (TAT) anomaly (i.e. the corruption of the temperature measurement due to ice particles), were used to conclude ice particles were present. The TAT anomaly will be presented as a key indicator that ice particles were present in these events, and support for this contention will be provided in section V. The TAT anomaly was noted in 35 of the 46 events. Rosemount TAT sensors of similar design are installed on all of the airplanes in the event database. The TAT sensor response appears to be different depending on the location on the fuselage where the sensor is installed. This was concluded after examining the events for a single engine type, and TAT design that is installed on more than one airframe. For one airframe, none of the events showed the TAT anomaly, however meteorological analysis suggested that ice particles were present. The ambient temperature presented for events having TAT anomaly is either estimated by interpolating between good data, or from radiosonde soundings.

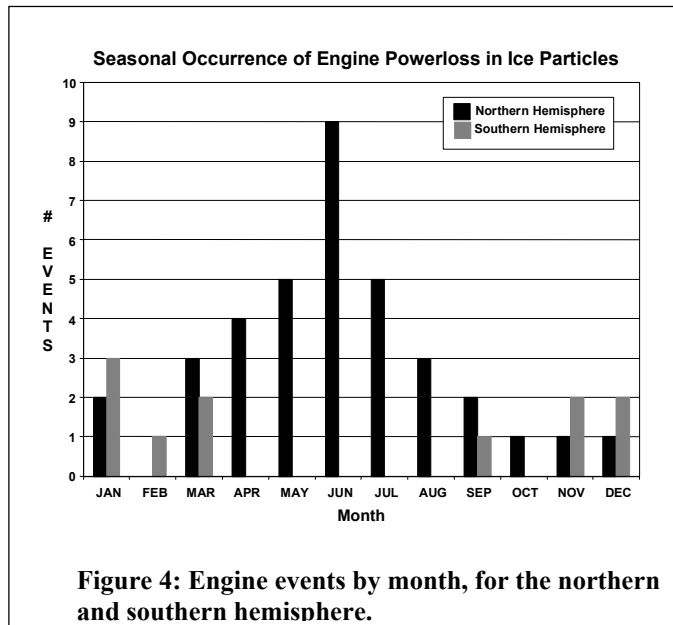
Fig. 4 presents the events by month, for the northern and southern hemisphere. There does seem to be a summertime trend to the data, perhaps a reflection of more vigorous convection in the summer. The relatively fewer events in the southern hemisphere may be explained by the smaller population and hence fewer flights in the southern hemisphere

**Figure 4: Engine events by month, for the northern and southern hemisphere.**

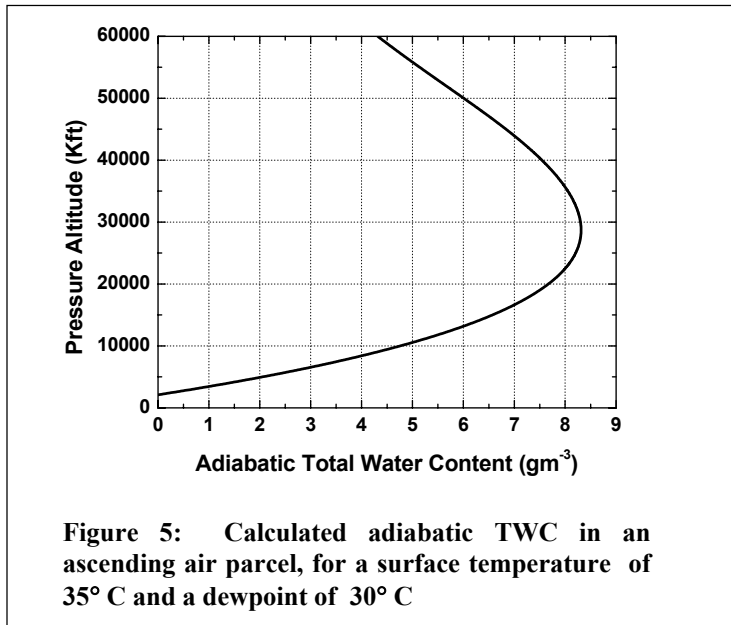
scenario of a fully glaciated cloud. Note that the IWC reaches a maximum of about  $9 \text{ gm}^{-3}$  at around 30,000', and thereafter decreases with altitude. This figure represents a first approximation for the highest cloud IWC that could be expected in such an atmosphere. In nature, we would expect this adiabatic value to be reduced significantly by dilution with mixing surrounding air and by fallout and/or redistribution by precipitation. For example, in tropical oceanic clouds, the low updraft velocities are thought to provide sufficient time for rain to develop below the freezing level, thus depleting the adiabatic values by fallout. Note however that the complexity of the precipitation redistribution process could, at least in theory, also lead to localized areas exceeding the simple adiabatic calculation (for example large particles falling into an undiluted adiabatic parcel), although in general it is commonly thought that even adiabatic levels are unlikely high in deep

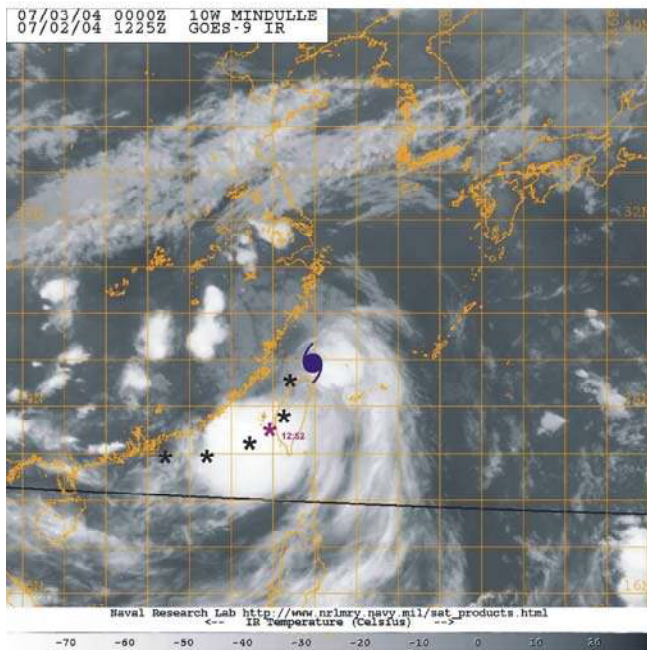
This case study provides a detailed description of a large transport engine event, and a more detailed discussion of some of the common observations noted during events that are summarized in section II. This particular event has been chosen due to its comprehensive in-flight, pilot report, and supporting meteorological data. The event occurred in the early summer on a flight between Hong Kong and Taipei. Category 4 Typhoon Mindulle had tracked from the south/southeast along the east coast of Taiwan, and at the time of the event its had been downgraded to a tropical storm, with a center located about 400 km to the northeast of the aircraft location. During the 5-hour period prior to the event, an area of intense multi-cell convection well to the southwest of the tropical storm center had built up over the South China Sea, and its rapidly expanding anvil area was visible in sequences of satellite imagery. Fig. 8 displays the satellite imagery about 30 minutes prior to the incident. The track of the aircraft is depicted as asterisk symbols at 15-minute intervals proceeding east to Taipei. A purple asterisk symbol marks the location of the event. The center of the storm is denoted with the special tropical storm symbol. Note that the incident occurred near the center of a circular bright cloud top anvil region, and was obviously in the vicinity of deep convection. The satellite picture one hour later looks similar, with some growth of the circular area but very little translation, and it is quite clear that the aircraft traversed through the center of this region. Composite imagery from ground meteorological radars over a smaller region encompassing the main cloud traversed by the aircraft is shown in Fig. 9, with open flight-track symbols at 15-minute intervals, and a asterisk denoting the engine event

**Figure 8: Satellite picture of tropical storm Mindulle, with flight track of aircraft across an area of convection in the south China Sea. Black symbols represent the track at 15-minute intervals. The Purple symbol denotes the location of the engine event. The center of the storm is indicated as the special symbol just north of the island of Taiwan.**

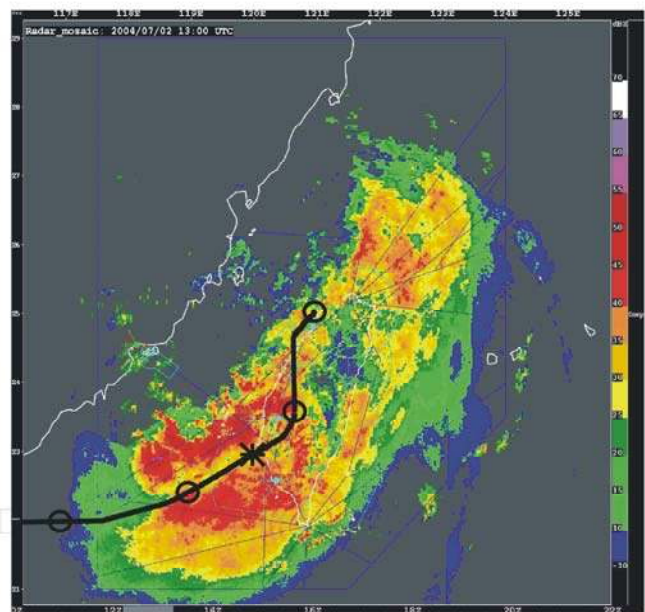
**Figure 9: Composite meteorological radar low-level mosaic for tropical storm Mindulle, approximately 8 minutes after the engine incident. The flight track of the aircraft is shown in the solid line. Fifteen-minute time intervals are marked by open circles, and the position of the engine event is shown by the asterisk.**

position. Note that this is a low-altitude radar reflectivity pattern from surface-based radars, and is thus mapping the pattern of rain and/or possibly unmelted hail regions well below the freezing level, and not at flight altitude. As the aircraft entered the region of precipitation at 38,000' and  $-42^{\circ}\text{C}$  SAT, it was flanking a region of intense low-altitude precipitation to the southeast, with a second intense region to the northwest. The pilot started a descent at about 12:45 (the symbol before the event asterisk on Fig. 9) just on the edge of an area of intense low-altitude radar echoes, and reported entering cloud, heavy rain, moderate turbulence, with some lightning in the general area, but noted no significant radar echoes on his radar and confirmed that there was no airframe icing. Figs. 10a and 10b show the SAT and TAT traces on the climb out of Hong Kong, and during this descent towards Taipei. First note that the SAT temperature profile is about  $20^{\circ}\text{C}$  warmer than a standard atmosphere, an observation similar to that of many engine events. The SAT climb trace is quite similar to that of the descent, except between 37,000' and 26,000', where the descent temperature-trace is peculiar. Overall, referring to the TAT profiles, the beginning of a TAT anomaly is apparent on the descent profile starting at about 37,000' as it pegs and holds at about  $0^{\circ}\text{C}$  until about 32,000', where the expected true TAT (roughly approximated from the climb TAT) goes above  $0^{\circ}\text{C}$ .

altitude, the reflectivity was approximately 16 dBZ, with occasional brief regions of 20 dBZ. Far below and below the freezing level in the heavy rain area of the hurricane, the reflectivity in the bright band exceeded 30 dBZ, similar to the low-altitude reflectivities of Fig. 9, and in fact was attenuated by the heavy precipitation so that actual values are underestimated. A standard pilot's weather radar has a threshold of about 20 dBZ, and would therefore be insensitive to such glaciated high-IWC regions, or would at most show some returns at the green level. One important note is that regions of low-altitude high reflectivity on ground meteorological weather radars in convective storms, such as shown in Fig. 9, are also an indication of potentially high IWC above the freezing level that may be conducive to engine powerloss.
