**THE MECHANICS OF LANDSLIDES IN LEDA CLAY**

W. J. EDEN AND R. J. MITCHELL

*Reprinted from*  
CANADIAN GEOTECHNICAL JOURNAL  
VOL. VII, NO. 3, AUGUST 1970  
p. 285

RESEARCH PAPER NO. 441  
OF THE  
DIVISION OF BUILDING RESEARCH

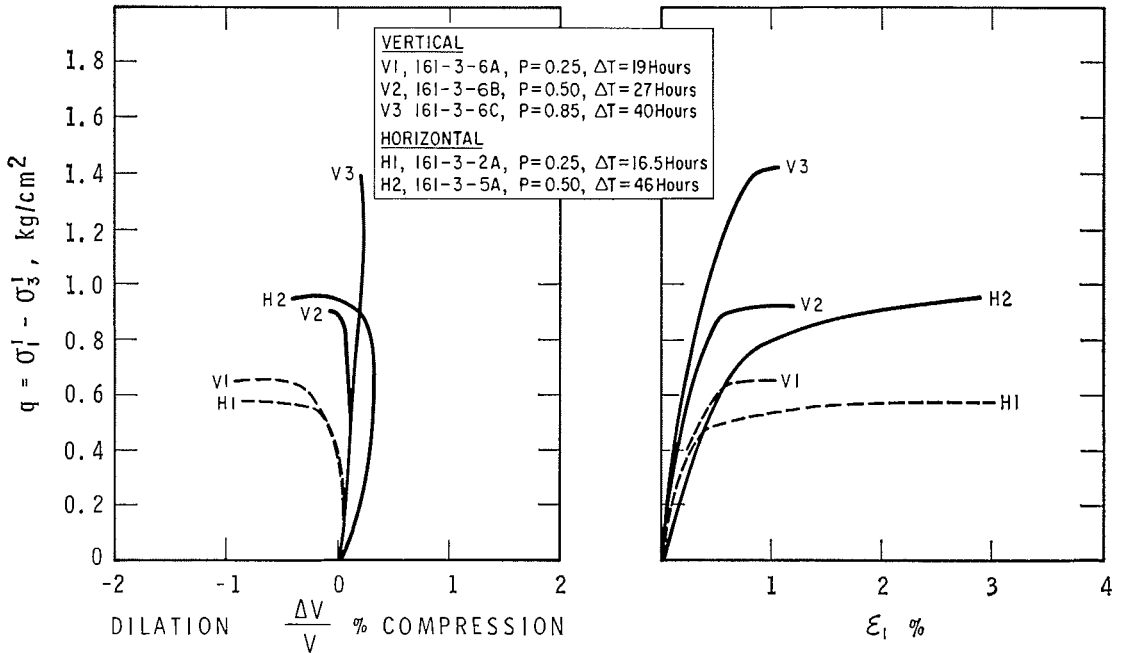
Stress-strain curves from several of the constant  $p$  tests are plotted in Figs. 2 and 3. Figure 2 shows a comparison between the behavior of vertical and horizontal specimens. Figure 3 shows the behavior of large diameter

FIG. 2. Shear behavior of Leda clay under low confining pressures.

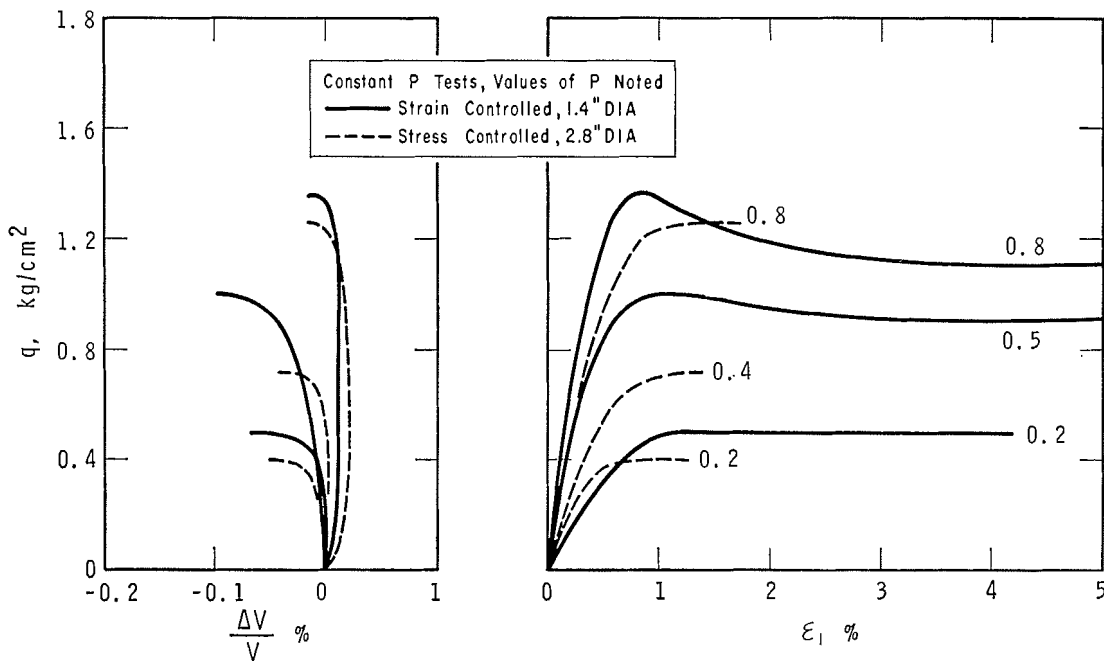
specimens and the behavior of specimens in strain controlled tests. All the specimens tested developed a shear plane at (or near) the maxi-

FIG. 3. Additional triaxial test data.

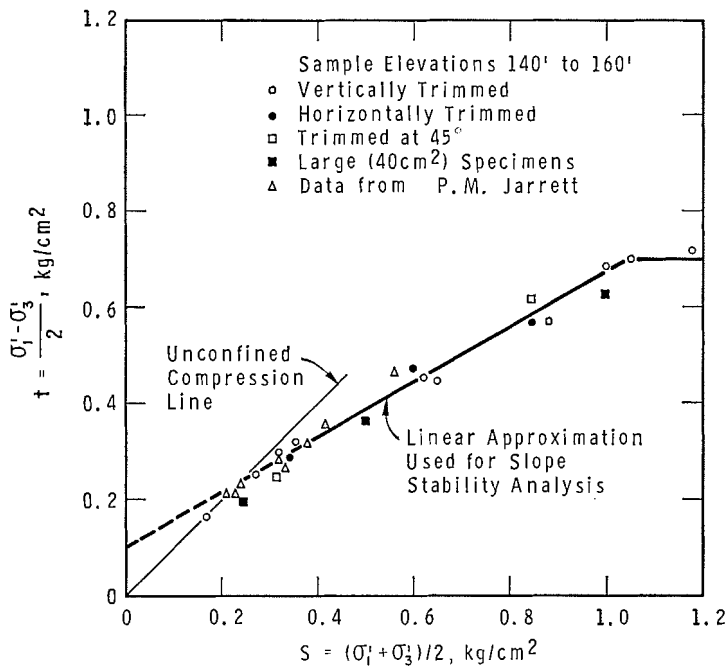
decreased as the mean normal stress at failure increased. Failure points (maximum deviatoric stress) for all tests are plotted in Fig. 4 with respect to the commonly used plane stress parameters

Test specimens of 10 cm<sup>2</sup> nominal area appear to be large enough to eliminate any significant size effect. At higher stress levels, such as shown on the horizontal portion of the envelope in Fig. 4 orientation and rates of testing might have an influence.

FIG. 4. Strength of Leda clay from the Rockcliffe site.

the trial circle numbers). A failure envelope ( $c' = 0.12 \text{ kg/cm}^2$ ,  $\Phi' = 33^\circ$ ) was chosen to approximate the triaxial test data in Fig. 4. The circles with centers at  $c_3$ ,  $c_4$ , and  $c_7$  in Fig. 7a yield stress points 3, 4, and 7 which lie on this failure line. As the circle with center  $c_3$  was calculated to be critical for  $\Phi' = 33^\circ$  the analysis indicates that the slope would be at a condition of limiting equilibrium when fully saturated under a hydrostatic groundwater condition.

The failure points plotted in Fig. 4 indicate a curved failure condition. In isolation those points contributed by P. M. Jarrett<sup>2</sup> give a planar strength criterion  $c' = 0.08 \text{ kg/cm}^2$ ,  $\phi' = 45^\circ$  as compared to the values  $c' = 0.12 \text{ kg/cm}^2$ ,  $\phi' = 33^\circ$  obtained by the authors. When used in the stability analysis both sets of strength parameters yield a safety factor close to unity. This somewhat surprising result occurs because these strength parameters define two planar failure criteria that intersect close to the value of the average normal stress on the critical circles. The absolute values of the strength parameters appear to be less important than ascertaining that the strength tests and stability analysis involve comparable normal stresses.

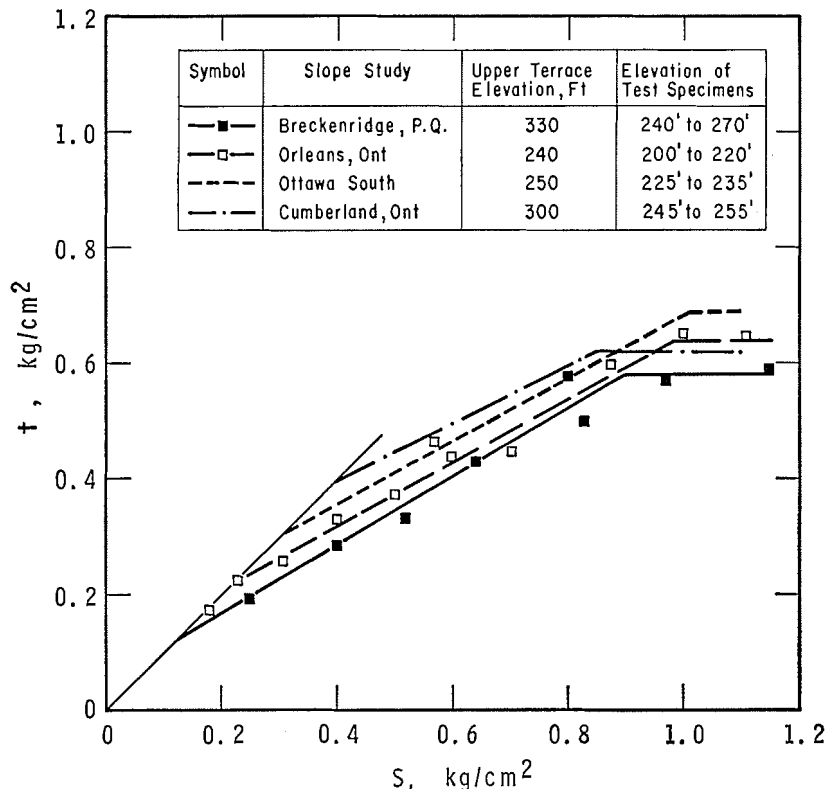
Failure points for specimens from the Breckenridge and Orleans landslide sites are plotted in Fig. 5. These points are approximated by linear failure envelopes for use in the slope

stability analysis. Failure envelopes obtained for Leda clay from other sites near Ottawa are also drawn to show that the low stress frictional

FIG. 5. Failure envelopes for Leda clay from various sites.
