The Potential Danger of Fire in Gas Turbine Heat Exchangers

C. F. MC DONALD

Senior Analytical Engineer,
Solar Division,
International Harvester Co.,
San Diego, Calif.
Assoc. Mem. ASME.

Contributed by the Gas Turbine Division for presentation at the Gas Turbine Conference and Products Show, Cleveland, Ohio, March 9-13, 1969, of The American Society of Mechanical Engineers. Manuscript received at ASME Headquarters, December 20, 1968.

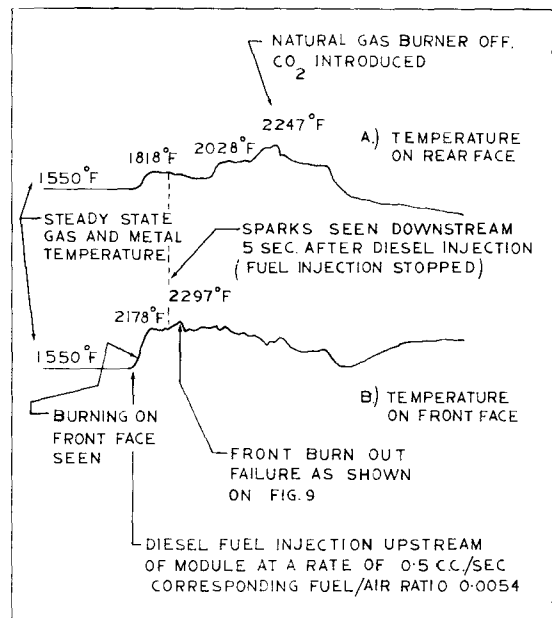
(g) Effect of Diesel Fuel Impingement on the Matrix Face. To simulate over rich or poor combustion characteristics, a series of tests to find the effect of diesel fuel impingement on the hot matrix were carried out. An approximate computation was made of the amounts of fuel which could be present for cases such as an aborted start with a hot and cold recuperator and high-speed surge. With an intermittent, and continuous injection of diesel in varying amounts, it was found that core leakage did not significantly influence the matrix burning temperature. For certain fuel flows, it was noticed that at temperatures up to about 1350 F no burning or flame was experienced, but above 1400 F, a continuous flame could be seen, and under these conditions, the matrix seemed to act as a flame holder, and local hot spots could be seen on the rear face. Some modules were tested in which a pickling process had been carried out to remove all the oxide film from the plates and fins prior to installation in the rig. The temperatures at which these modules burned were not significantly different from the rest of the modules tested. The lowest temperature at which a module burned was 1550 F, and a view of a typical failure is shown in Fig.9. From the Sanborn temperature trace shown in Fig.10, it can be seen that burning of the fuel on the front face took place, and that a rather violent front burnout was experienced. With the design gas flow, the amount of diesel injected represented an air-to-fuel ratio in the order of 185, which is a little lean for expected combustion to give direct flame impingement onto the matrix. A module was thoroughly saturated with diesel oil and a light off to 1500 F resulted in a lot of smoke but no evidence of fire. This test simulated an engine cold start where poor combustion efficiency at low speeds had resulted in unburned fuel passing into the recuperator. Based on the module tests carried out, it can be concluded that one of the main matrix fire hazards is that associated with unburned fuel being deposited on a hot recuperator face. On the units which burned out the rear, little evidence was seen of oxidation of the leading edge of the fins at the inlet face. Without more scientific tests to study the actual mode of ignition, it would appear that the gas side corrugations act as flame holders and burning starts on the fin just inside the core within the laminar boundary layer, some fuel being carried over into the center of the matrix where combustion is completed. Proof of the fact that the metal combustion starts inside the core was evidenced on one module in which the fuel flow was cut and the CO₂ turned on after a few sparks had been observed, and a rapid increase in outlet temperature noted.

Fig.10 Typical matrix metal temperature traces during fuel injection test

On removal of the module, no external damage was visible, but when sectioned, it could be seen that metal combustion had occurred internally, an inch or so in from the gas inlet face.
