THE *TEMPIO DELLA CONSOLAZIONE* IN TODI: INTEGRATED GEOMATIC TECHNIQUES FOR A MONUMENT DESCRIPTION INCLUDING STRUCTURAL DAMAGE EVOLUTION IN TIME

F. Radicioni^{a,*}, P. Matracchi^b, R. Brigante^a, A. Brozzi^a, M. Cecconi^a, A. Stoppini^a, G. Tosi^a

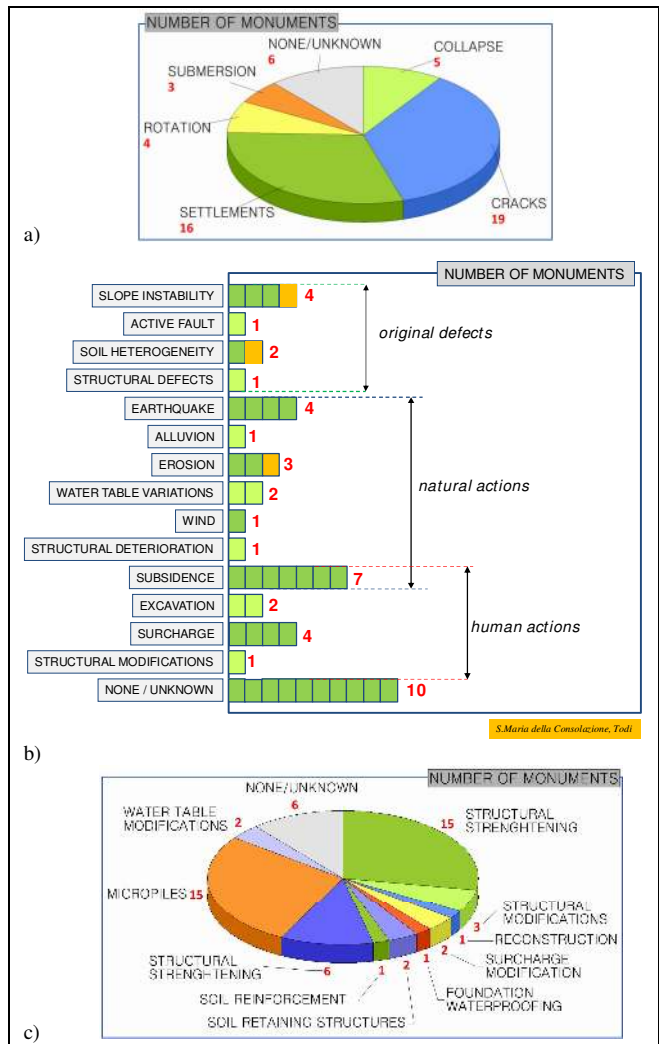
Figure 14. Analysis of some Italian monuments (modified from Cecconi et al. 1997): a) damage types; b) possible causes of damage; c) preservation measures.
