Tungsten coatings under high thermal loads in JET and Magnum-PSI

C Ruset¹, H Maier², E Grigore^a, G F Matthews³, G De Temmerman⁴, A Widdowson³
and JET-EFDA contributors⁵

Inspection of the W coatings from the ILW

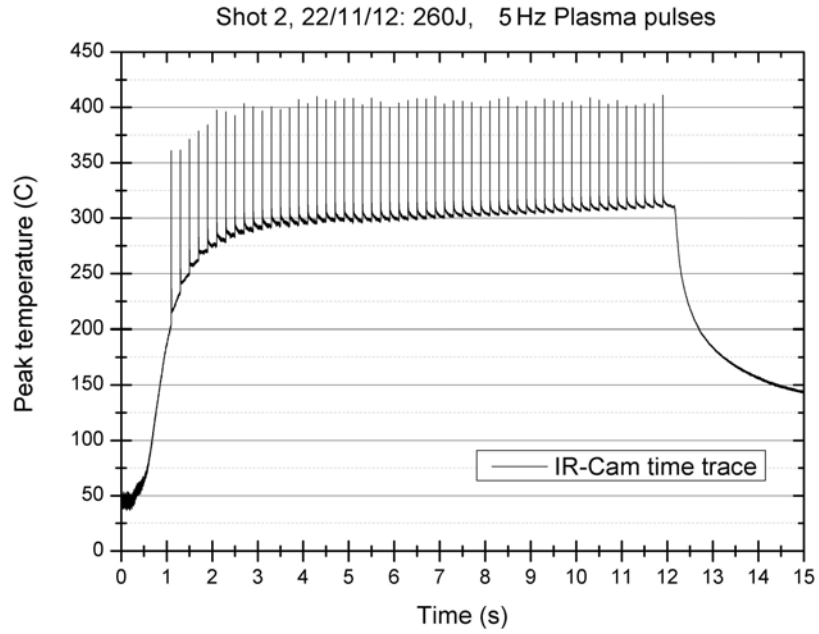
The plasma beam with a diameter of about 30 mm was centered on the area 80×70 mm of the sample. The temperature was measured with an IR camera at a frequency of 4 kHz on the wavelength of 4 μm . Under these conditions the base temperature due to the steady state plasma started at ~ 40 °C and reached after 12 s a temperature of ~ 315 °C. The base temperature at which thermo-shocks were applied was $\sim 200 - 315$ °C. The increase of surface temperature due to short pulses was about 100-120 °C. The time dependence of the W coating temperature is shown in Fig.2.

Fig.2 Typical temperature time trace of applied thermal shock loads at 5 Hz in Magnum PSI, super positioned with a steady state heat load of 10 MW/m²

Fig.2 Typical temperature time trace of applied thermal shock loads at 5 Hz in Magnum PSI, super positioned with a steady state heat load of 10 MW/m^2
