Uplift of an Underground Tank in Northern Malabar Region, India

ABSTRACT: *An underground reinforced concrete tank was constructed for a project in the southwest region of India. The tank was 90 m x 35 m in plan and 7.3 m deep resting on partly filled-up and partly native soil. During the peak monsoon, a sudden uplifting of the base slab by about 300 mm and subsequent failure of the foundation raft and a partition wall was observed. Laboratory testing was executed and hydrogeological survey was carried out using ground penetrating radar, seismic refraction and infiltrometer testing, and an analytical study was carried out to identify the root cause of the tank uplifting. Based on this study, it was observed that the uplifting and structural failure was essentially due to the peculiar land terrain and soil properties and the development of excess hydraulic head below the bottom of the tank. After considering different options, the rectification measures were carried out by provision of dewatering wells along the tank periphery to release the excess hydrostatic pressure and stabilize the foundation raft. The structural repair of the top of the foundation raft and partition wall was

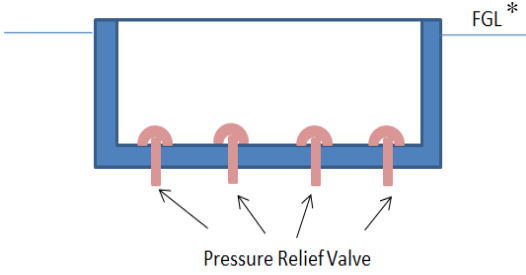
<p>There is a chance of groundwater contamination in case of malfunctioning of the non-return valve. This was not acceptable from an operation point of view.</p>
<p>Option 4</p>	<p>DEAD WEIGHT:</p> <p>Provision of dead weight in terms of 1.2 m thick layer of plain cement concrete (PCC) on top of the foundation raft inside the tank. This would increase the dead weight of the tank and would counterbalance the uplifting due to groundwater pressure.</p>

<p>Option 3</p>	<p>NON-RETURN PRESSURE RELIEF VALVES:</p> <p>Provision of non-return pressure relief valves on the bottom slab to release groundwater pressure, by allowing the groundwater to enter the tank through these valves.</p>

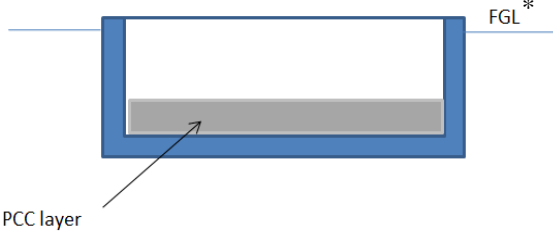
<p>Provision of PCC would also reduce the volume and ultimate capacity of the tank which was not acceptable from an operation point of view. Very high cost involved in this option.</p>
<p>Option 5</p>	<p>GROUND ANCHORS:</p> <p>Provision of ground anchors to hold the tank against uplifting.</p>

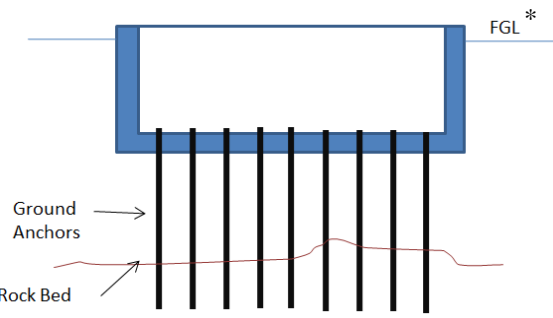
<p>During execution of ground anchors from inside the tank, dewatering of tank is required and has a risk of tank uplifting and cracking after dewatering. Else the groundwater level has to be temporarily lowered during anchoring by means of a well point system. Very high cost involved in this option.</p>
