JHRP-75-15

USE OF PRECAST-PRESTRESSED  
CONCRETE FOR BRIDGE DECKS

### USE OF PRECAST-PRESTRESSED CONCRETE FOR BRIDGE DECKS

July 30, 1975  
Revised Dec. 1976  
Project: C-36-56N

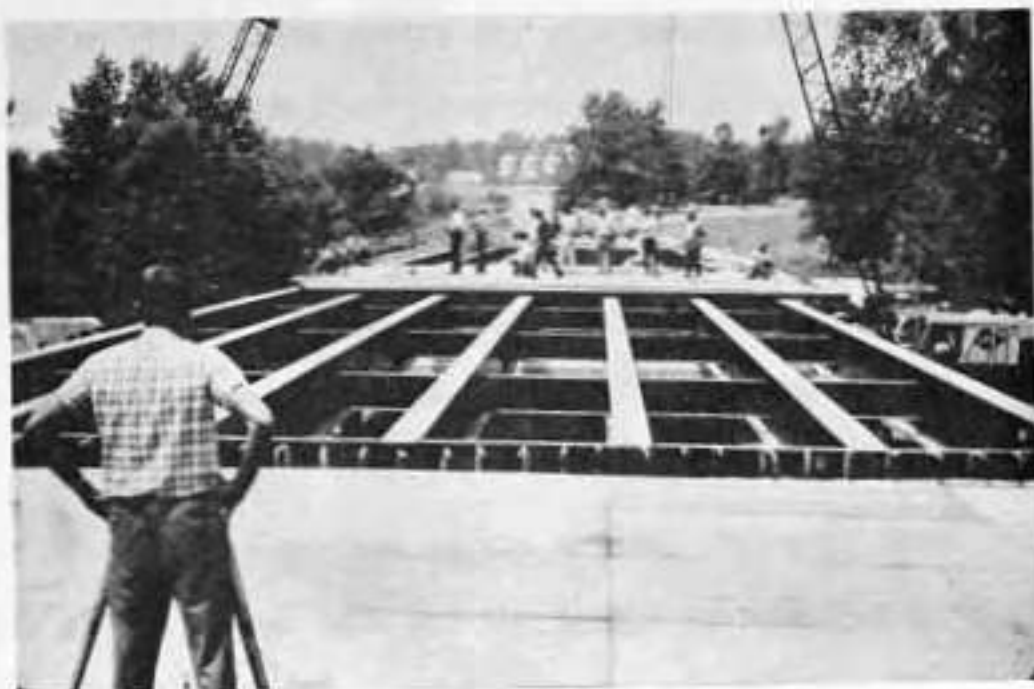
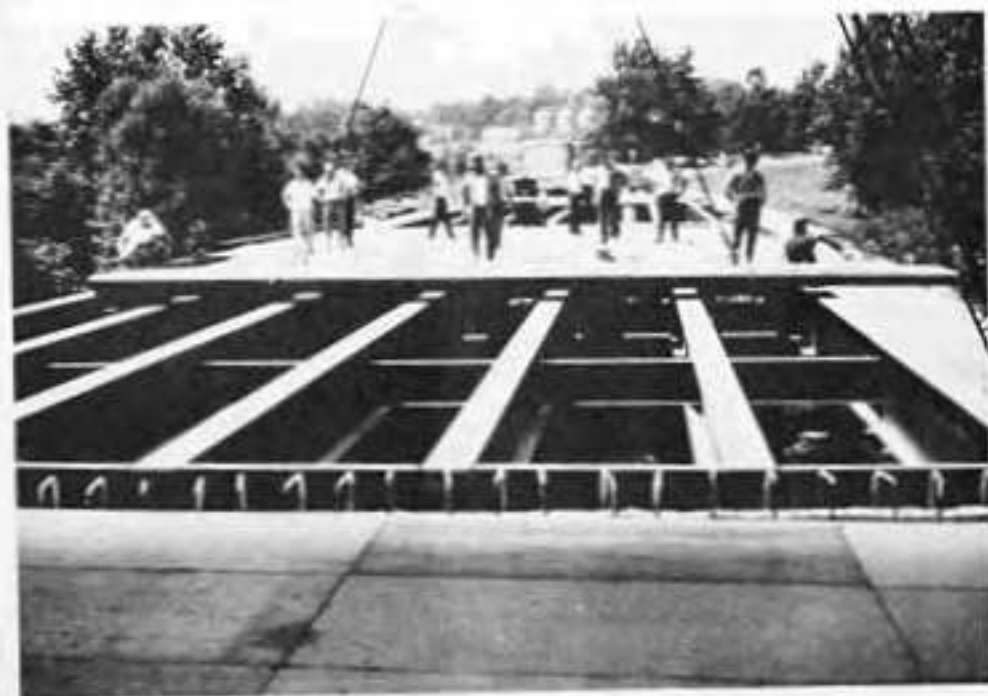
Figure #7. Precast Slab Placement at the Knightstown Bridge

were set and post-tensioned. Figure #7 shows the slab placement operation. A problem which arose during the post-tensioning operation was the appearance of eight 2'-0" long cracks which ran in the longitudinal direction of the bridge. This was due to irregularities in the top portions of the joints which caused a poor fit between adjacent units. The post-tensioning operation caused a bending stress in the slabs which fit poorly, resulting in the cracks. Due to the fact that water could seep down into these cracks and rust the pretensioning cables, a seal coat of epoxy was applied to the bridge. Integral curbs were poured in place on the bridge deck and the bridge was opened to traffic on August 6, 1970.

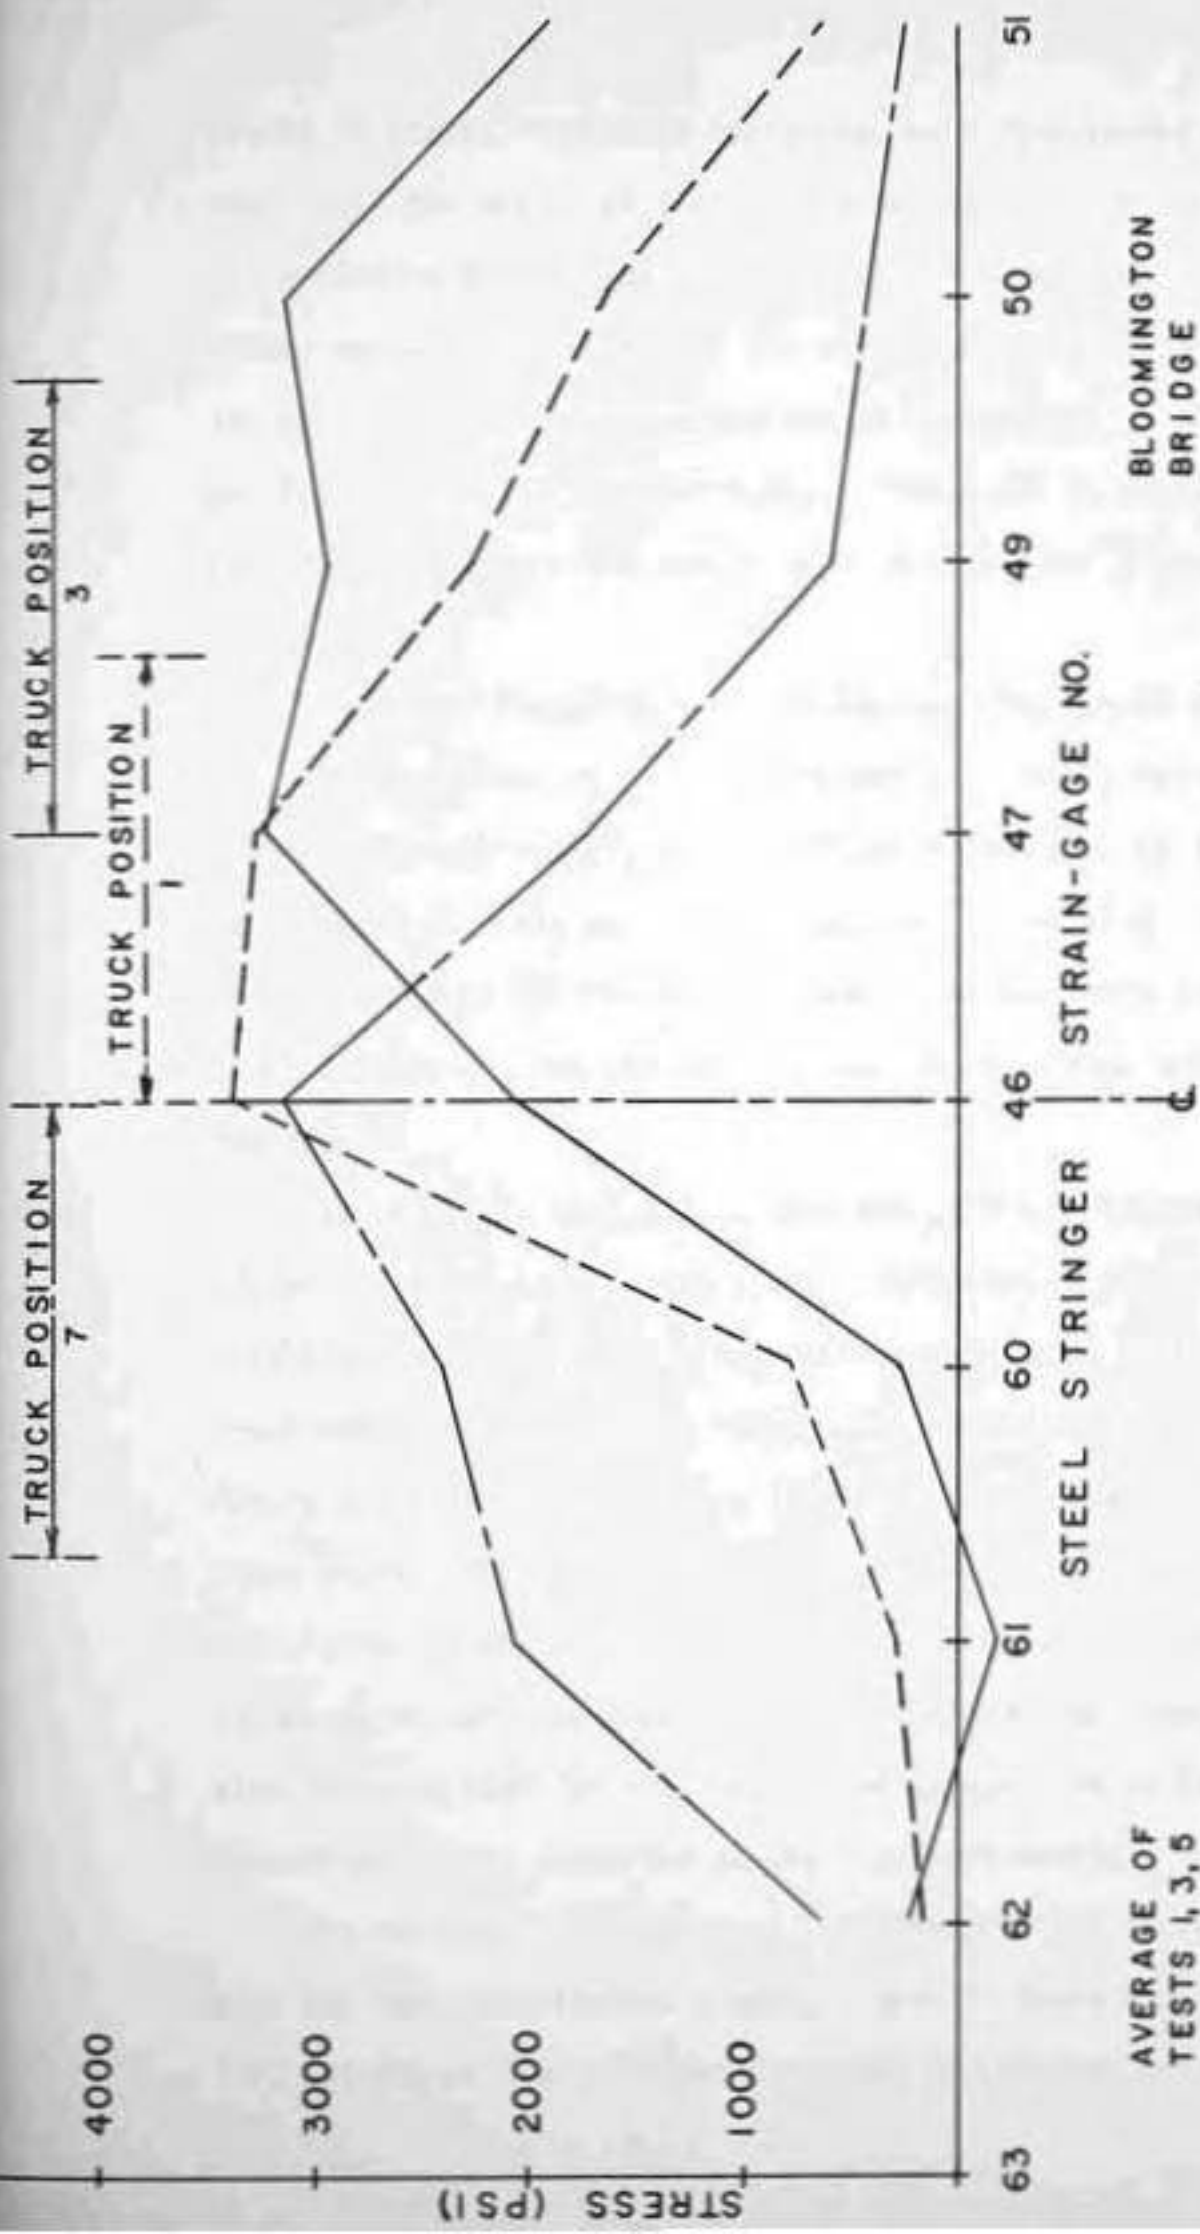
FIGURE NO. 19  
 DISTRIBUTION OF STRESSES AT SECTION W  
 FOR TRUCK POSITIONS 1, 3, AND 7.

Figure #19 indicates that the maximum stresses or moments occur in the stringers directly under the tandem axle, which was to be expected. (For truck positions #1, #3, and #7 the tandem axle of the test vehicle is centered directly over Section W. (See Figure #16). Figure #20 shows that as the test vehicle is moved away from the centerline of the stringers (i.e. Section W), the stresses at Section W decrease which also was to be expected.

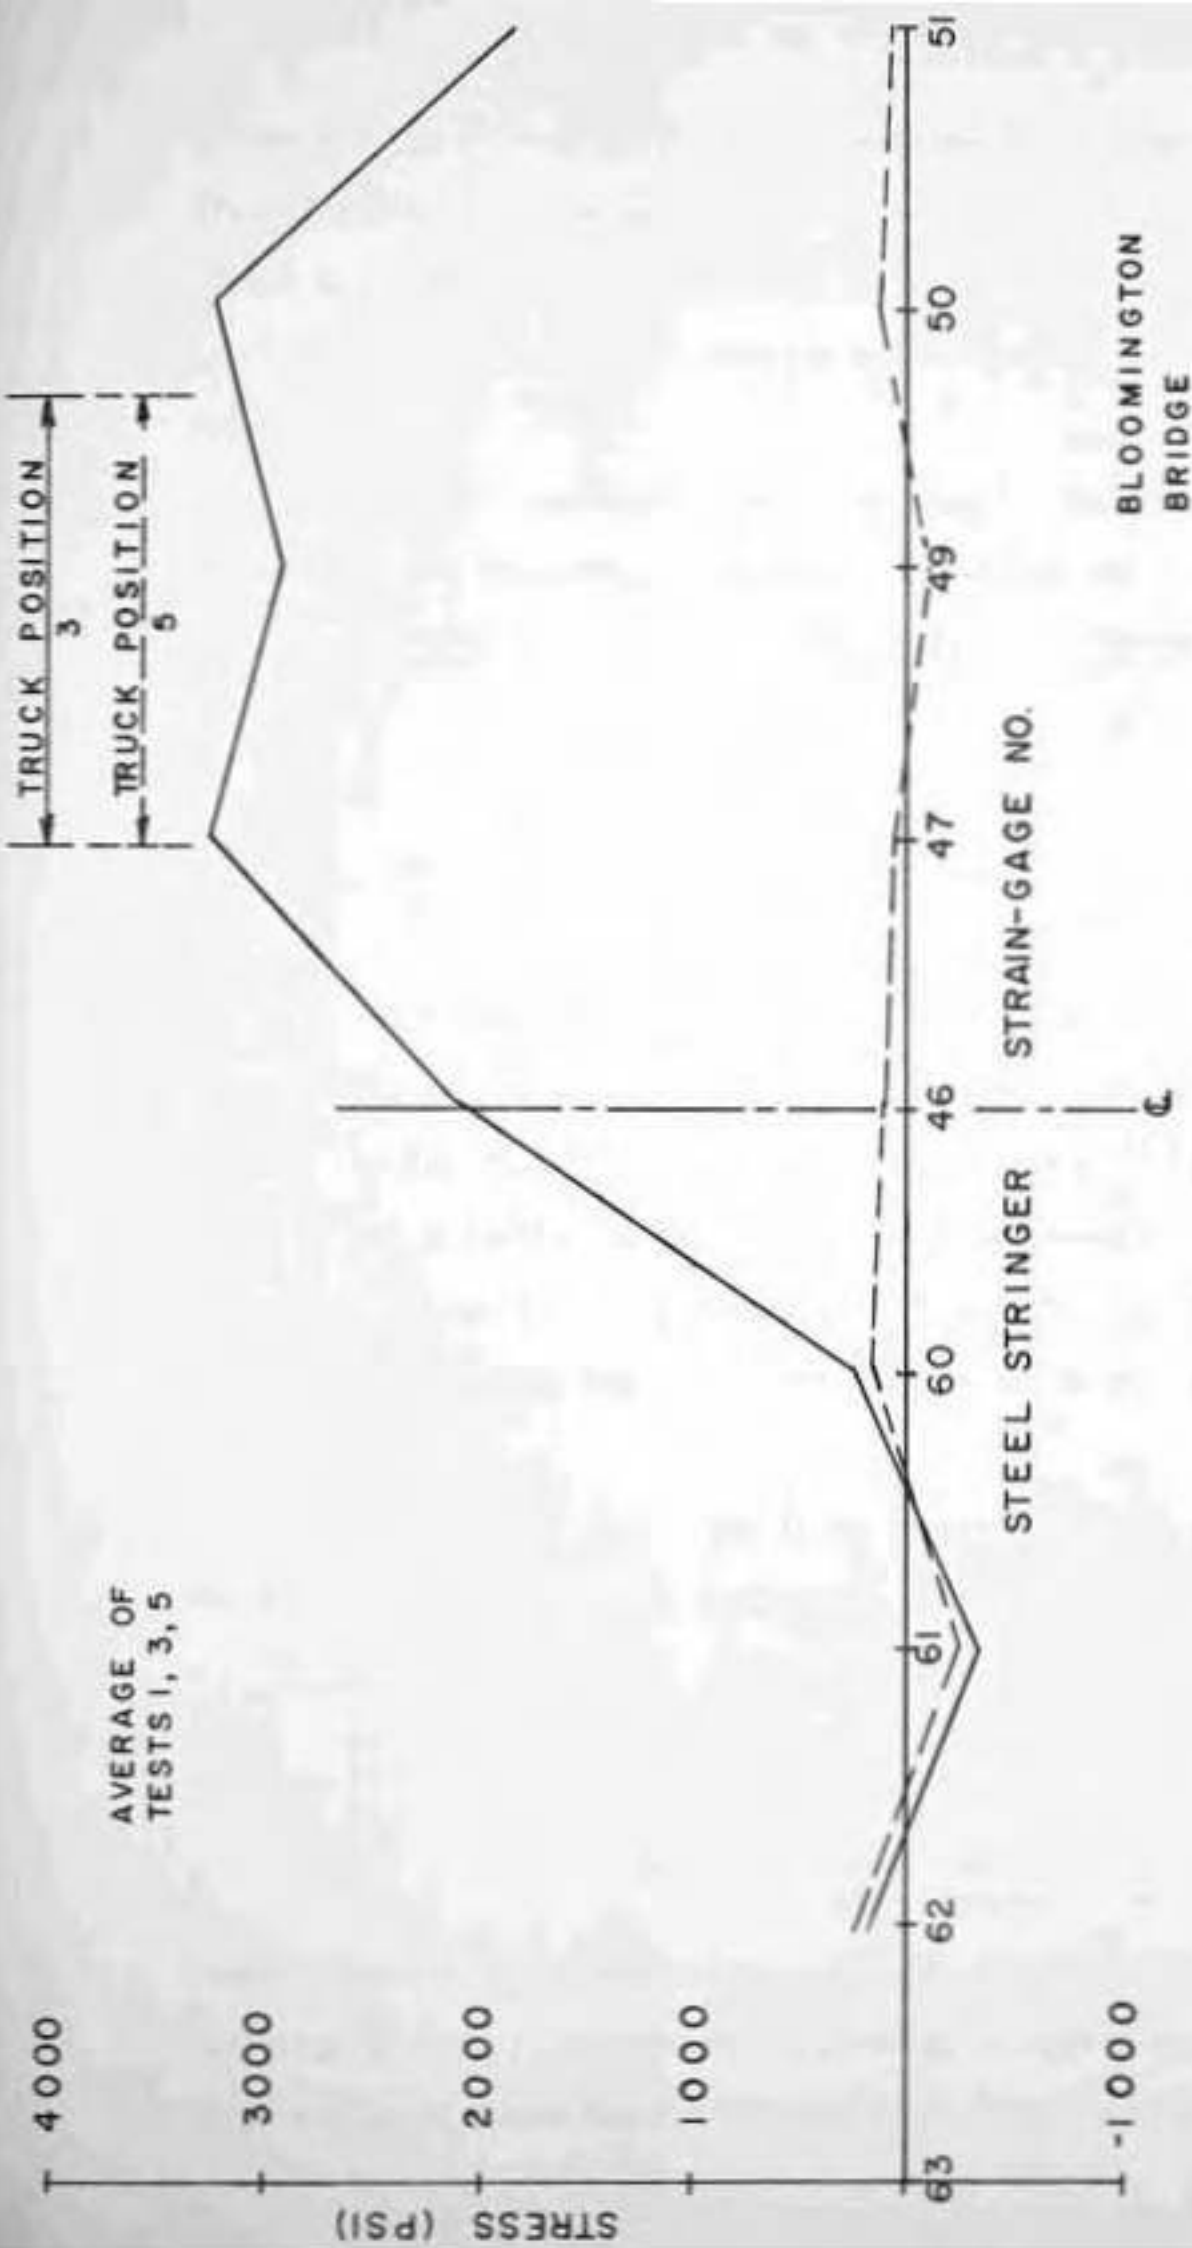
FIGURE NO. 21  
 DISTRIBUTION OF STRESSES AT SECTION W  
 FOR TRUCK POSITIONS 3 AND 5.

Figure #21 is included to show the magnitude of the load transmitted across the floor beam by the slabs. Referring to Figure #16 it can be seen that truck position #3 is midway between the first two floor beams while truck position #5 is midway between the second and third floor beams. Figure #21 indicates that very little moment is transferred across the floor beams. This would justify disregarding the front wheel loads in the calculation of the moment under the tandem axle, provided the front and tandem axles were not located between the same two floor beams. This would also indicate that for the purposes of design, the stringers could be assumed as simply supported at their support points.

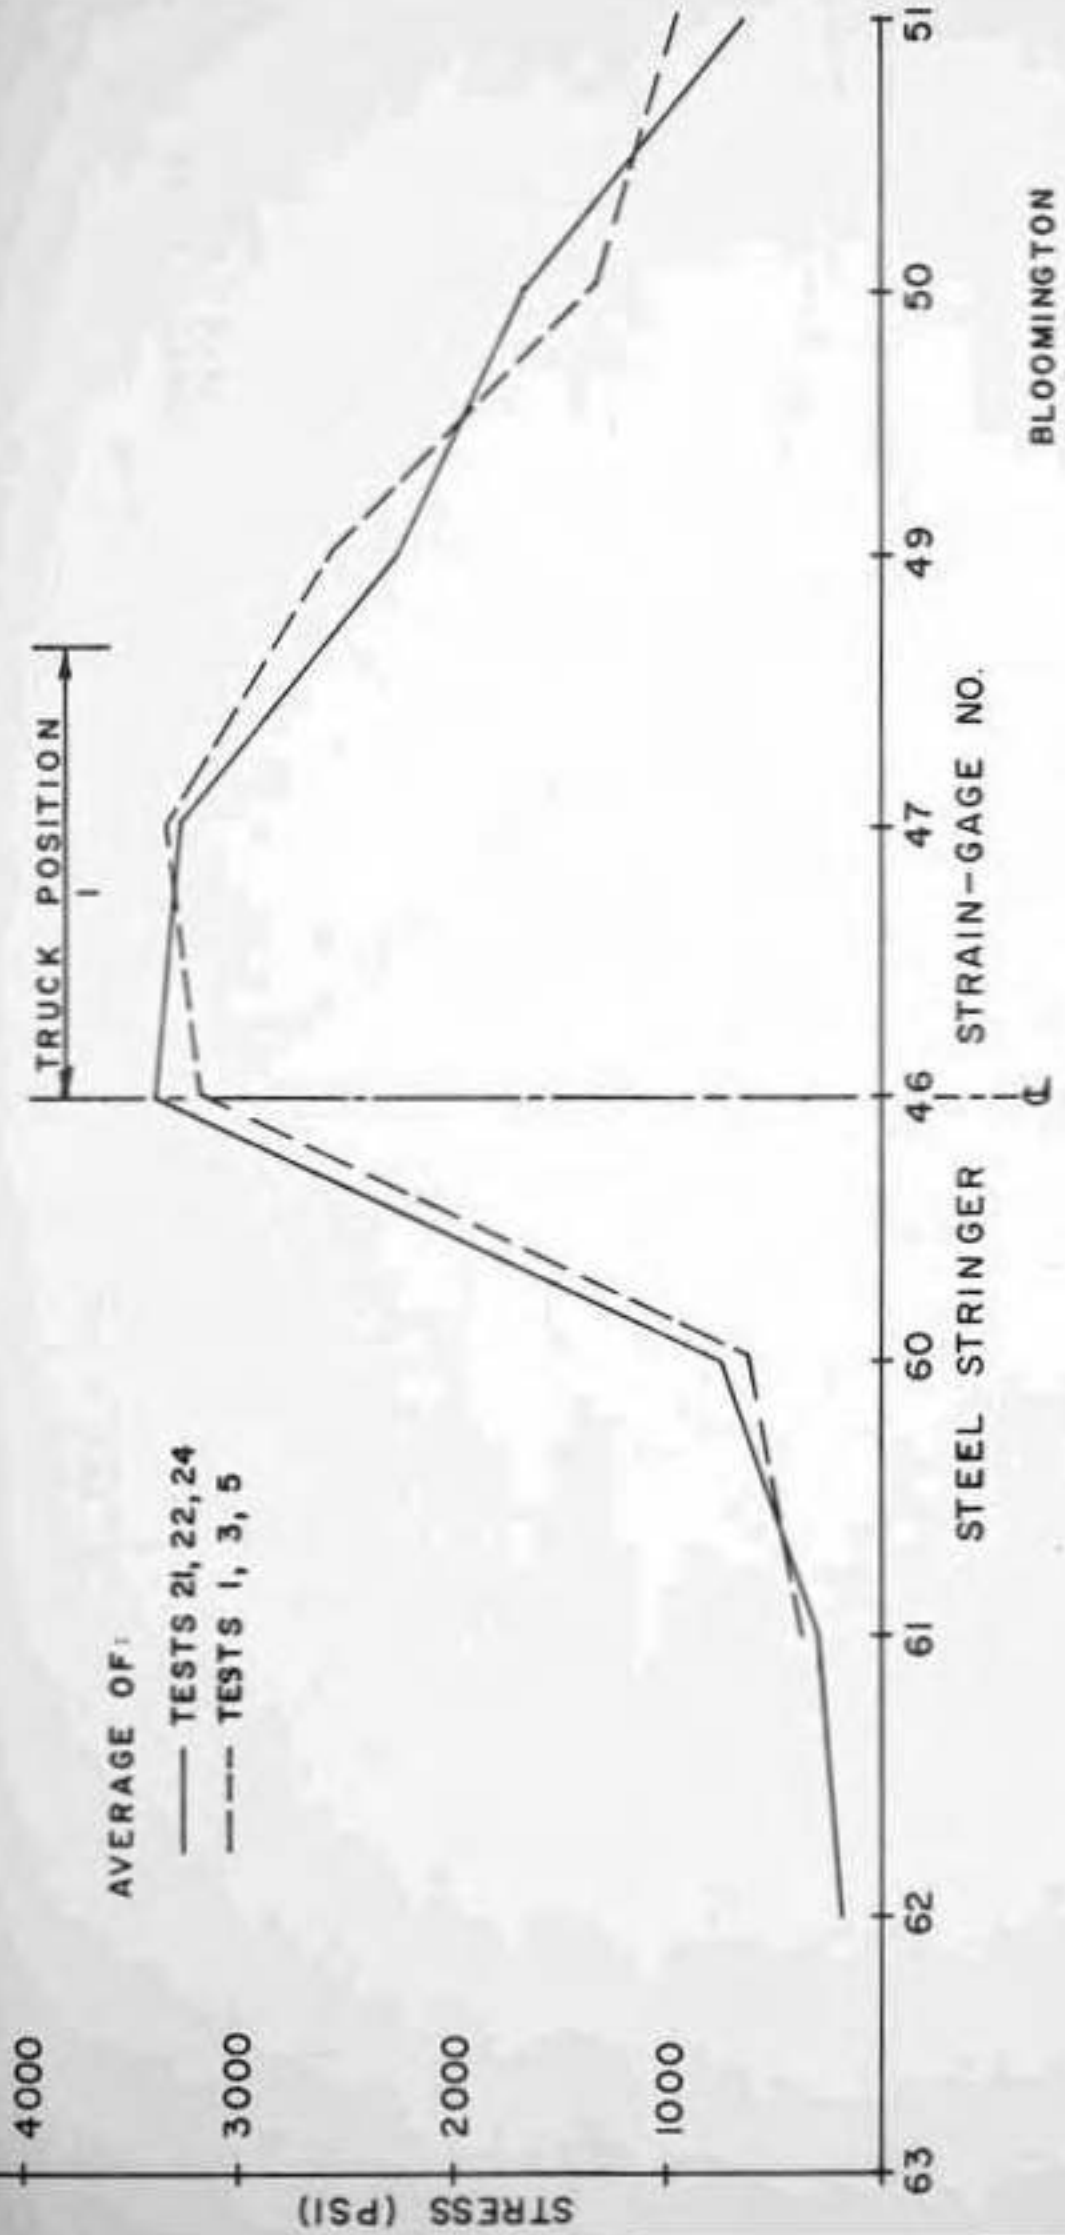
FIGURE NO. 22

In a previous section the variation of stress over a period of time for a particular gage was examined. Figures #22 and #23 indicate the change in the stress (load) distribution at Section W over a period of approximately two years. The stresses were averaged from Tests #1, 3, 5, and Tests #21, 22, 24 (See Tables B1, B2 and B3). The average of Tests #21, 22, 24 is plotted as a solid line. As was concluded for the stress variations over time for the individual strain gages, the load distribution has remained virtually unchanged over the two year time period.
