## Using electrical, magnetic and acoustic sensors to detect damage in segmental concrete pipes subjected to permanent ground displacement

This paper describes results of an experimental study that used sensing methods for monitoring damage along segmental concrete pipelines resulting from permanent ground displacement across a simulated earthquake fault. The literature contains examples of such damage occurring during actual earthquakes, significantly impacting the functionality of the pipelines. Detecting the location of the damage and the extent of the damage in pipelines can significantly accelerate post-earthquake repair efforts. In this paper, electrical sensing methods, magnetic sensing, and acoustic emission are used to monitor structural damage in a segmental concrete pipeline during a large-scale test. In this test, the segmental concrete pipeline was subjected to a concentrated transverse permanent ground displacements (PGDs). The majority of the damage to the pipe segments was localized at the joints, especially the bell sections while the damage to the spigots was minimal. The damage extended away from the joints in the pipe segments in the immediate vicinity of the f

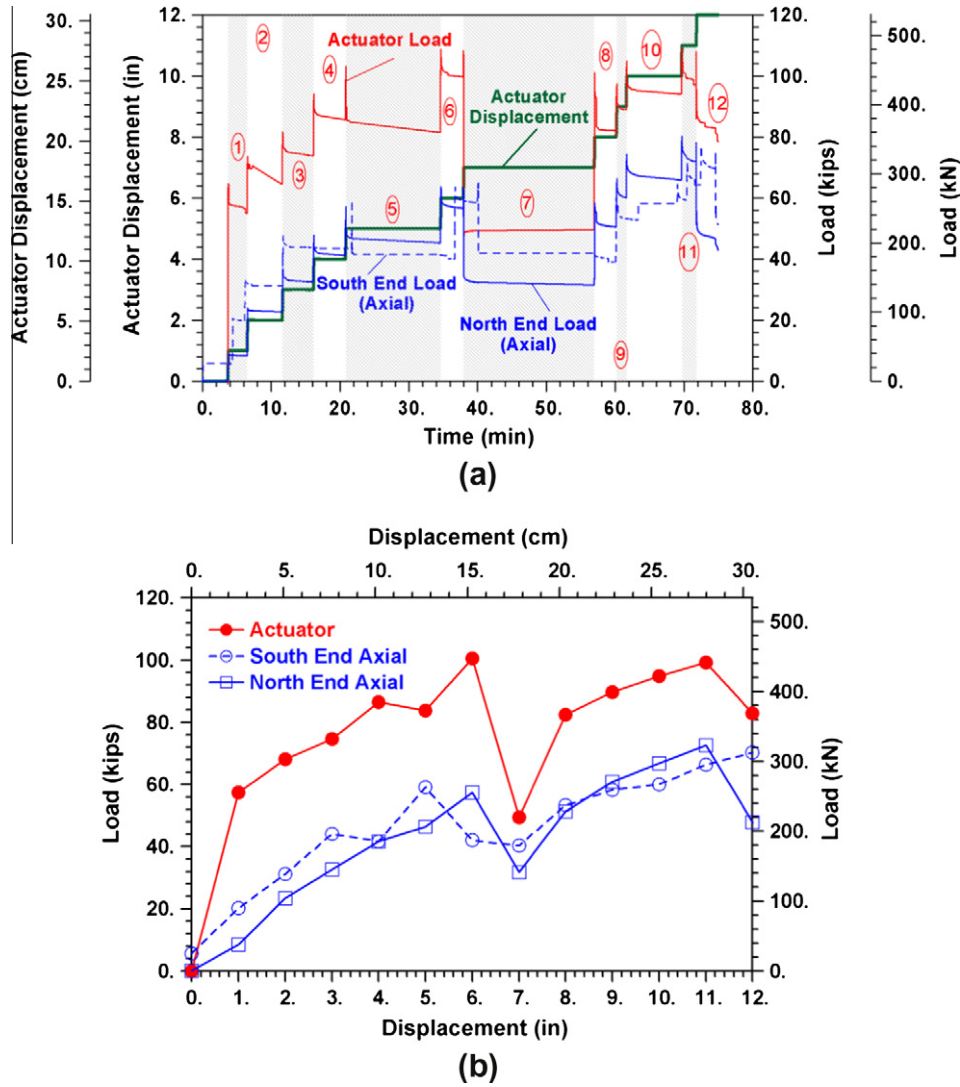
Fig. 6a illustrates the actuator displacement, actuator load, and the total axial load at the North end (moveable end) and the South end (fixed end) of the test basin. The change of load with time at both ends of the test basin shows the same pattern as that of the actuator load. The load at the south end (fixed end) of the test basin slightly lags behind the applied actuator load, especially for the fifth and seventh displacement steps.

The average load in the actuators during the relaxation periods and the average axial forces measured by load cells at both ends of the test basin are plotted in Fig. 6b. This figure is useful for tracing the damage accumulation in the pipeline. The development of damage is accompanied with a dramatic reduction in load due to the increase of the compliance (loss of stiffness) of the system.

During the first four applied displacement steps the load in the actuators and at both ends of the pipeline increased with the displacement. During the fifth step, the load slightly decreased in the actuator and a slight increase in the end load was observed at both ends of the pipeline. A significant decrease in load is observed at the seventh displacement step indicating significant damage to the pipeline. Further decrease in load is observed in the twelfth step. It is noted that damage starts to accumulate in the pipeline from the first displacement step; however, it cannot be seen by only looking at the load–displacement plot as the damage up to the seventh step is not significant to increase the compliance of the system to affect the measured loads.

Fig. 6. Actuator displacement, load and the total load at the north (moveable) and south (fixed) end of the test basin.

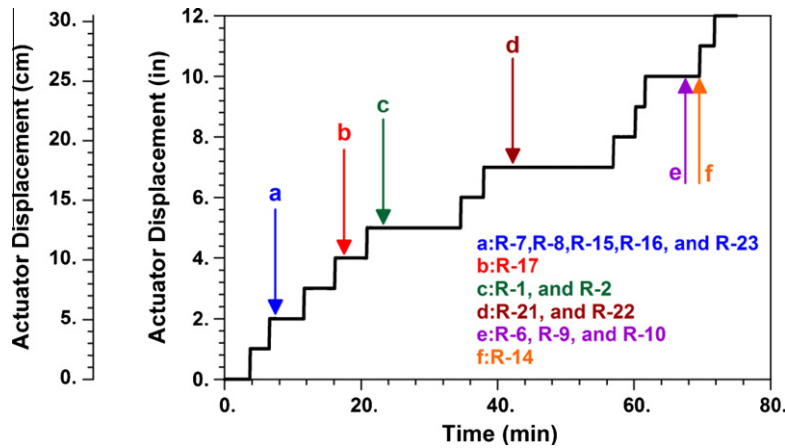
Before rupture, the CST sensor's resistance is approximately  $0.05 \Omega$ . However, after rupture, the resistance increases several orders of magnitude. The resistance measurements are treated as binary, with zero indicating an intact CST (i.e., no damage) and one indicating a ruptured CST (i.e., damaged).

Fig. 7. Sequence of signals received from conductive surface tape (CST) sensors in relation to the actuator displacement.

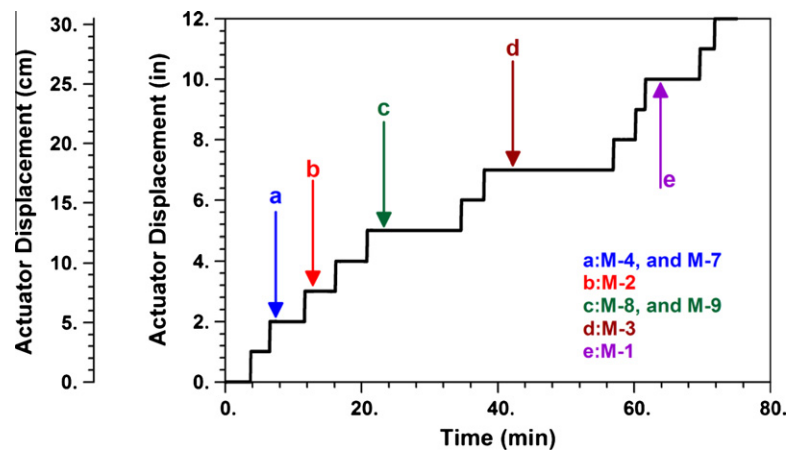
**Fig. 10.** Sequence of signals received from magnetic (M) sensors in relation to the actuator displacement.

This indicates extensive damage to the joints. The cracking at Joints 2 and 3 continues up to the tenth displacement step (i.e., 10-in. displacement).

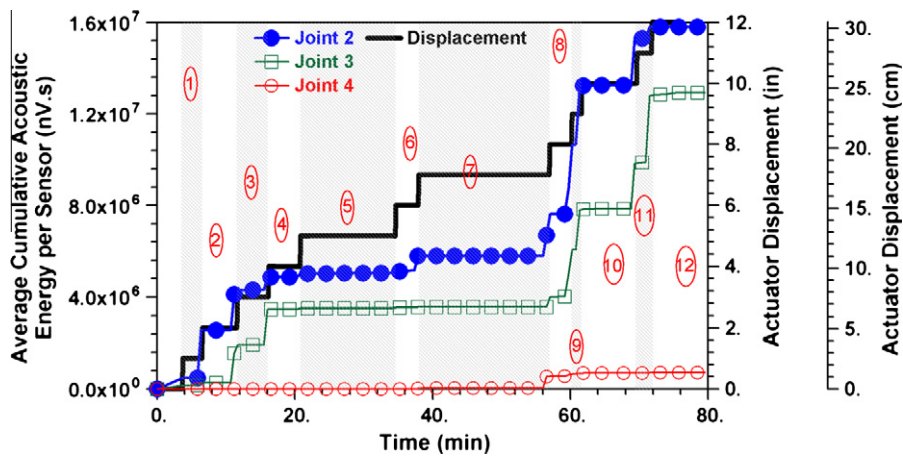
Fig. 12. Average captured cumulative acoustic energy.

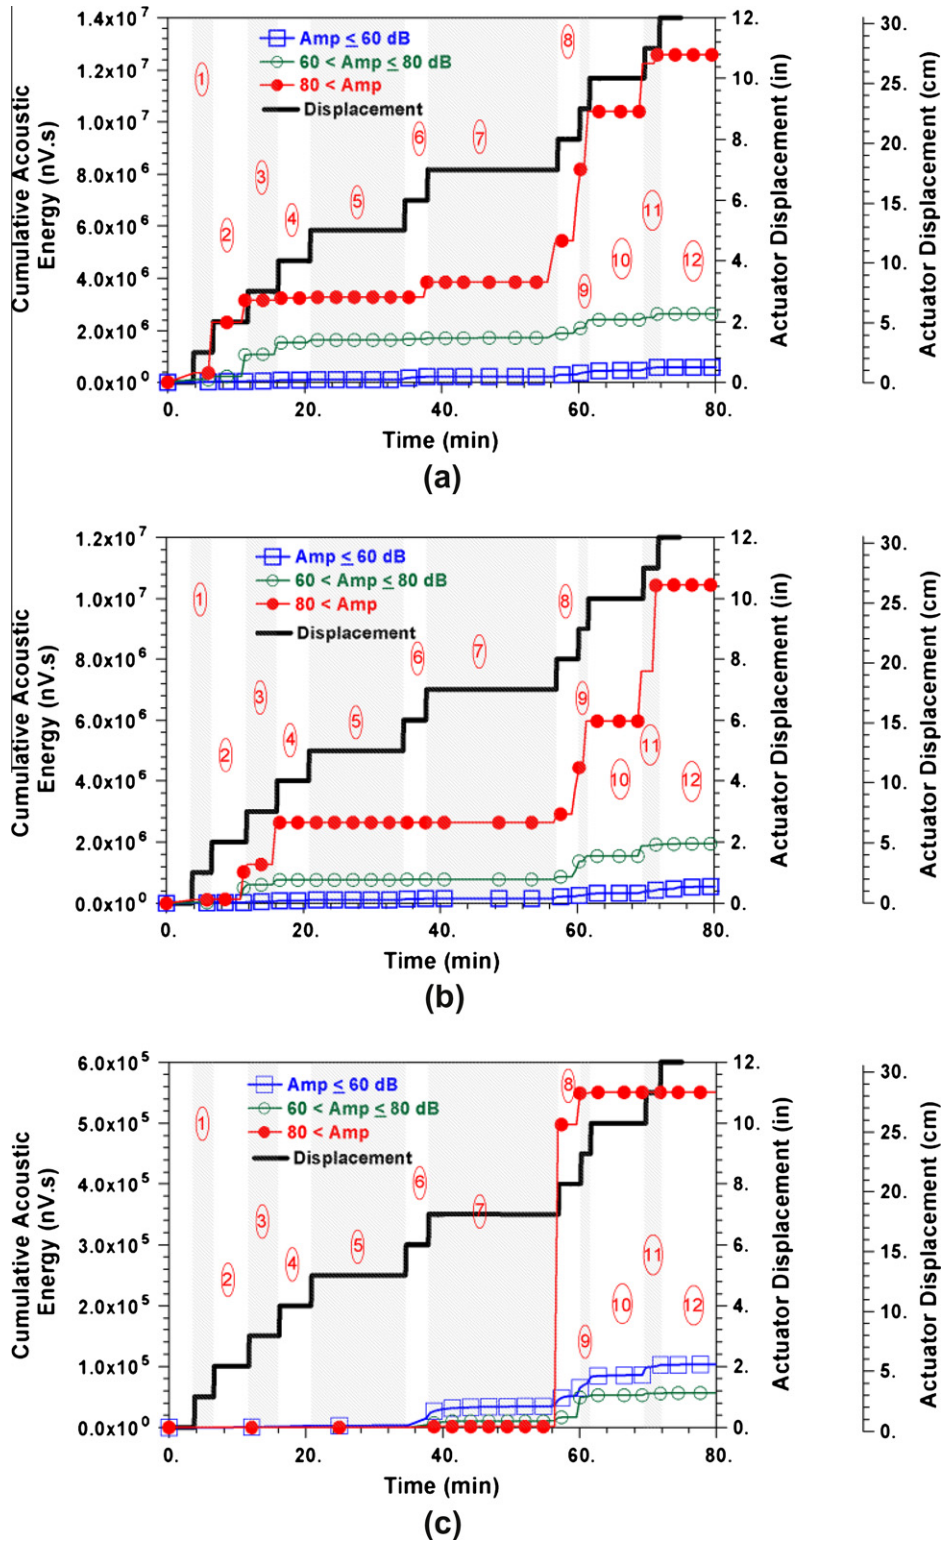
Fig. 13. Average captured cumulative acoustic energy at Joints (a) 2, (b) 3, and (c) 4.
