## Review Article

# A Comprehensive Review on Reasons for Tailings Dam Failures Based on Case History

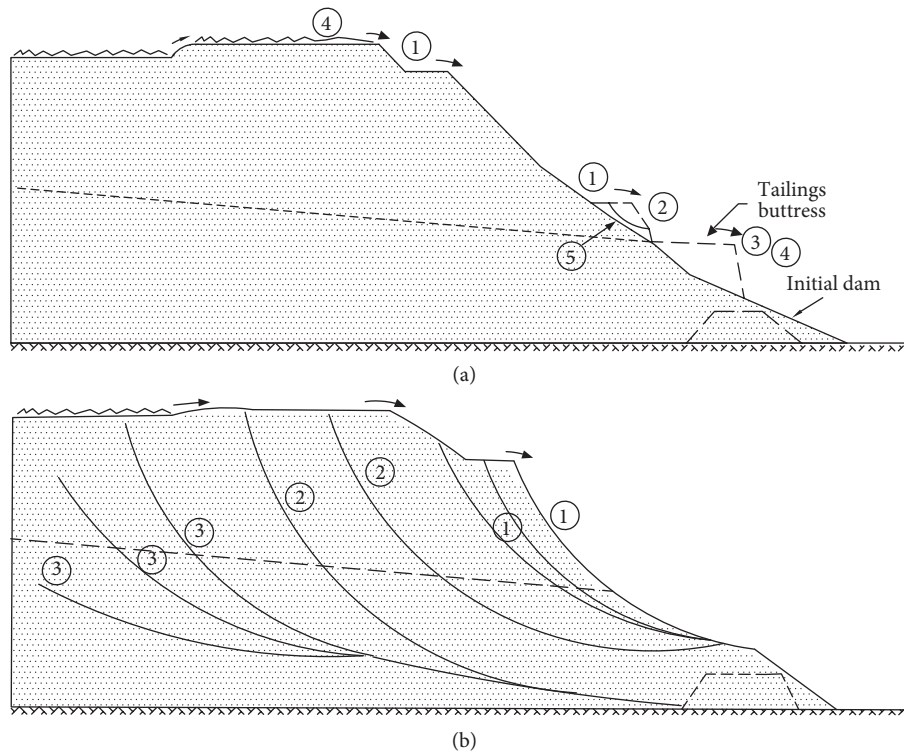
FIGURE 2: (a) The sequence of retrogressive failures (redrawn after Wanger et al. 1998), the early stages of flooding over the dam. (b) The sequence of retrogressive failures (redrawn after Wanger et al. 1998), the later stages of flooding over the dam.

In 1994, the Merriespruit tailings dam in South Africa failed, releasing 600,000 m<sup>3</sup> of tailings and 90,000 m<sup>3</sup> of tailings water [81, 117–119]. The tailings dam broke after a few hours of thundershowers [120]. It is worth mentioning that this tailings pond is basically an upstream structure with less freeboard length and less reservoir area. When the flow rate of the overtopping water flow was greater than the starting flow rate of the tailings, the tailings dam continued to cause downward and bilateral erosion [23, 65]. The hydraulic erosion caused the breach of the tailings dam to expand, and the slope became steep, which caused the tailings dam to collapse locally and completely. Wanger et al. [121] presented a hypothetical diagram (Figures 2(a) and 2(b)) of the Merriespruit tailings dam failures, based on information from eyewitnesses [53, 120, 126]. At the early stages of flooding over the dam, the dam break process can be divided into the following 5 steps. They are (1) a small gully appeared on the tailings dam after a rainstorm, (2) erosion of loose tailings in the lower slope, (3) local instability of the lower slope (tailings butter), (4) the water level in the tailings pond is high and the flood erosion

tailings dam, and (5) local instability on a central slope, the failed material is washed away. At the later stages of flooding over the dam, the dam break process can be divided into the following 3 steps, they are as follows: (1) after the erosion, the tailings dam slope began to be unstable overall, and the tailings sand was taken away by the water, (2) the tailings dam slope continues to be unstable under the domino effect, and the tailings sand is taken away, and (3) a large amount of tailings flow causes the slope to be unstable.

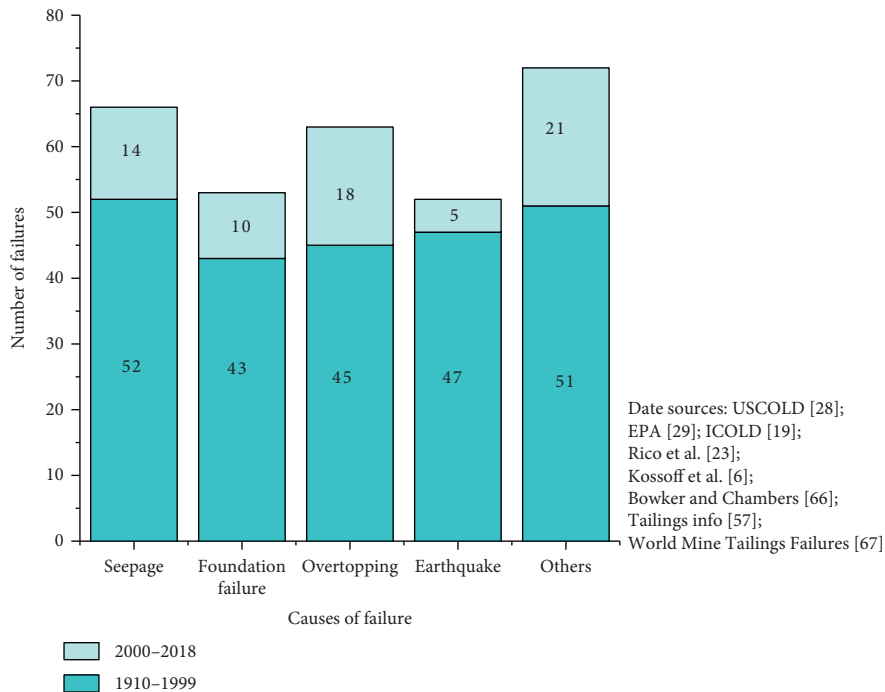
FIGURE 6: Failure distribution by cause.

Figure 6 highlights the reasons for the occurrence of tailings dam breakage in the last 100 years. One scholar divided the causes of tailings dam breakage into 11 categories, namely, seepage or piping, foundation failure, overtopping, seismic liquefaction (earthquake), mine subsidence, unusual rain, snowmelt, structural, slope instability, maintenance, and unknown cause. But many accidents are

the result of a combination of multiple causes, and this classification has some overlapping parts, such as unusual rain, snowmelt, and overtopping. According to the main cause of tailings dam failure, the accident percentage of

seepage, foundation failure, overtopping, earthquake, and others, are respectively, 21.6%, 17.3%, 20.6%, 17.0%, and 23.5%. It can be seen from the collected data that extreme weather causes serious damage to the safety and stability of

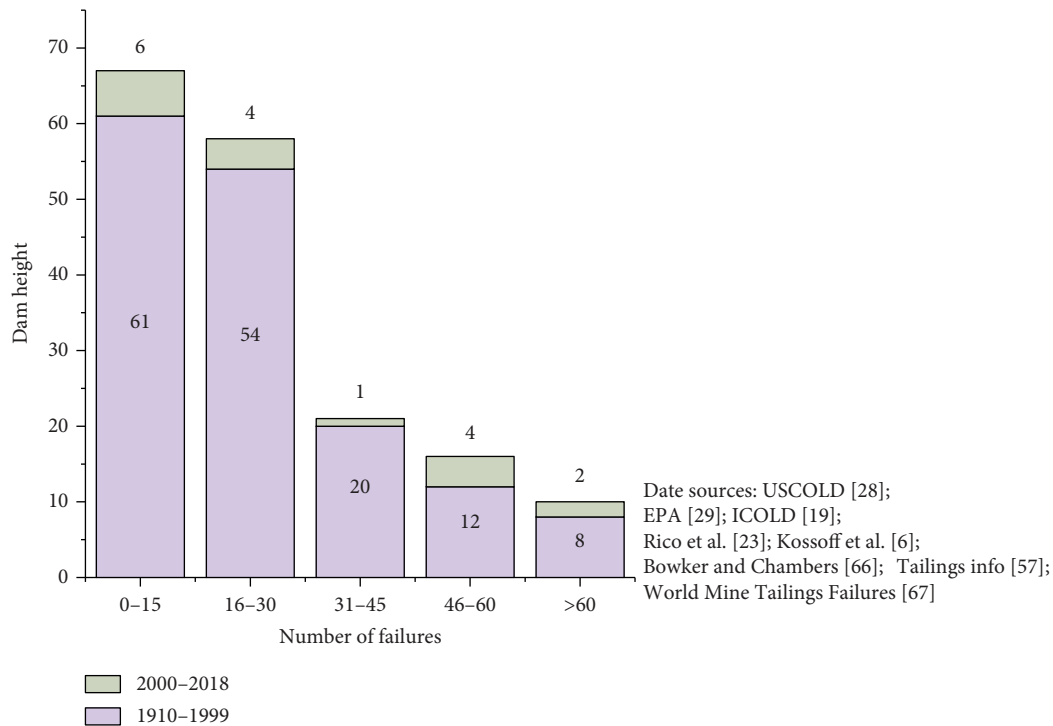
FIGURE 7: Failure distribution by tailings dam height.

Figure 7 analyzes the height of the tailings dam accident in the world; it can be concluded 39% of accidents occurred in tailings dams less than 15 meters, 34% of the cases occurred in tailings dams between 15 and 30 m in height, and only 27% of incidents in tailings dams over 30 m. This distribution is generally similar for many countries although

there are some differences. The proportion of accidents in high dams over 30 meters in the United States is large. Considering the fast-growing economy of the United States, this phenomenon is reasonable. The graph illustrates that dam breakages occurred mostly with dams less than 45 m. The authorities can improve the specification requirements for tailings dams below 45 m to ensure the safety of small- and medium-sized dams. From the statistical data, we can draw a conclusion that most of these dams were established in the 1960s and 1970s. The dam failures frequently occurred due to the lack of management or disposal of small dams and old dams by managers. The height of the tailings dam can increase the storage of tailings, but it also increases the safety

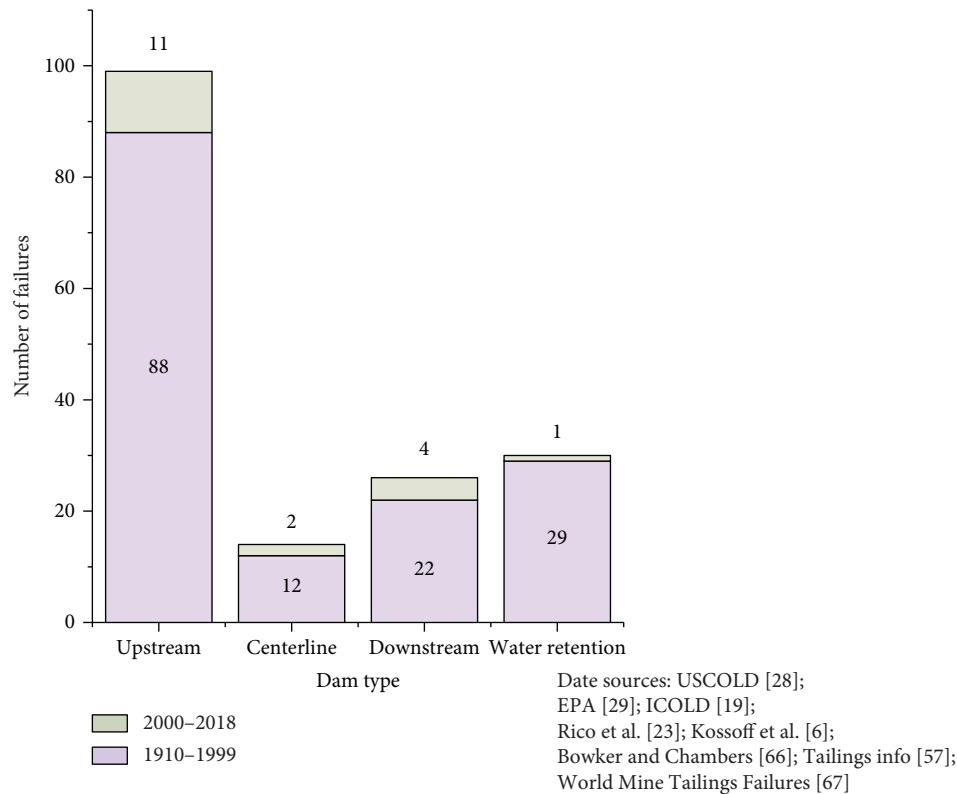
FIGURE 8: Failure distribution by the tailings dam type.

Figure 8 depicts the highest probability (58%) of tailings dam breakages built using the upstream construction method. Water retention dam type accounts for a higher proportion (18%) of tailings dam accidents. The upstream constructed dams require fewer construction materials, but their dams have a high phreatic line and poor stability. Before the establishment of the tailings dam, it is necessary to evaluate the geological conditions and environmental factors comprehensively. A safe method of centerline construction method and downstream construction method is chosen to build a dam, thus reducing the number of dams built by upstream construction methods. In countries such as South Africa and China, tailing dam failures related to abnormal rainfall have occurred. Rain-rich countries should design suitable drainage systems and choose stable central and downstream construction techniques. The reliable flood discharge system is conducive to the treatment of excess water in the reservoir area, thus ensuring safe and stable operation of the tailings dam. In countries with frequent earthquakes, such as Japan and Chile, the dangers caused by earthquakes to tailings dams should be fully considered. The foundation needs to be reinforced to ensure the safe operation of tailings dams.
