Condition Assessment of Power Transformer Onload Tap Changers Using Wavelet Analysis and Self-Organizing Map: Field Evaluation

Pengju Kang and David Birtwhistle

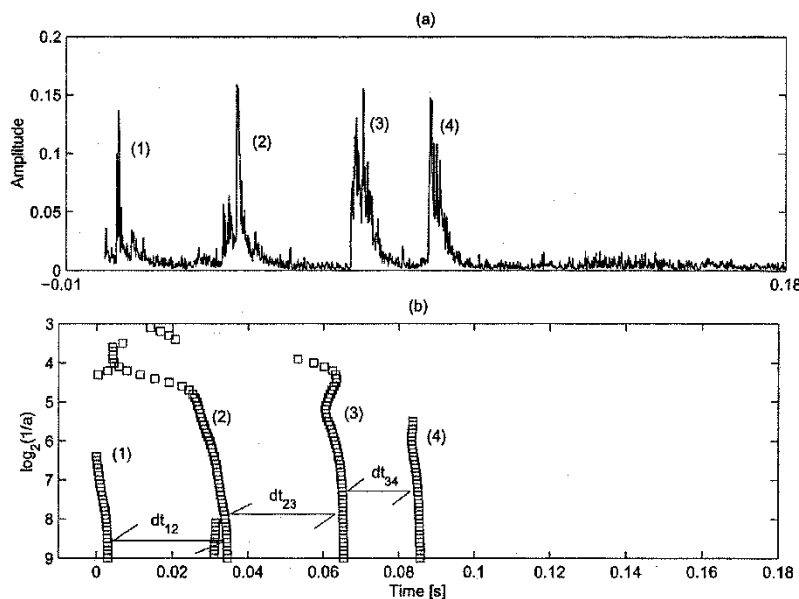
Fig. 1. (a) Envelope signature of normal condition of a resistance type tap changer operating from tap 7 to 8. (b) CWT ridge plot of the envelope signature.

Fig. 1(a) shows the envelope of a vibration signature of a resistance type tap changer, and the corresponding CWT ridge plot of the envelope is given in Fig. 1(b). The measured vibration signal was initially in volts and was proportional to acceleration. As this signal was normalized following Equation (1), the vibration signals shown in this paper are dimensionless unless specified. The ridge plot shown in Fig. 1(b) is a two-dimensional (2-D) display of dominant local maxima of the CWT performed on the normalized envelope signal shown in Fig. 1(a) at different time and scale values. The detailed procedure of obtaining the ridge plot can be found in [4]. Each ridgeline in Fig. 1(b) represents the occurrence of a vibration burst in the original signal.

As can be observed, the vibration signature of this type of OLTC contains four dominant transient bursts, shown as busts (1)–(4) in Fig. 1(a), and there are four dominant ridgelines, as shown in Fig. 1(b). The condition indicators for this type OLTCs have been established as: $[\delta_1, \delta_2, \delta_3, \delta_4, dt_{12}, dt_{23}, dt_{34}]$, where $\delta_1, \delta_2, \delta_3, \delta_4$ are the strengths of bursts 1 to 4 respectively defined in the wavelet domain [see (4)], and $dt_{12}, dt_{23}, dt_{34}$ are the time delays between the designated bursts. At higher scale values in the ridge plots, times may be

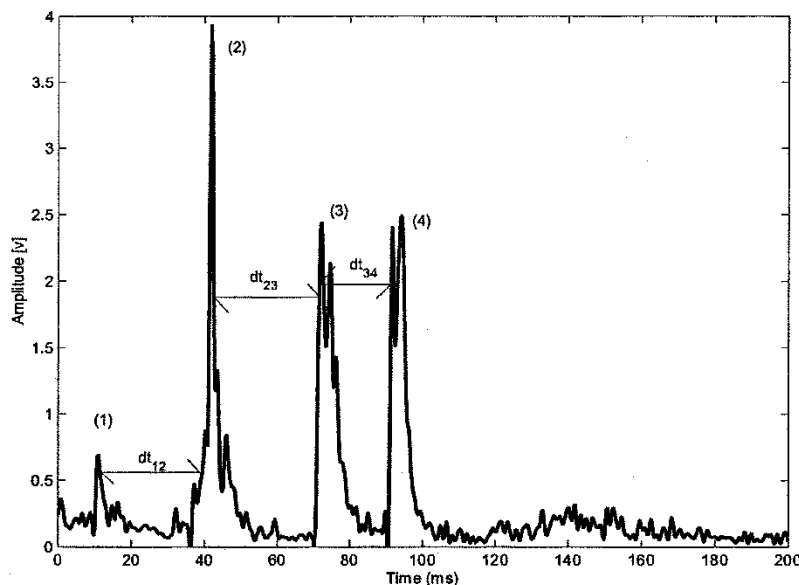
The operation given in equation (5) is a progressive smoothing of the input signal $x(t)$. Therefore, the wavelet transform of a noisy envelope of a vibration signal at a predetermined scale value is the smoothed envelope. Fig. 2 shows the smoothed envelope of a vibration signature of a resistance type OLTC for tap operation from 7 to 8. The smoothed envelope will be used for automatic detection of the changes in the shape of the envelope that is caused by faults developed in a tap changer.

Fig. 2. Wavelet smoothed envelope of the vibration signature of a resistance type tap changer operating from tap 7 to 8. The amplitude of the envelope shown is not normalized.

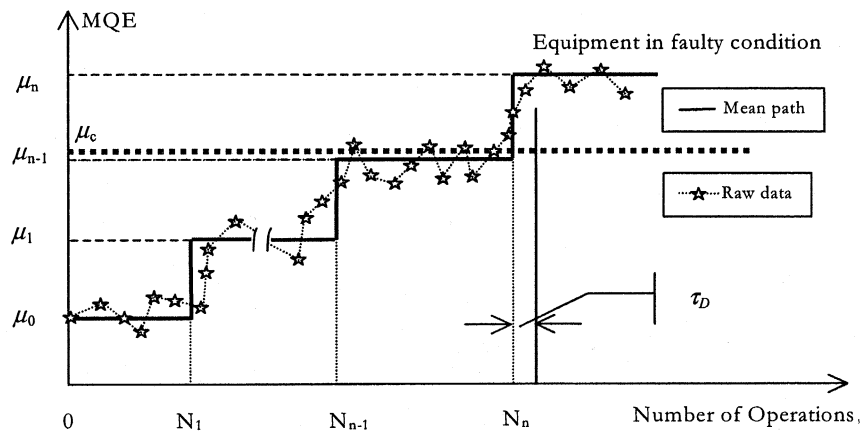
Faults by failure mode 1 and 2, such as a broken component, will cause a sudden increase in the value of condition indicator mqe. Faults of failure mode 2, such as contact wear, will normally cause the mqe to gradually drift upward as shown in Fig. 3. The mean value of the mqe undergoes a monotonic process: a series of upward shifts, $\mu_1,\, \mu_2 \cdots \mu_{n-1}$, before it approaches the critical value, μ_c, after which faults may start to develop in the OLTC. When the mean is below μ_c, the OLTC is regarded as being in normal condition. As soon as μ_c is exceeded, an alarm should be raised with minimum detection delay τ_D so that field personnel can be notified and remedial actions are to be taken on the faulty tap changer. As long as the mean is under μ_c, the equipment is deemed to be in a normal condition.

Fig. 3. Schematic illustration of gradual degradation of contact condition of resistance type tap changers.

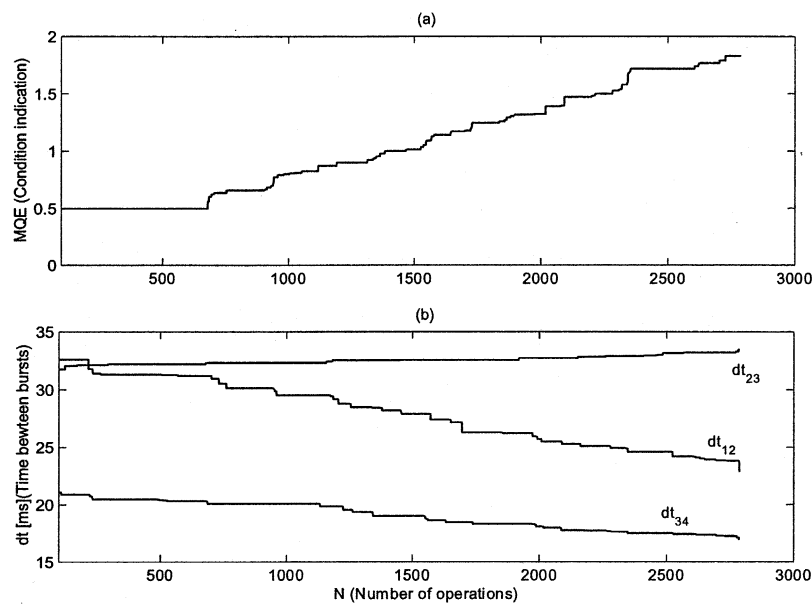
Fig. 4. (a) Plot of the mean path of the overall condition indicator against the number of operations. (b) Plot of the mean paths of the timing condition indicators against number of operations.

Fig. 4 shows the changes in the mean paths of the mqe and the delays in the time between vibration bursts for the signatures of a resistance type tap changer operating from 7 to 8 for a period of 2787 operations. This overall condition indicator shows monotonically increasing trend with respect to the gradual degradation of contact condition. The overall condition indicator mqe is used to automatically initiate the need for closer inspection of vibration signatures. The critical mean value μ_c for this type of OLTC has been determined to be 4.50 from the data of controlled experiments as well signatures recorded before and after maintenance. The present mqe value is 36% of its critical value.

Newly maintained	Due for maintenance	Rate of change (Dg) in %
No of operations	1	2787	
dt_{12} [ms]	34.02	22.90	$Dg_{12} = 32.65$
dt_{23} [ms]	30.26	33.47	$Dg_{23} = -10.65$
dt_{34} [ms]	21.10	17.00	$Dg_{34} = 20.00$
dt_{14} [ms]	85.38	73.37	$Dg_{14} = 14.07$

Table III gives the results of changes in the timing of the bursts in the vibration signatures for the resistance type tap changer operating from 7 to 8. We define Dg as the rate of change in time delay related to the value for a newly maintained OLTC. This rate of change of the time delay indicator is given in the fourth column of Table III. The values of Dg are related to the degree of contact wear, and we have been able to correlate the values of Dg with contact degradation. The data used in this correlation was obtained by conducting controlled experiments

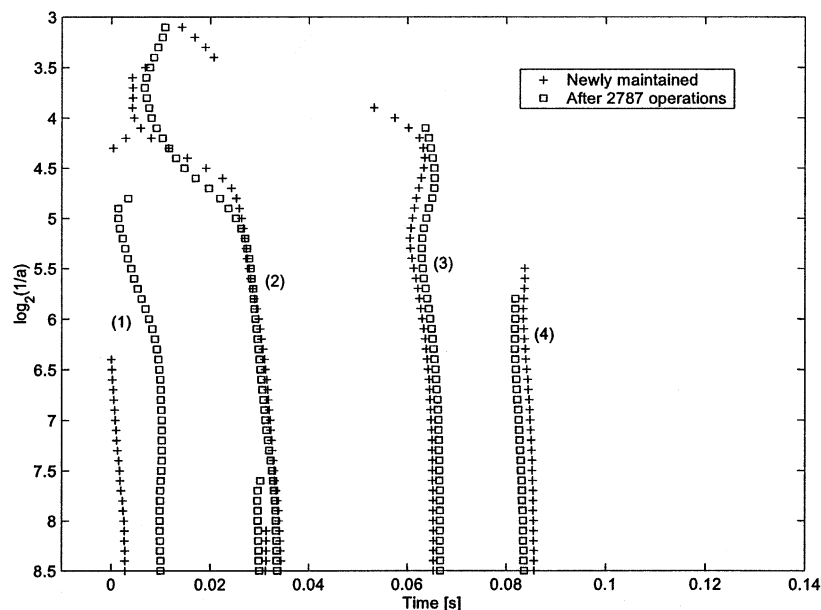
Fig. 5. Comparison of CWT ridge plots of a newly maintained resistance type OLTC and the same equipment after 2787 tap operations from 7 to 8.

Fig. 5 shows the CWT ridge plot of a vibration signature of a resistance type OLTC immediately after previous maintenance and the corresponding ridge plot after 2787 operations. Small changes in timing of the major bursts after over three year's operation are observable in the CWT ridge plots. However, the strengths of the four bursts were found to remain constant over the entire monitoring period of this tap changer. This is due to the fact that the degree of contact wear has reached approximately 36% of its allowable wear limit. The maintenance crew later confirmed that the actual physical degree of contact wear is comparable with the estimation made from the monitoring data. It has been demonstrated that with the help of the monitoring system, the maintenance of OLTC can be scheduled at a later time until the remaining life of the contacts has been reached.

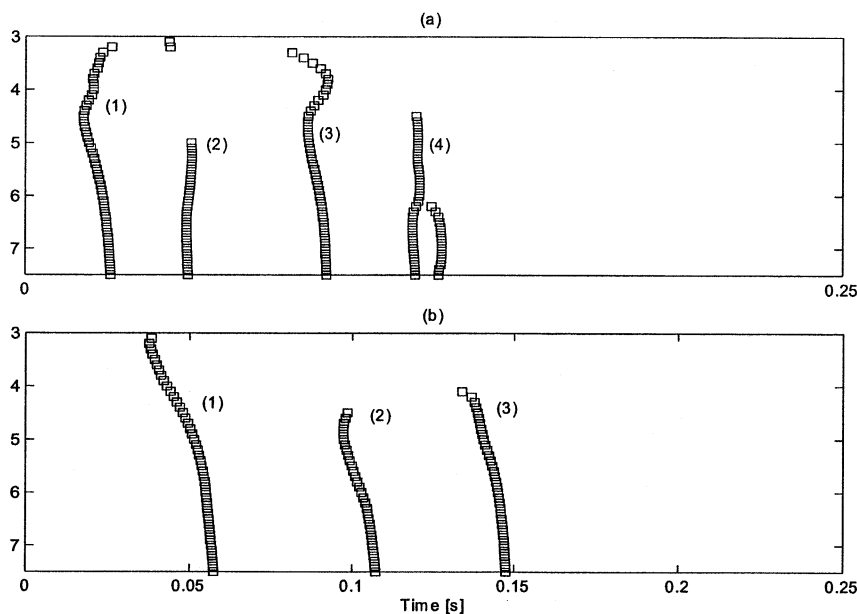
Fig. 6. (a) CWT ridge plot of a signature of good condition. (b) CWT ridge plot of a signature of abnormal condition.

Fig. 6(a) shows a typical CWT ridge plot of vibration signature of another resistance type tap changer measured immediately after the maintenance. This is a typical signature obtained for the tap changer operating from tap 7 to 8, and is considered to be the signature of the tap changer in normal condition. The monitoring system gave a warning 6 mo after the maintenance that there were occasional abnormal signatures. A typical CWT ridge plot of an abnormal signature is shown in Fig. 6(b), in which, one of the four bursts normally appearing in the normal signature is missing. The abnormal signature occurred in signatures of all tap positions.

It appeared that there were significant changes in the contact operating sequence leading to abnormal signatures. It was hypothesized that this could be due to slipping of the tap changer drive shaft. At that stage, the rate of occurrence of the abnormal signatures appeared to be constant (not increasing). There was a concern that the abnormal contact sequence could be causing changes to the tap changer condition and might lead to catastrophic failure. It was therefore recommended that the tap changer be inspected at the earliest opportunity.

When field crew disassembled the drive wheel shaft, the slippage in the shaft was identified in the key and keyway of the Geneva wheel. There was about 1–2 mm of play within the keyway, which, when taken at the extremities of the moving contacts, equated to approximately 40 mm of play. Considering that the distance between the fixed contact is about 50 mm if this condition were left unchecked then a failure would have been inevitable.
