The Weld Cracking Susceptibility
of High Hardness Armour Steel

Ship Structures and Materials Division
Aeronautical and Maritime Research Laboratory

DSTO-TR-0320

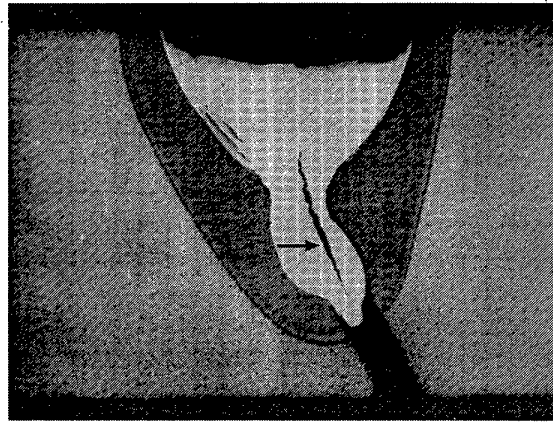
Mag. 6X approx.

Figure 5: *Weld centreline solidification crack (arrowed) in 312 stainless steel weld metal resulting from the large depth to width ratio of fusion zone welded with low heat input*

The duplex stainless steel electrode used complies with AWS A5.9 ER312. Centre-line cracks were observed in the fusion zone of these welds when the heat input was low (0.5 kJ/mm). These weld metal cracks can occur for a number of reasons, including too high a weld depth to width ratio or too small a bead size coupled with high restraint conditions. In this work it was found that increasing the heat input to 1.2 kJ/mm reduced the depth to width ratio of the fusion zone and eliminated the centreline cracking problem. No other cracks were observed in these weldments at any of the levels of heat input and preheat used. The fusion zone hardness did not vary greatly with the heat input and preheat used, and was marginally below the hardness of the ferritic electrode fusion zones. The hardness profiles and zone sizes of the RH-HAZ and T-HAZ were similar to those produced using the two other electrode types when similar heat input and preheat were used. The hardness ranges at various heat input and preheat levels are summarised in Figure 10.

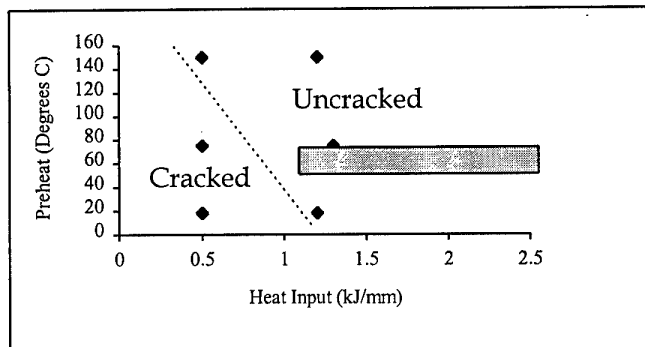
In this work it was found that under the high restraint conditions of the Y-groove test, cracking did occur at very low heat inputs, 0.5 kJ/mm, when the preheat was at or below 75°C. No cracks were observed when a preheat of 150°C was used. When the heat input was increased to 1.2 kJ/mm no cracking occurred, regardless of the preheat temperature. The incidence of cracking is summarised in Figure 7.

Figure 7:   Relationship between preheat, heat input and HAZ cracking of ferritic welds. The dotted line represents the approximate demarcation between cracking and non cracking conditions. The weld parameters trialed are shown by ◆

Based on this work and the Bisalloy Steels handbook it is recommended that heat input levels should be 1.0 - 2.5 kJ/mm and the preheat should be 50 - 75°C. These limits are considered to be reasonably conservative and should allow for welding in workshop conditions.

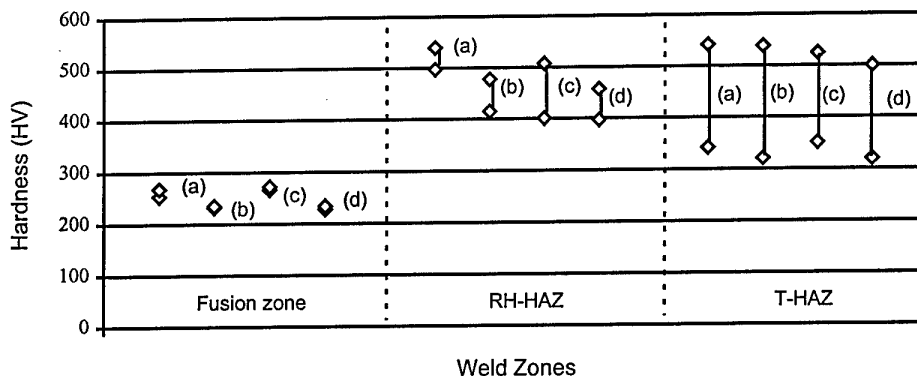
Figure 8: Hardness of weld zones for various combinations of heat input and preheat with the ferritic electrode

a.	Heat input 0.5 kJ/mm, no preheat
b.	Heat input 1.2 kJ/mm, no preheat
c.	Heat input 0.5 kJ/mm, 150°C preheat
d.	Heat input 1.2 kJ/mm, 150°C preheat

The hardness reductions in the RH-HAZ, brought about by increasing the levels of heat input and preheat are relatively modest and may not fully account for the elimination of cracking in these zones. A concomitant reduction in residual stress may also help to eliminate the conditions necessary to cause cracking.

Softening in the T-HAZ was also found to be significant, although the minimum hardness measured in this zone was greater than in the fusion zone. The minimum hardness in the T-HAZ (heat input 0.5 kJ/mm and no preheat) was approximately 60% of that of the original plate. When the heat input level was increased to 1.2 kJ/mm and a preheat of 150°C was used, the minimum T-HAZ hardness also decreased to approximately 60% of that of the original plate. The zone size was also significantly affected by the level of heat input and preheat used. The zone size increased from 9 to 23 mm (156%) when the heat input and preheat were raised from 0.5 kJ/mm heat input, room temperature preheat to 1.2 kJ/mm heat input, 150°C preheat.

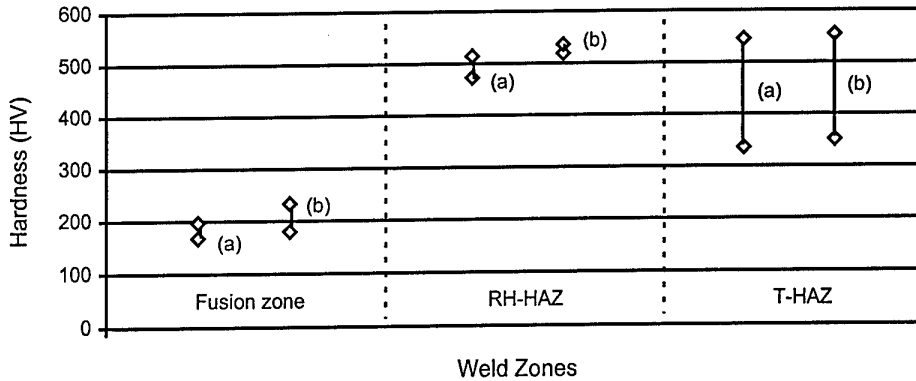
relatively low (168 - 233 HV_{10}) when compared with those produced with the other electrodes and poorer structural strength would be expected. The hardness profiles and zone sizes of the RH-HAZ and T-HAZ were similar to those produced using the ferritic electrode when similar heat input and preheat were used. The hardness ranges for each weld zone are summarised in Figure 9.

Figure 9: Hardness of weld zones produced with the austenitic electrode

a.   Heat input 0.7 kJ/mm, no preheat
     b.   Heat input 0.9 kJ/mm, no preheat

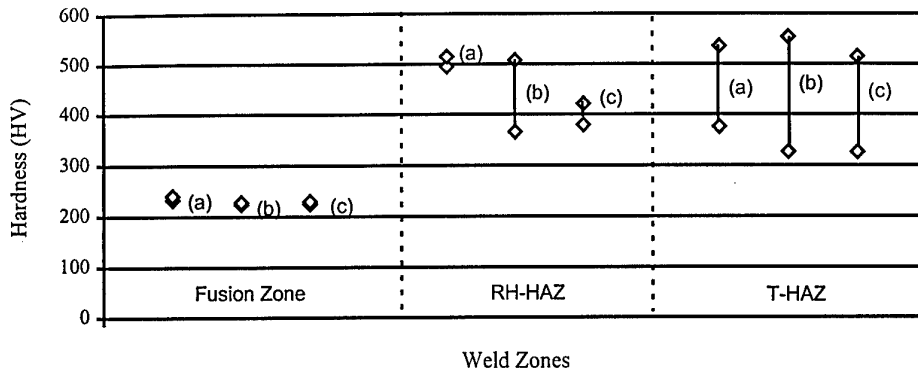
Figure 10: *Hardness of weld zones produced with the duplex stainless steel electrode*

a.   *Heat input 0.5 kJ/mm, no preheat*
    b.   *Heat input 1.4 kJ/mm, no preheat*
    c.   *Heat input 1.2 kJ/mm, 150 °C preheat*
