## **A monitoring technique for disbond area in CFRP bonded joints using embedded fiber Bragg grating sensors: development and experimental validation**

This study evaluated fatigue-induced disbond areas in CFRP double-lap joints by using embedded fiber Bragg grating (FBG) sensors. When the disbond grew by cyclic loading, the embedded FBG sensors yielded reflection spectra having two peaks representing a step-like strain distribution generated by the disbond; the peak at the shorter wavelength corresponded to the unloaded disbond region. The ratio of the peak intensity at the shorter wavelength to that at the longer wavelength increased gradually with increasing disbond length. The relationship between the peak intensity ratio and the disbond length was analyzed by coupled structural-optical analysis and was validated by comparing analytical peak intensity ratio with experiment results. The disbond length was then estimated from the measured spectra based on this analytical calibration relationship, but the estimated disbond area exceeded that observed using the ultrasonic C-scan technique. Additional experiments

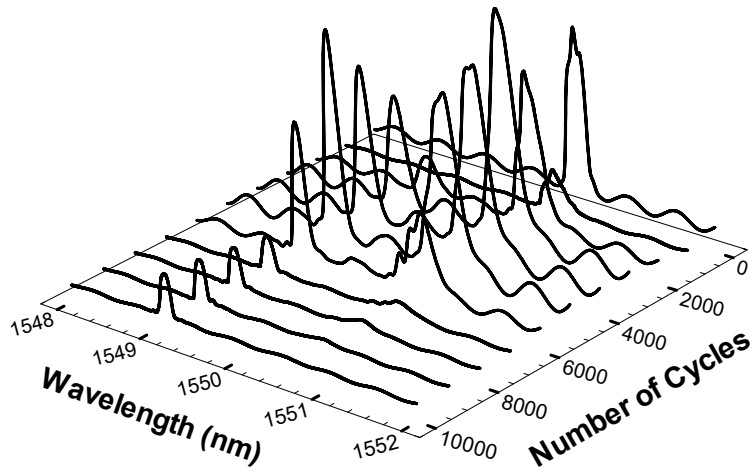
Figure 3 Measured reflection spectra of embedded FBG sensors. A new peak at a shorter wavelength appeared and grew as the number of cycles increased.

Disbond lengths along the three sensor lines were estimated from the measured reflection spectra (Fig. 3) by using Eq. (1), and the disbond area was determined by connecting the three disbond tips with a quadratic curve. This disbond area was represented in the finite-element model, and strain field was evaluated. Figure 8 presents a contour plot of the longitudinal strain  $\epsilon_{xx}$  considering the disbond area determined by the reflection spectra measured at  $N = 2000$  and  $8000$ . The strain in the disbond area was almost zero, and a step-like strain distribution appeared in the longitudinal ( $x$ ) direction. Figure 9 presents the analyzed reflection spectra of the three FBG sensors considering the estimated disbond area. The spectrum had two peaks. The original peak was at a longer wavelength (1550.5 nm), reflecting the constant tensile strain in the intact region, and a new peak appeared after 2000 cycles at a shorter wavelength (1549 nm), reflecting the unloaded disbond area.

Figure 4 compares the peak intensity ratio of the estimation (Fig. 9) with the experiments (Fig. 3). The estimated disbond area and corresponding strain distribution were based on the completely-analytical relationship between the peak intensity ratio and the disbond length. Nevertheless, the estimated peak intensity ratio increased monotonically with increasing the cycles, and this trend agreed

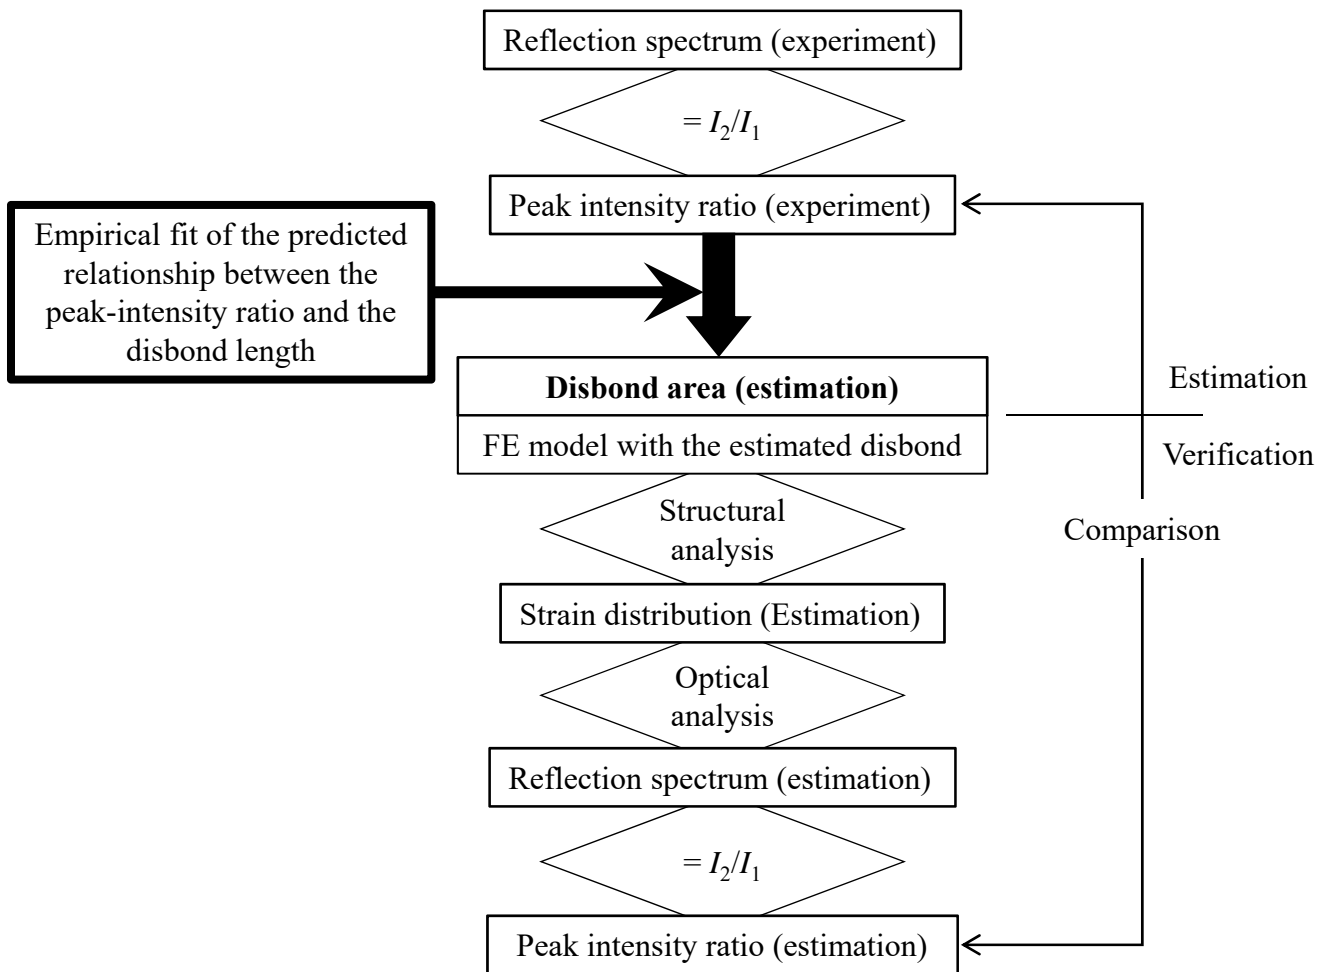
Figure 5 Estimation procedure for disbond area using the reflection spectrum and its verification procedure.

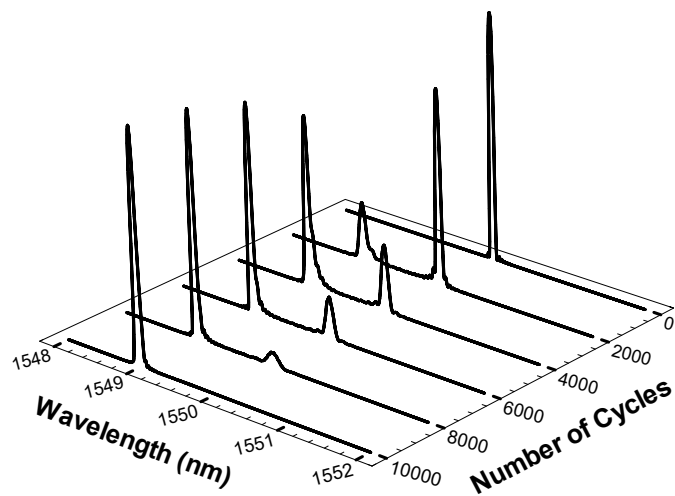
Figure 9 Analyzed reflection spectra of FBG sensors considering the estimated disbond area.
